Board Questions April 24, 2019

Item 4 - 3 historic structures

**LA HONDA CREEK OPEN SPACE PRESERVE
UNINCORPORATED SAN MATEO COUNTY, CALIFORNIA**

B: Structural Conditions Assessment and Treatment Recommendations

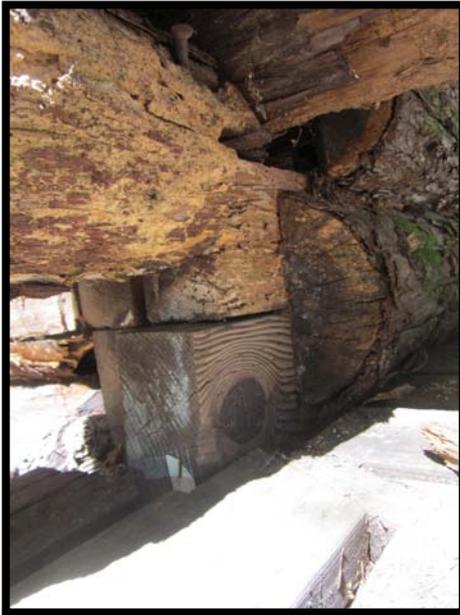
In general, the log walls appear to be in good condition. Some localized beetle or termite damage was observed and a more extensive inspection should be completed by a licensed pest control firm. Some gaps have developed between logs due to shrinkage and loss of the fibrous caulk material. These gaps should be re-filled and made rodent-proof.

The roof overhangs the exterior walls by around 2-feet, providing some protection from rain. In general, the horizontal logs do not appear to have significant deterioration due to weather. However, at the corners of the building, the interlocking horizontal logs extend around 12-inches beyond the face of wall. These projecting ends of the logs have less protection from the roof overhang, and some of the lower logs have experienced significant water damage and deterioration. The short pieces of shaped logs at the ends of the sawn beams have in some cases experienced significant deterioration and have become detached.

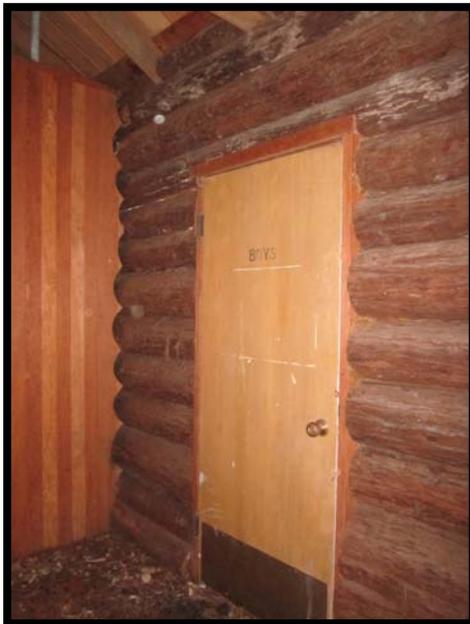
The lower portions of the walls may also have experienced some water damage. The sawn lumber beams are generally hidden from view although movement of the split log cladding at some locations has exposed some portions of the beams. It may be necessary to temporarily remove the split log cladding to allow complete examination of the sawn lumber beams and repair as necessary.

The horizontal logs have generally experienced significant drying shrinkage. The moisture content of freshly cut lumber can be around 50%, including free water between the cells and water within cell walls. With long term exterior exposure, the moisture content of the lumber reduces until it is at equilibrium with the humidity of the air, typically between 10% to 15% for exterior conditions. During the first drying phase, free water between the cells is lost, reducing the moisture content to around 30%. The second drying phase results in water loss from within the cell walls, and as this water is lost, the cells shrink, resulting in shrinkage of the lumber.

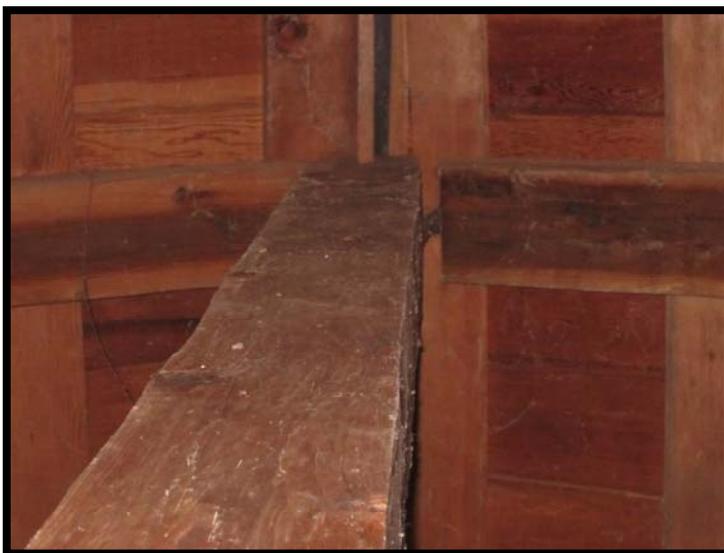
The roof structure bears directly on the log walls. As these bearing walls have reduced in height, the roof structure has lowered. However, two of the roof trusses are supported by vertical logs rather than horizontal logs and some of the trusses also have an intermediate support at the interior walls. Due to potential differential shrinkage between vertical and horizontal logs, some gaps have appeared between the roof structure and the supporting walls.

This has changed the support conditions of the trusses, and the top connection of at least one truss has opened significantly. Under normal conditions, this joint would be kept closed by the compression forces in the truss. However, due to loss of support at the end of the truss and the additional support from the vertical log at the end of the interior wall, the top joint has now opened. This has also resulted in a significant gap opening in the roof sheathing, with the roofing felt

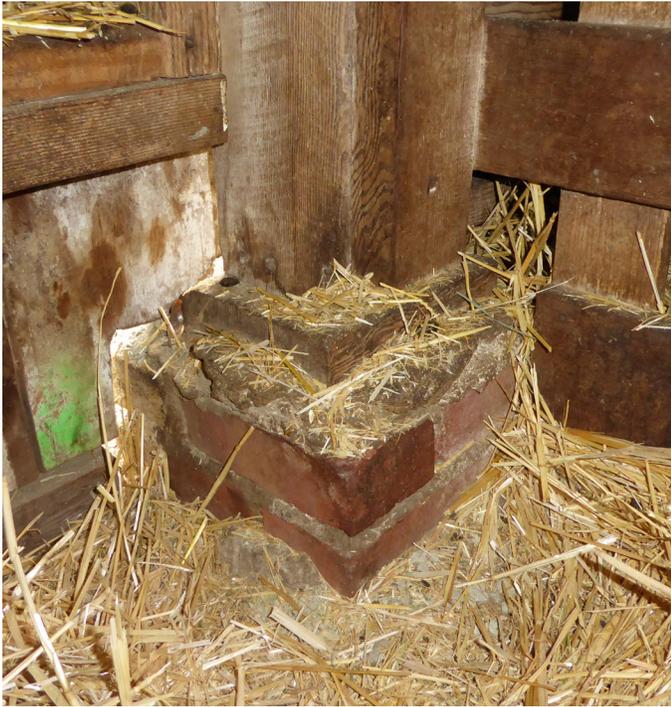
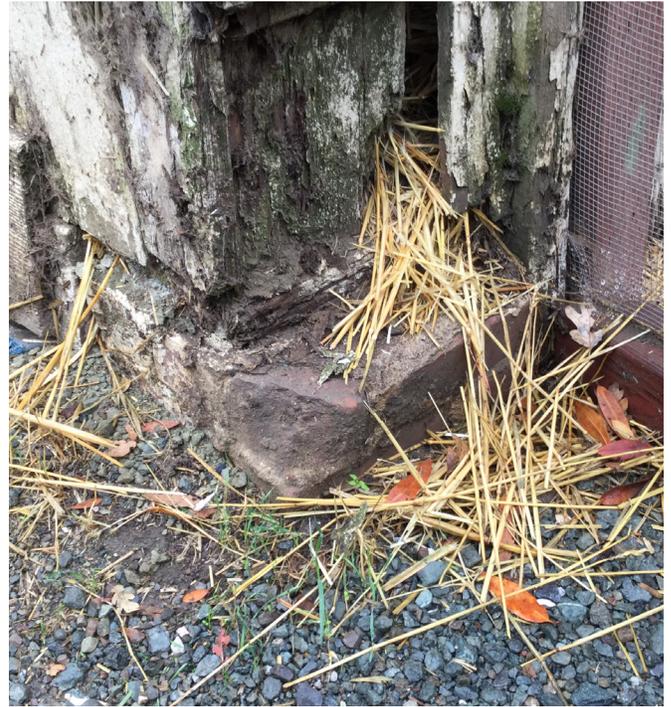
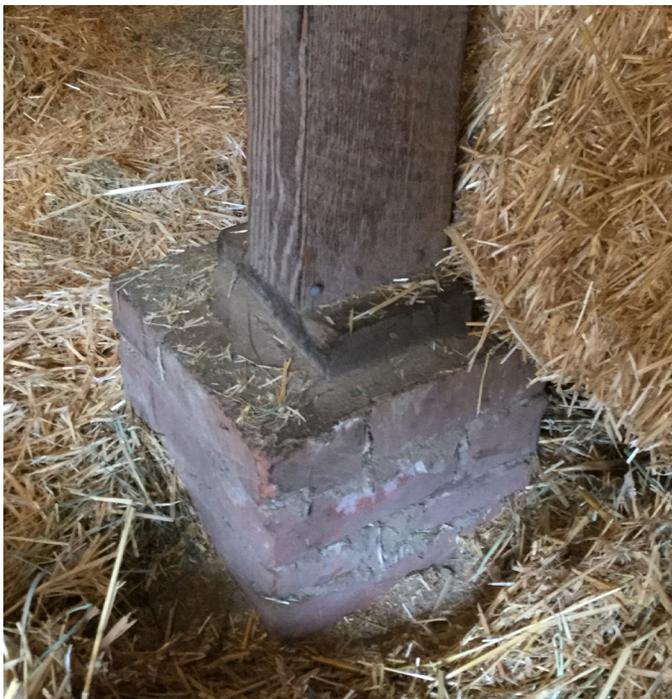
The common red brick used for the pier foundations are in fair to poor condition. Some show signs of minor efflorescence. Nicks, gouges or broken corners are common. Mortar is generally intact.

Image 9 - (top left) Brick Piers are low and surrounded by straw and other organic material.

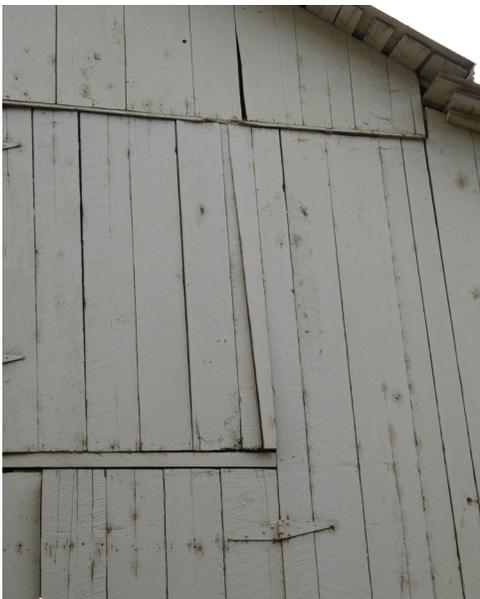
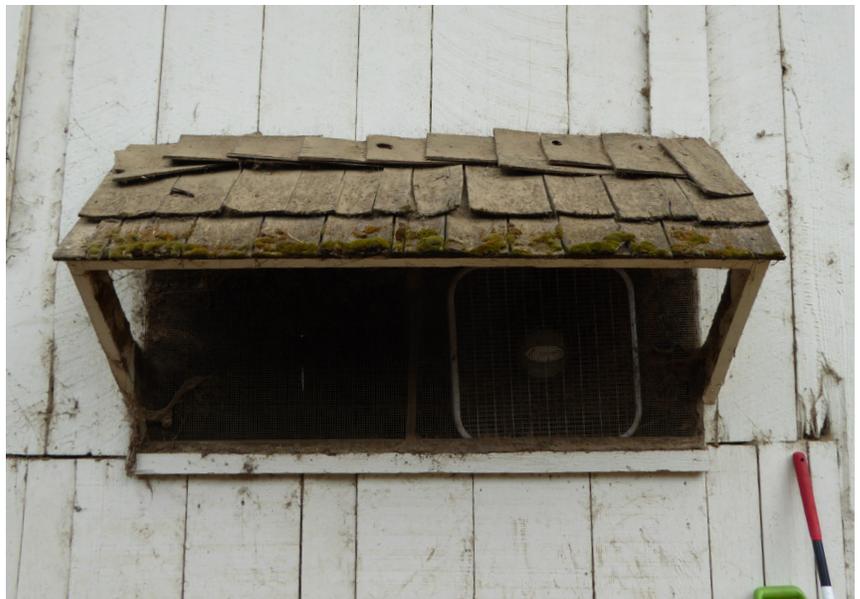
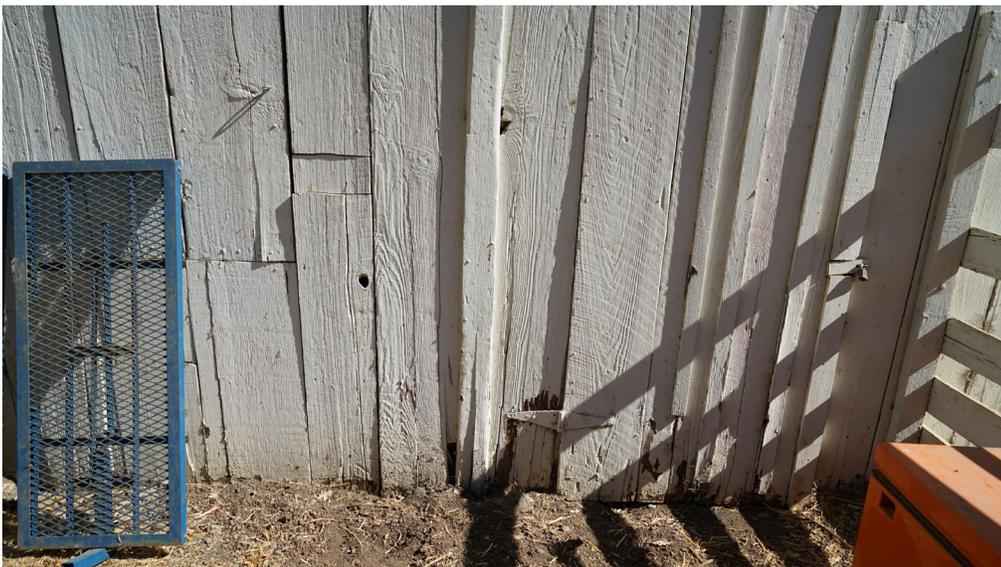
Paint remains well-adhered to boards, with minimal delamination. It appears the barn has not been regularly repainted or maintained much with respect to the coating.

Image 12 - (top left) Irregular sized gaps and proud boards where anchors are loose are typical.

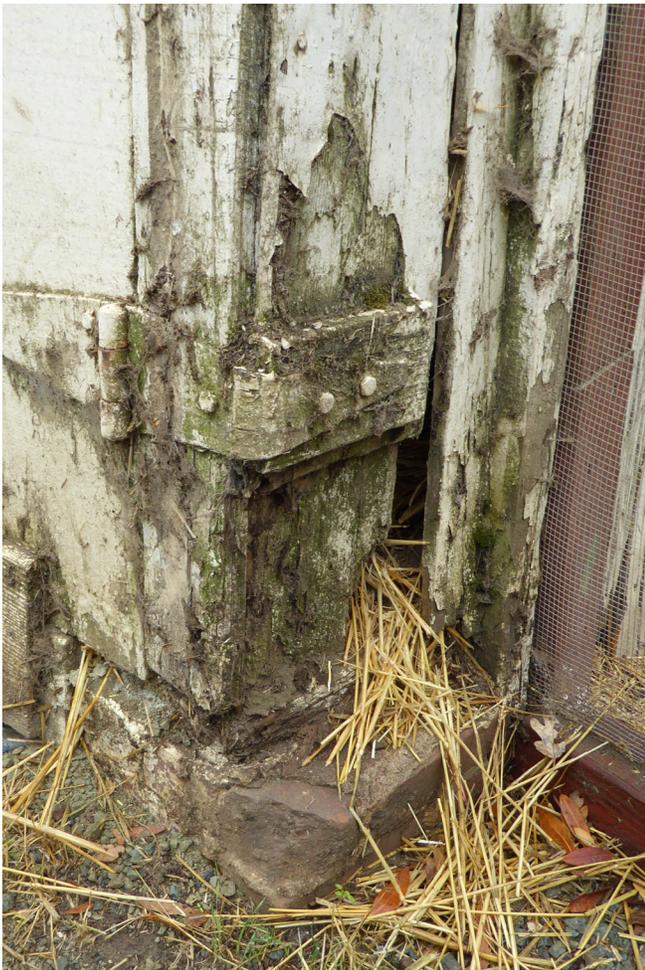
Sill plates and posts around the building perimeter show evidence of termite damage (carpenter ants are the other possible culprit) and post beetle holes are evident in some locations. The northeast corner post is especially brittle with evidence of internal damage up to at least 7' on the post. See the structural condition assessment for information about the structural integrity of the wood frame.

Image 15 - The post at the northeast corner exhibits biological growth, wood rot, and material loss due to damage and insect infestation.

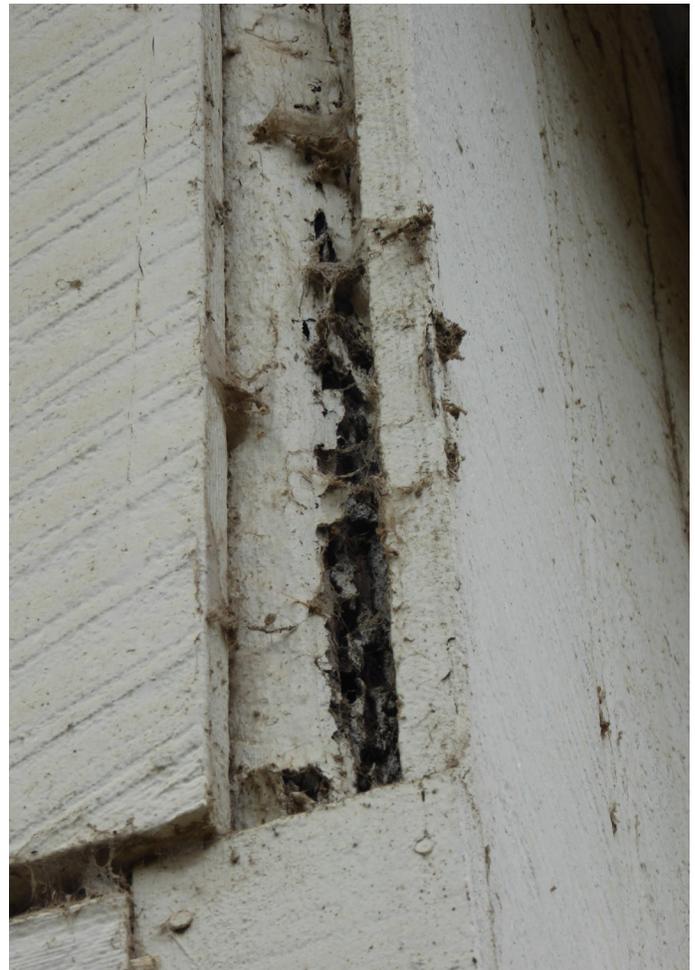
Image 16 - Termite holes are visible in the northeast post above 6 feet.

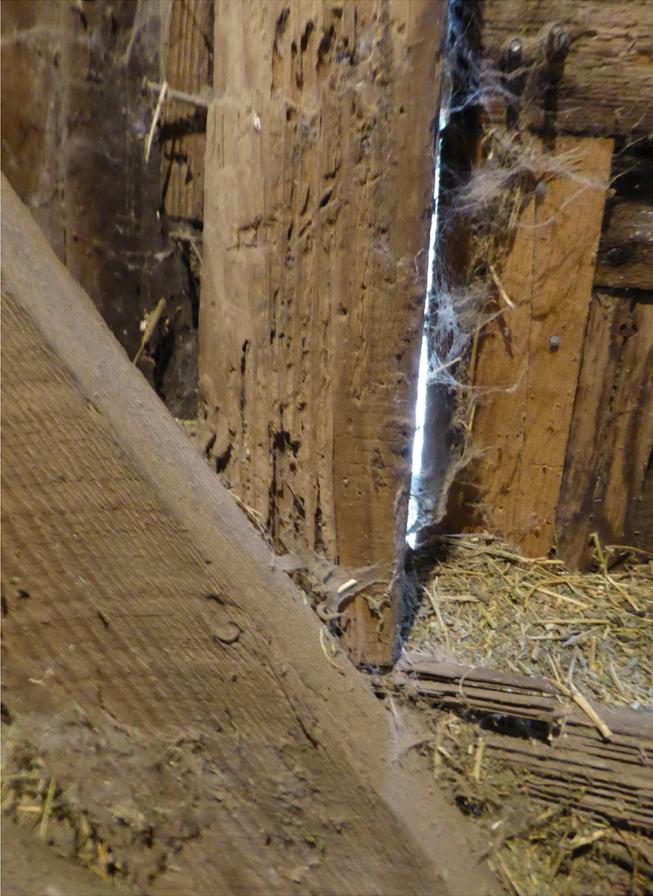
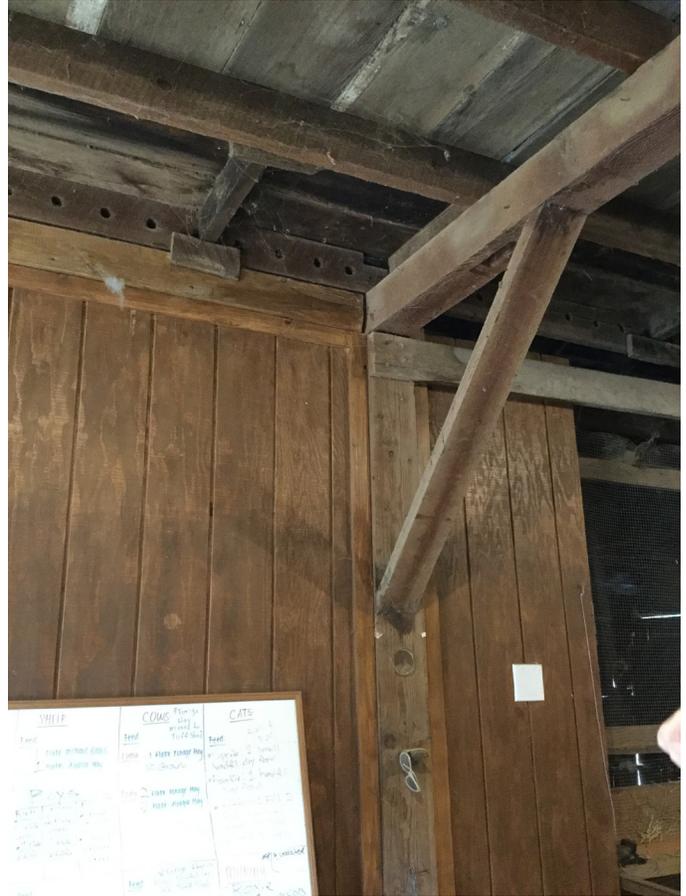
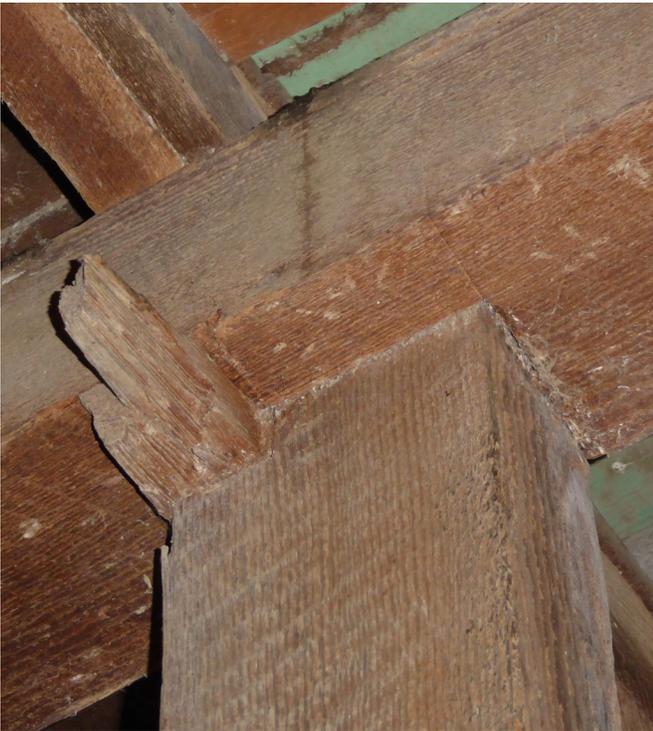
Image 17 - (top left) Insect infestation and wood rot are evident at sill plates and exterior perimeter posts throughout the structure.

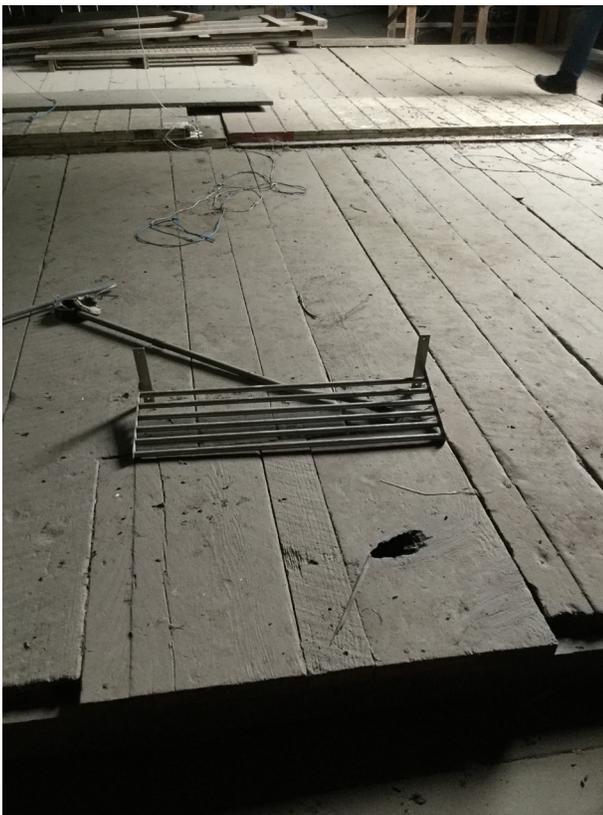
The hay loft floor through the center bay of the barn is secured only at the end points of each board. Some nails are likewise loose, missing, or insufficient to tack down the board. Wood boards themselves are worn, however, they are in serviceable condition and retain structural integrity enough to serve as a flooring material in both locations.

Image 20 - (above) The hay loft floor. The cut-out section in this photo covers the hay trough for the horse stall below. Boards otherwise extend from the edge of the center bay to the opening in the floor here covered by doors.

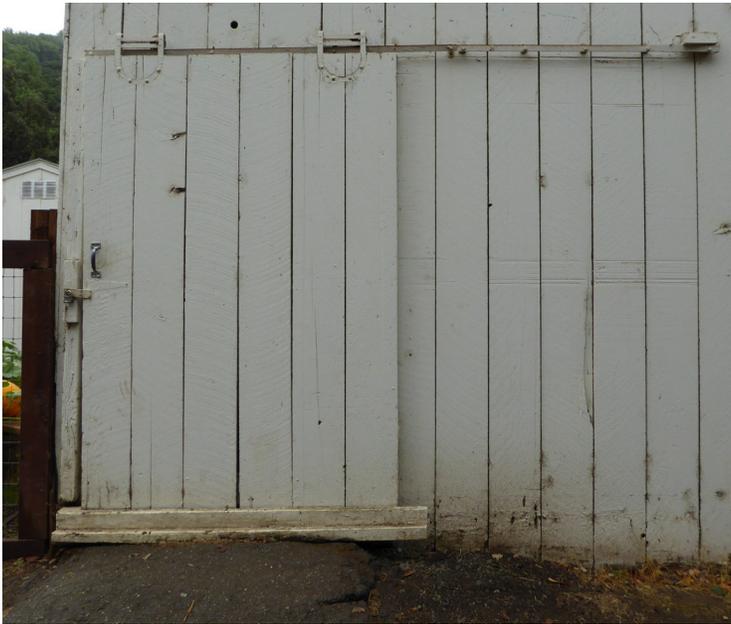
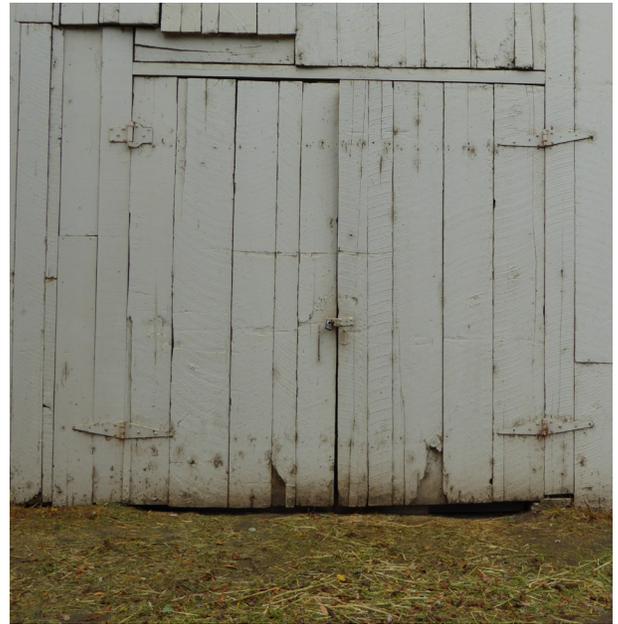
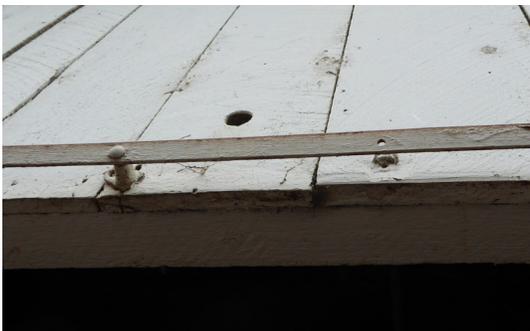
Image 23 - (clockwise, from top left) Sliding barn door into the horse stall area. The panel and operable elements are in good condition.

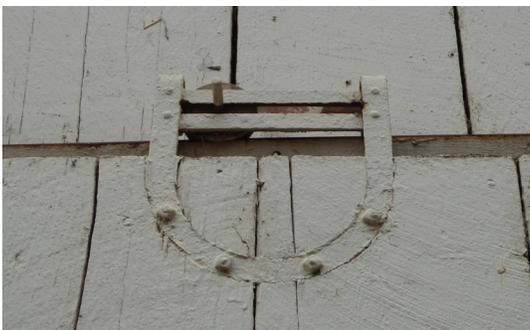
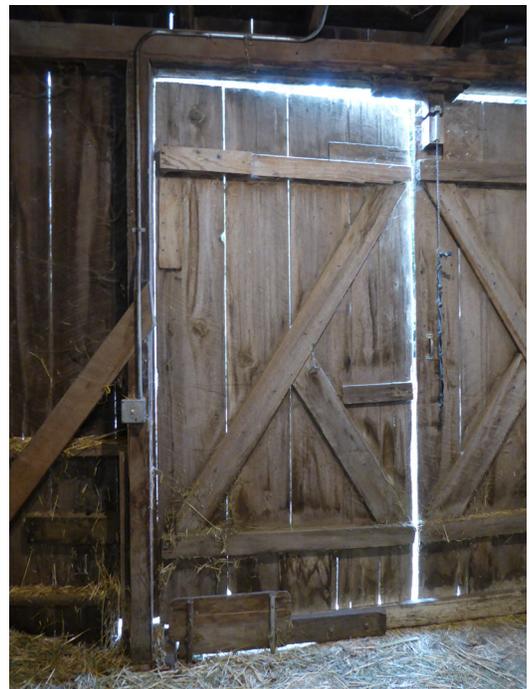
Image 27 - (left, above) Missing thru-bolts on the sliding door track.

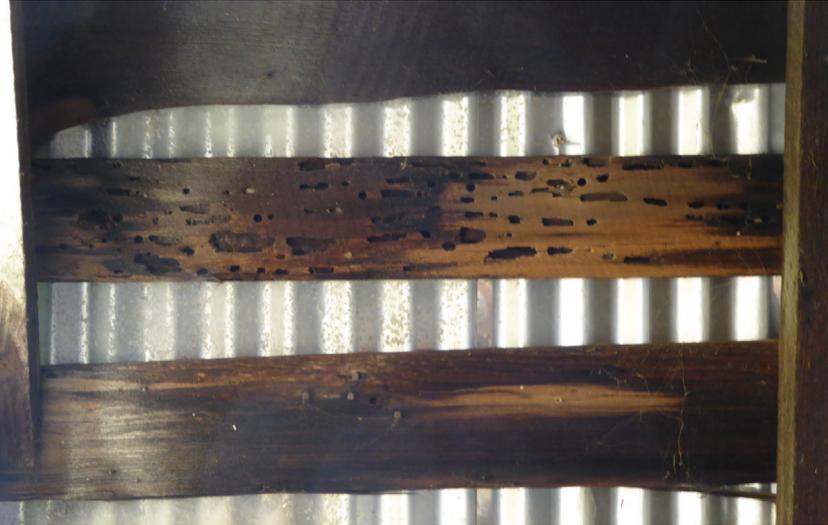
Image 33 - Evidence of insect infestation in the skip sheathing.

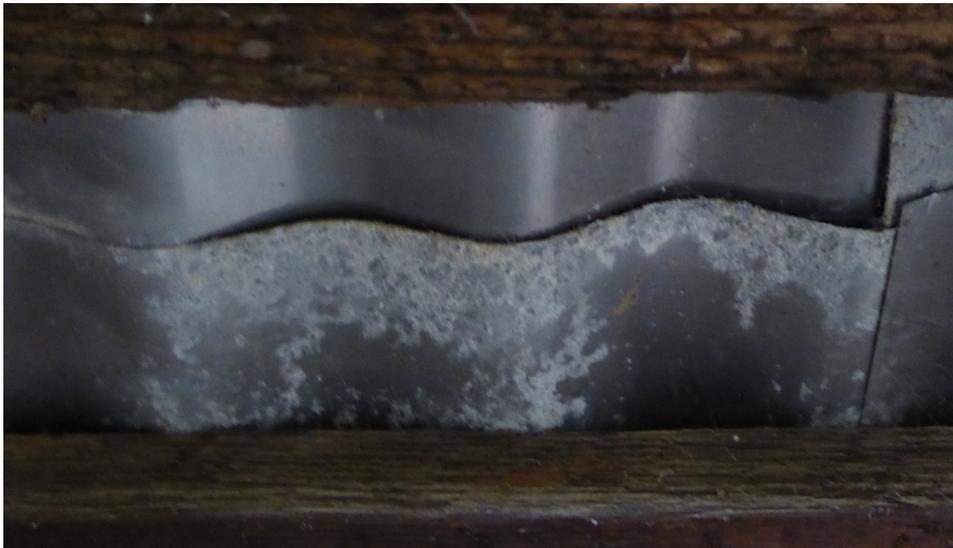
Image 35 - Oxidation of the zinc galvanizing on the sheeting.

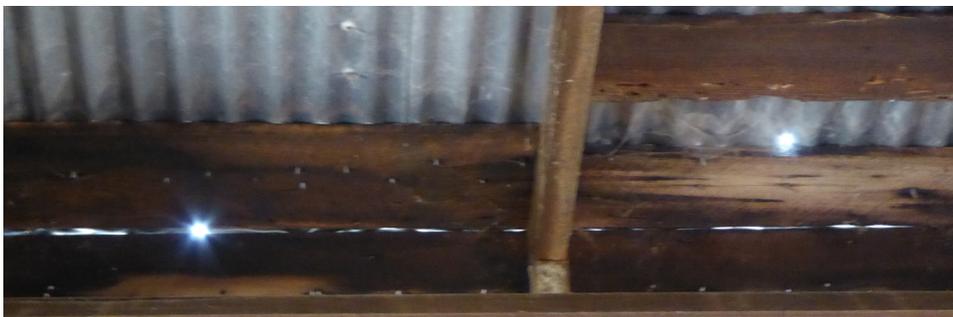
Image 37 - Daylight is visible through the sheeting in some areas, however farm staff indicate that there are no leaks during rains.
