Midpeninsula Regional  
Open Space District

Contract Amendment for Engineering Services with Wiss, Janney, Elstner Associates, Inc., for the Mount Umunhum Radar Tower Repair Project

## **MOUNT UMUNHUM RADAR TOWER Condition Assessment and Recommendations**

### **Final Report**

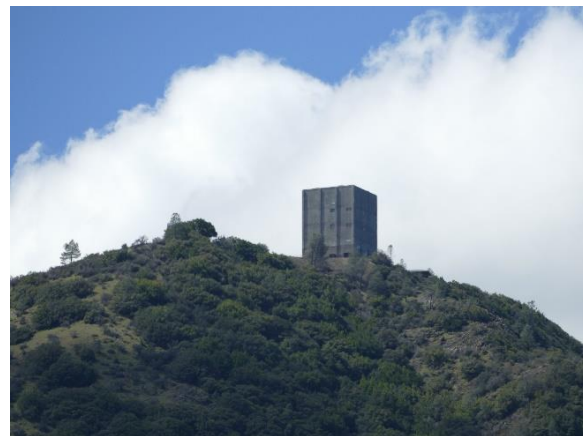
*Figure 4. Photo of the radar tower, facing west.*

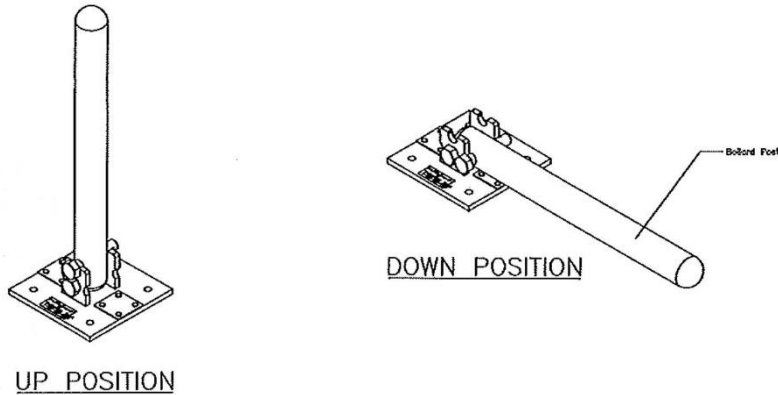
Figure 5. Foldable bollard used on Mt. Umunhum Road.

Replace the two removable bollards with a bollard system that is tolerant of exposure to sand and debris. A foldable bollard system, similar to that used along the roadway to the peak of Mount Umunhum (Figure 5) would appear to be easier to operate and would be less likely to become jammed with debris. Replacement bollards would be expected to last at least 30 years.

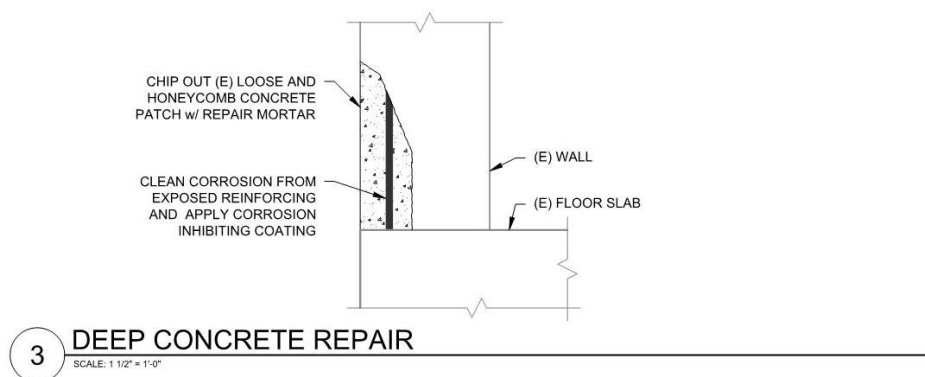
Figure 8. Base deep concrete void or spall repair.

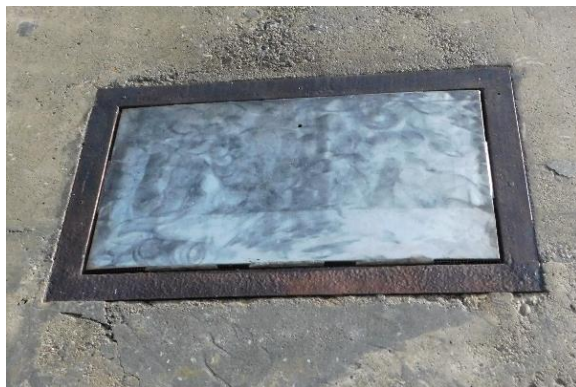
Figure 15. Typical opening in concrete wall, closed with steel plate.

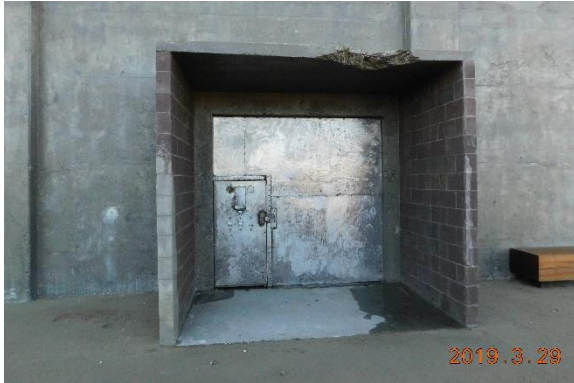
*Figure 17. Covered exterior entryway around main entry door on west elevation. Note the spall at the edge of the roof slab.*

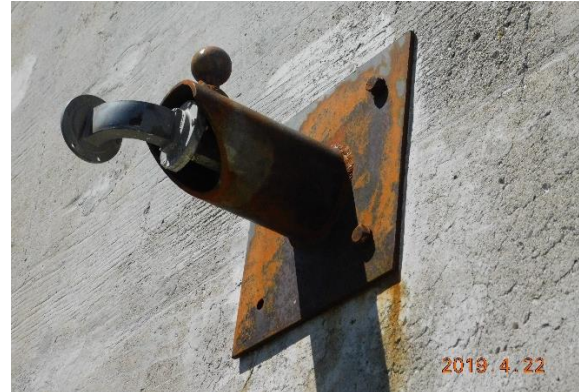
*Figure 18. Steel fixture attached to concrete wall.*

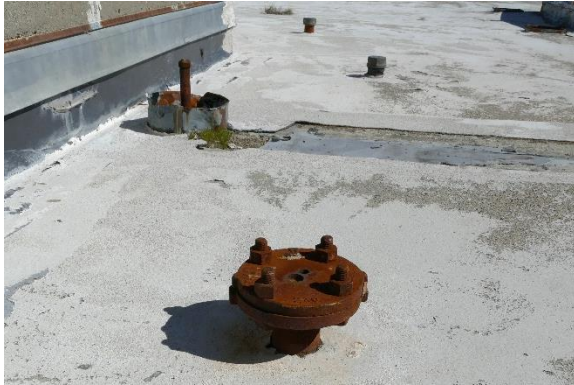
*Figure 21. Various pipe penetrations, conduit in a pitch-pocket, and visible sealant repairs at the expansion joint. Photo facing north.*

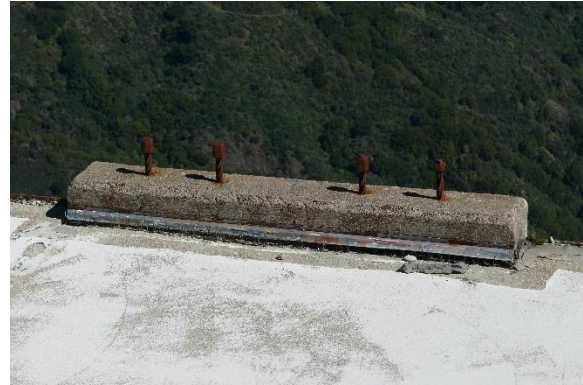
*Figure 22. Curb with counterflashing at roof edge, facing north.*

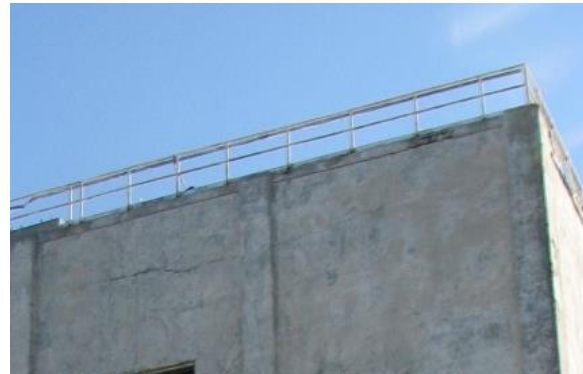
*Figure 26. Apparently metal guardrail that was present circa 2013.*

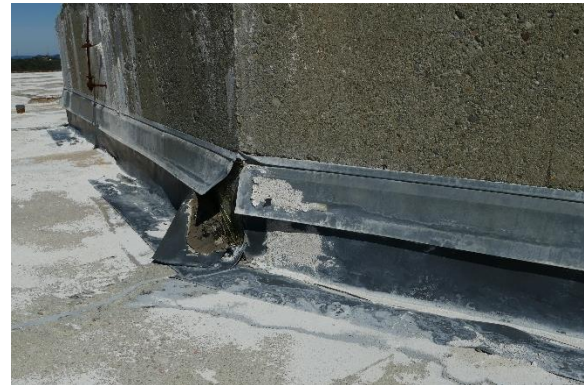
Figure 28. Counterflashing at concrete pedestal. Note the single-ply membrane flashing that was later added, and has failed.

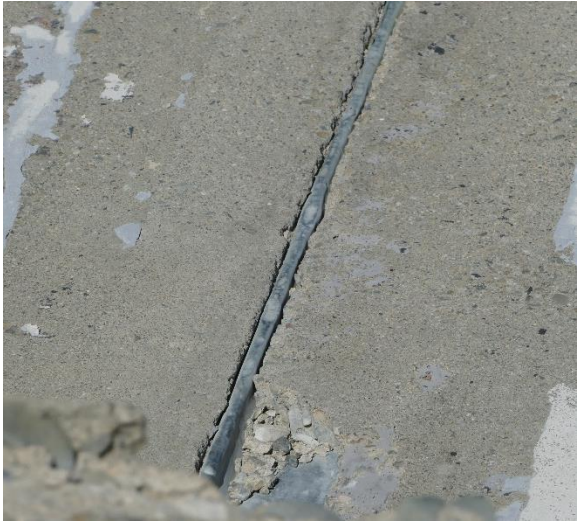
Figure 30. Wearing slab expansion joint formed from folded copper sheet that was originally covered by sealant. Note that the other three joints in the slab were concealed by more modern repair sealant.

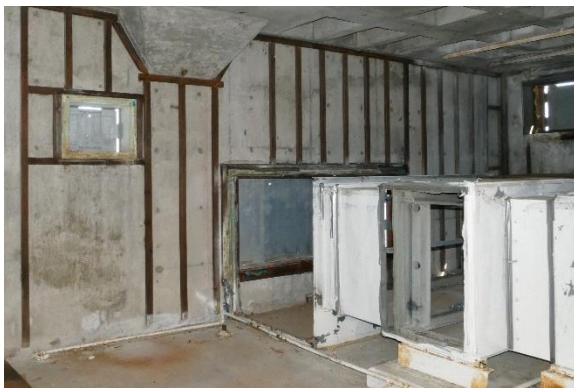
*Figure 35. The building interior has remaining wood-framed partitions, furring and some abandoned HVAC equipment.*

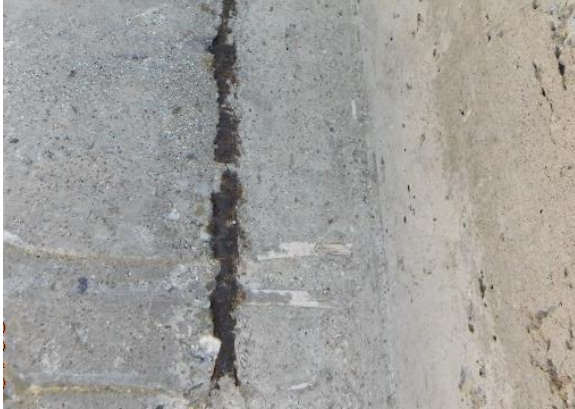
*Figure 39. Corroded reinforcing steel with minimal concrete cover.*

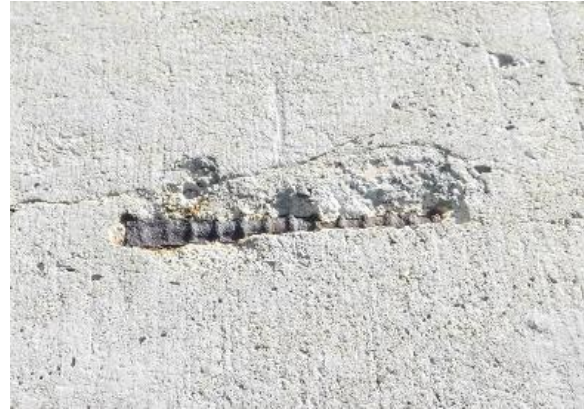
*Figure 40. Reinforcing steel with little to no cover.*

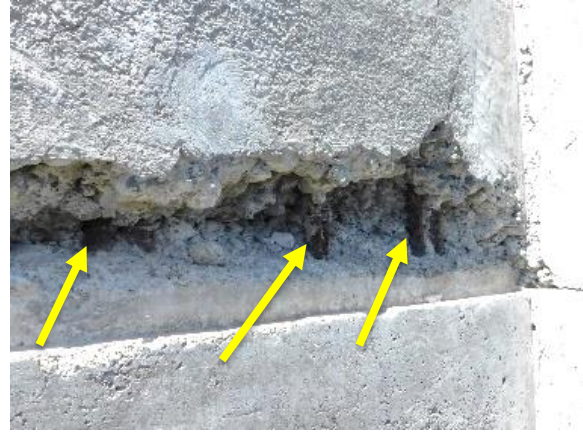
*Figure 44. Poorly consolidated concrete above the horizontal construction joint above the floor slab revealing the joint key and reinforcing steel (arrows).*

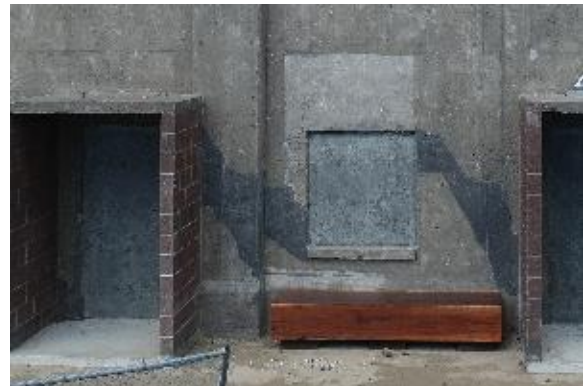
*Figure 46. Repaired cracks and infilled openings at east elevation.*

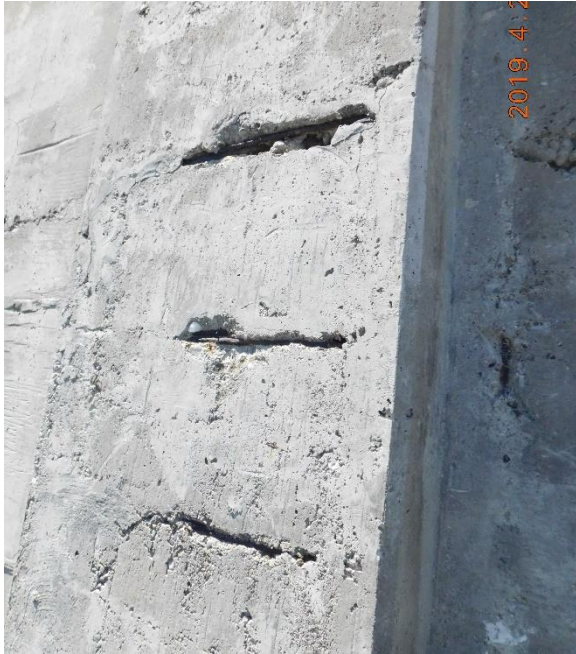
The concrete pilasters have experienced significantly more frequent and severe concrete spalling than the surface of the walls. This spalling has exposed corroded reinforcing steel. Most of the spalling at the horizontal reinforcing is the result of inadequate concrete cover over the horizontal reinforcing (Figure 47 and Figure 48).

*Figure 47. Concrete spalling on face of pilaster due to inadequate concrete cover.*

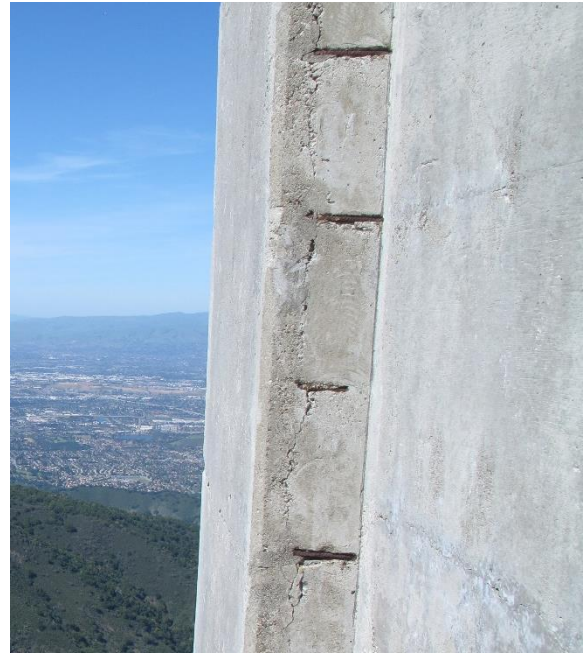
*Figure 48. Concrete spalling on side of pilaster due to inadequate concrete cover.*

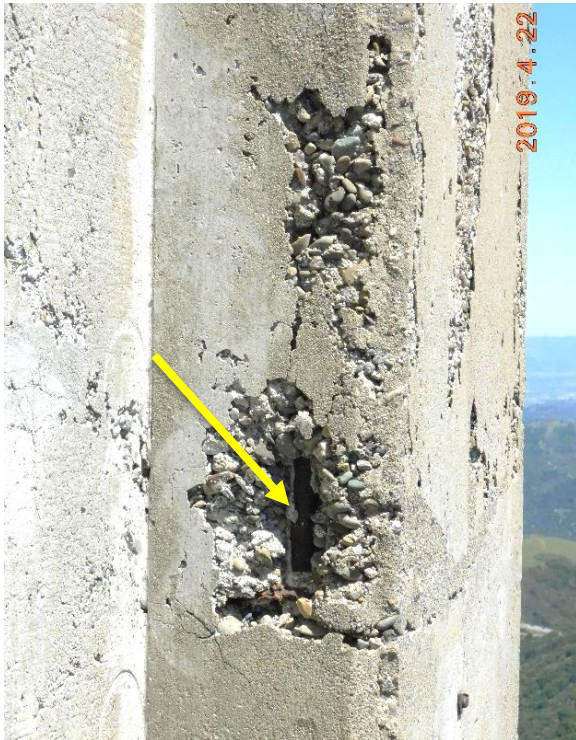
In other locations where the vertical reinforcing is exposed, spalling occurs in areas of poor concrete consolidation on the sides and corners of the pilasters between the vertical reinforcing bars and the finished exterior concrete surface (Figure 49 and Figure 50).

*Figure 49. Poorly consolidated concrete on the side and corner of the pilaster. Note exposure of reinforcement steel (arrow).*

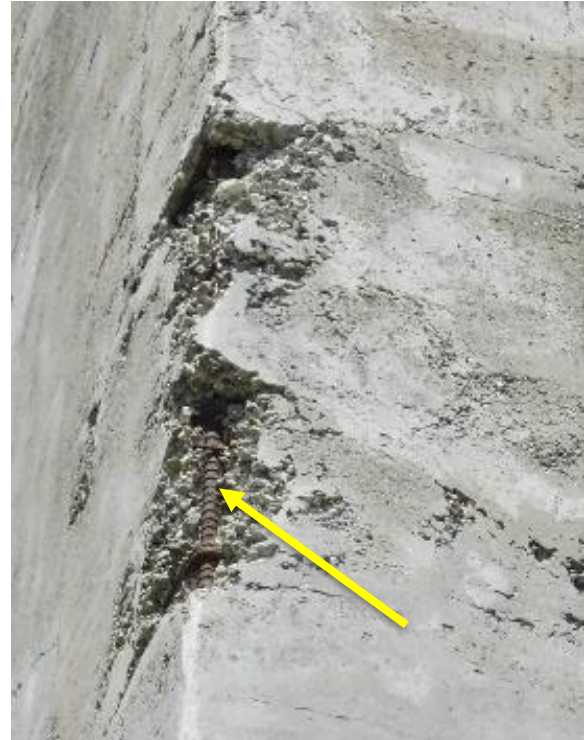
*Figure 50. Poorly consolidated concrete on the sides and corner of the pilaster. Note exposure of reinforcement steel (arrow).*

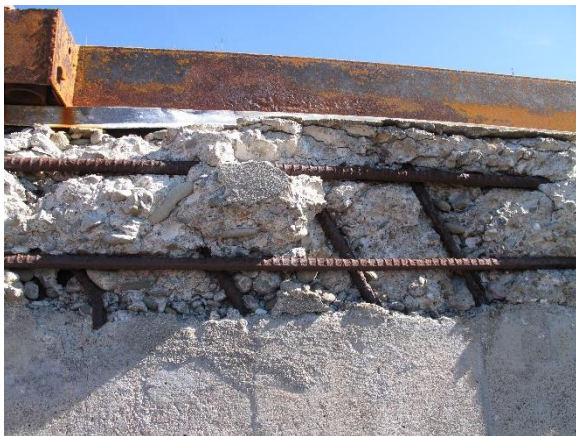
Significant concrete spalling has occurred along the perimeter beam along the edge of the roof slab, which it protrudes from the exterior face of the walls, exposing the wall and roof slab reinforcing steel in places (Figure 51 and Figure 52). Smaller concrete spalls that are not associated with corroded reinforcing are also present, primarily along the bottom of the perimeter roof edge beam at the drip (Figure 53 and Figure 54).

*Figure 51. Concrete spalling and exposed reinforcing along the perimeter roof edge beam.*

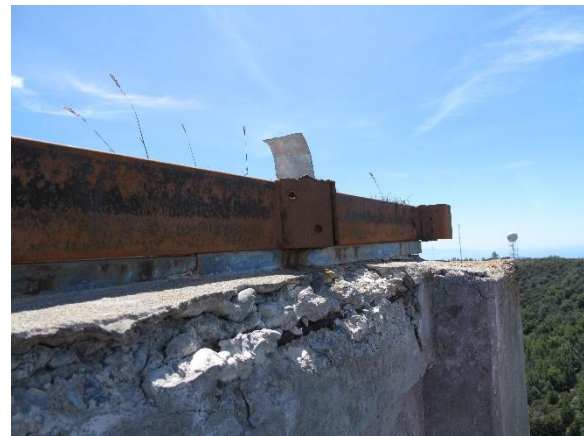
*Figure 52. Concrete spalling and exposed reinforcing along the perimeter roof edge beam.*

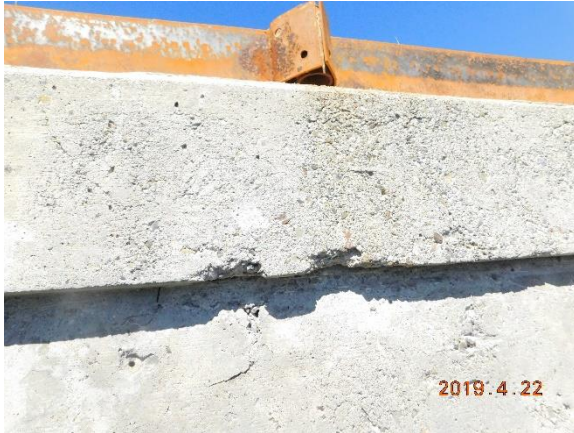
*Figure 53. Small concrete spalls along the bottom edge of perimeter roof edge beam.*

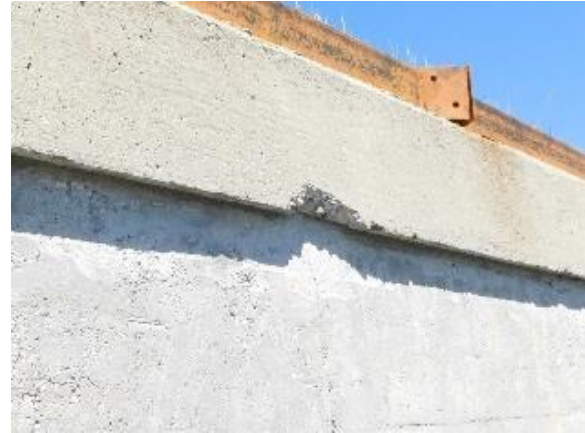
*Figure 54. Small concrete spall along the bottom edge of perimeter roof edge beam.*

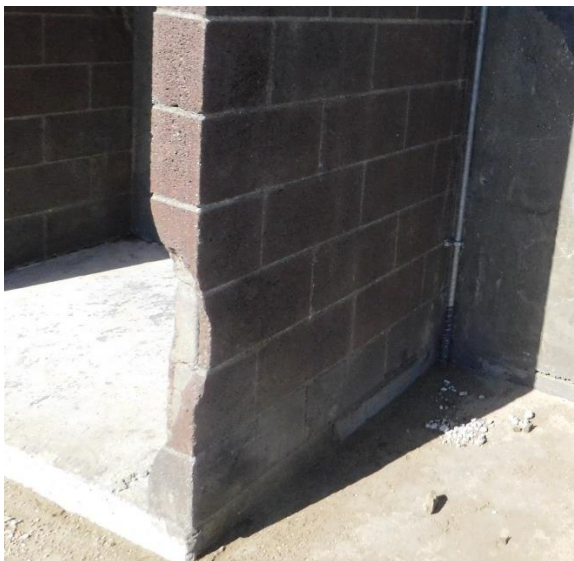
Several of the concrete block wind screens were also observed to have some spalling (Figure 55). Spalling of the concrete slab forming the roof of the wind screens was also observed (Figure 56).

*Figure 55. Spalling of concrete block wall of wind screen*

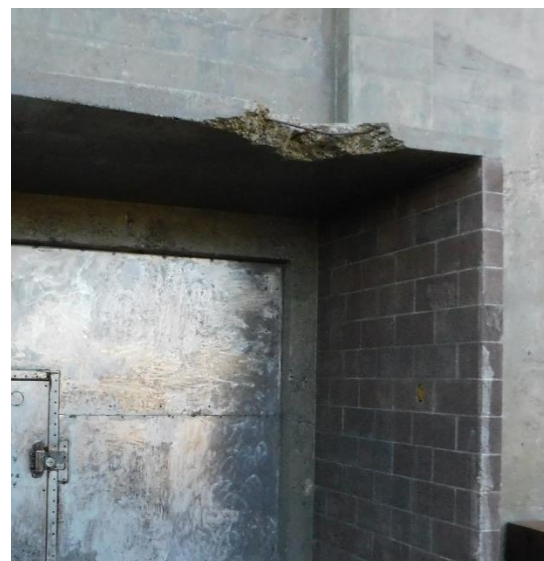
*Figure 56. Spalling of concrete slab at top of roof of wind screen.*

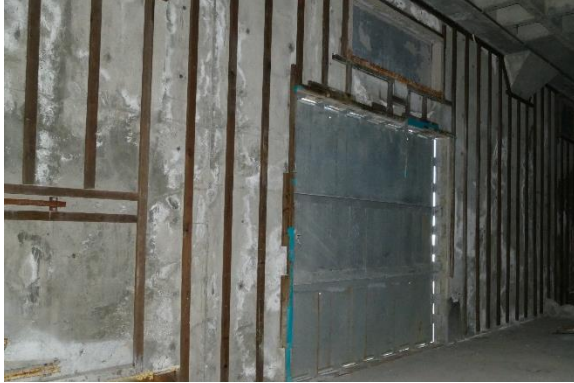
*Figure 57. Efflorescence stains at interior of concrete walls.*

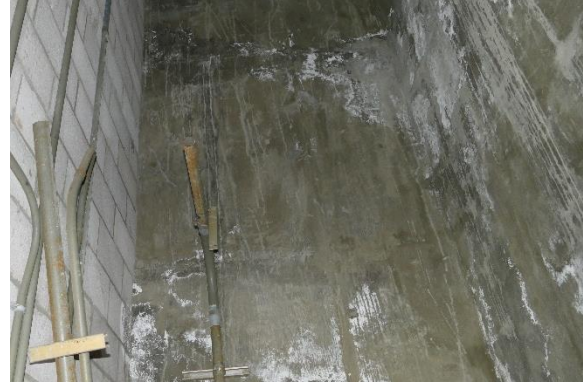
*Figure 58. Efflorescence stains in utility shaft at southeast building corner, facing east.*

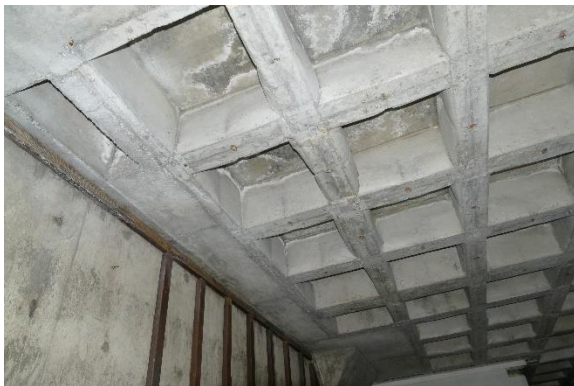
*Figure 59. Efflorescence visible on the underside of the third floor slab where water leaks into the building and through the slab.*

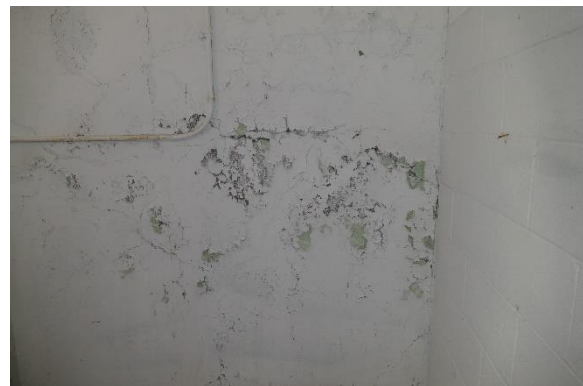
*Figure 60. Peeling paint on the inside face of the exterior wall.*

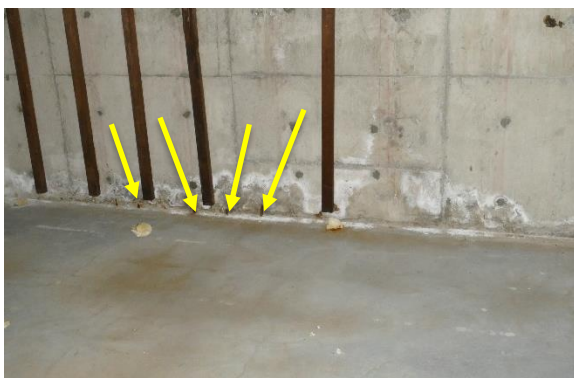
reinforcing steel is exposed and observed to be corroded along the base of the wall (Figure 61 and Figure 62),

*Figure 61. Exposed reinforcing steel observed along the base of the wall (arrows).*

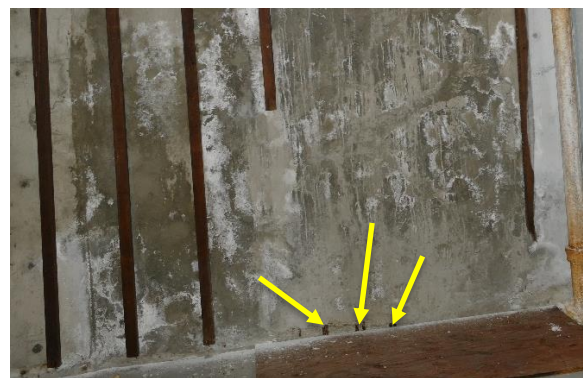
*Figure 62. Exposed reinforcing steel observed along the base of the wall (arrows).*

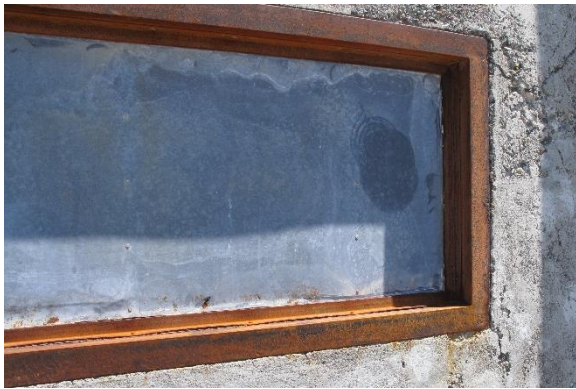
The galvanized steel plates that cover the wall openings are generally in good to fair condition (Figure 63) however some of the original steel frames embedded into the concrete wall around openings that they are attached to are corroded, with corrosion staining below and adjacent to some openings at the interior (Figure 64). The ventilation gap around the perimeter of these plates allows water to enter the building with no means to collect and discharge it. There was standing water on the floor in several locations below these openings at the time of our visit.

Figure 63. Galvanized steel plate with light oxidation and corroded steel frame.

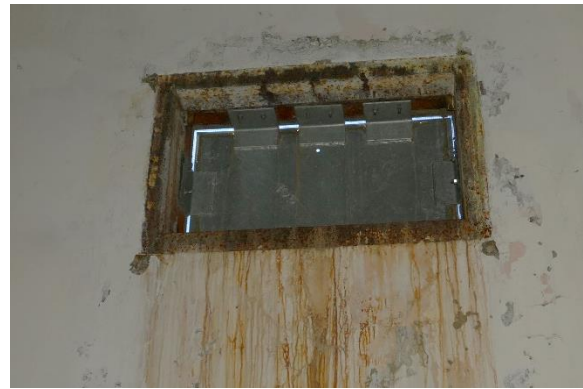
Figure 64. Water and corrosion staining below wall penetration.

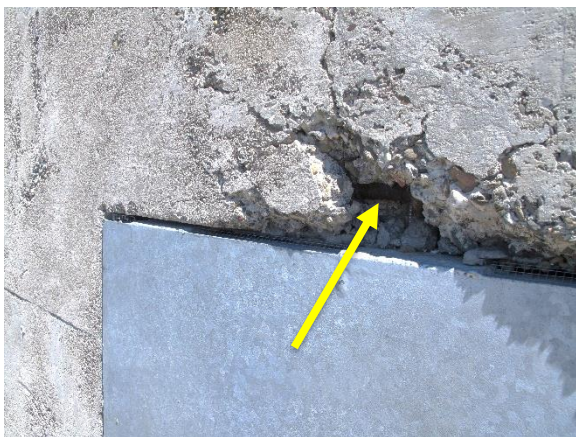
Spalling of the concrete was observed on the exterior adjacent to several of the openings. At some locations spalls expose corroded reinforcing steel (Figure 65), but at most locations there is poorly consolidated concrete adjacent to the steel frames (Figure 66).

Figure 65. Concrete spalling and exposed reinforcing steel (arrow) adjacent to infilled window opening.

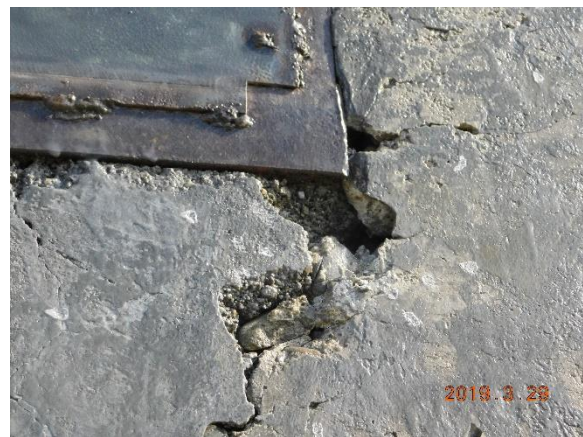
Figure 66. Voids in concrete due to poor consolidation adjacent to window opening.

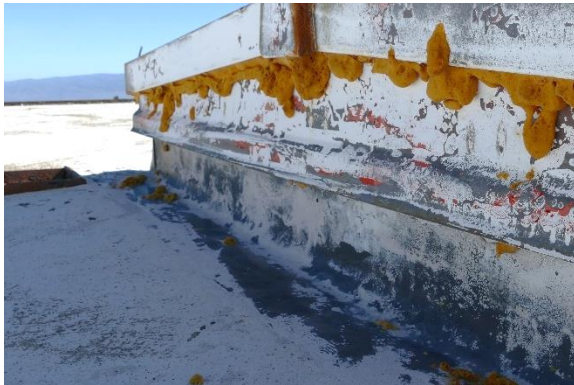
*Figure 67. Single-ply membrane flashing (black), spray foam (yellow), and fluid-applied coating (white) at roof equipment hatch.*

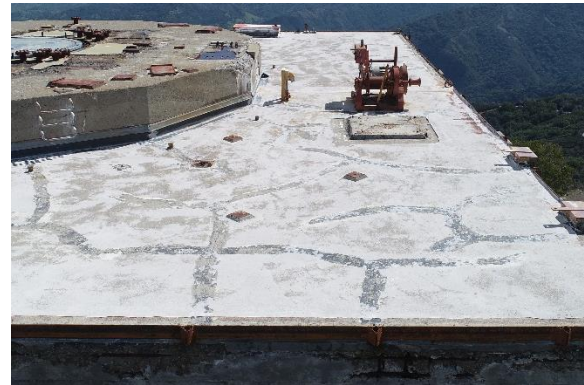
*Figure 68. White traffic coating on main roof, facing east. Note the darker stripes where underlying cracks were treated.*

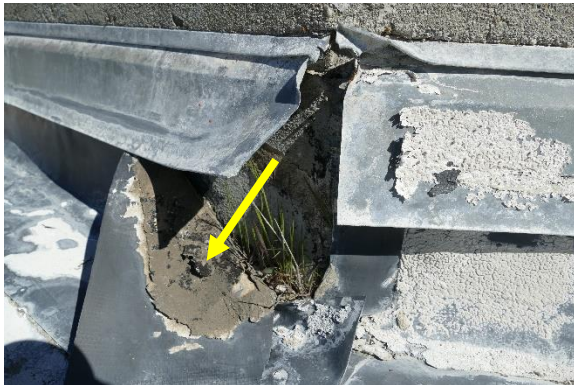
*Figure 69. Damaged counterflashing at concrete pedestal showing single-ply membrane flashing (black sheet, damaged), fluid-applied coating (white), and original built-up flashing (black residue adhered to interior surface of single-ply flashing, arrow).*

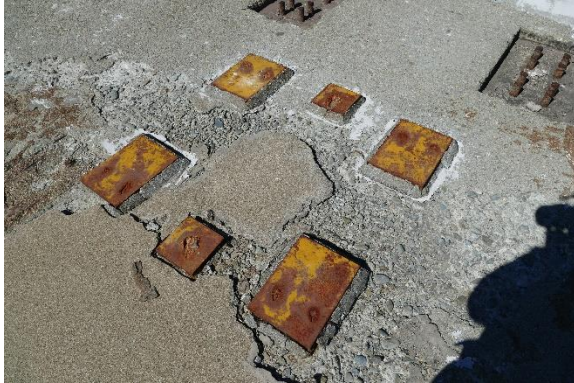
Figure 70. Concrete spalling and corroded steel plates on the top surface of the concrete pedestal.

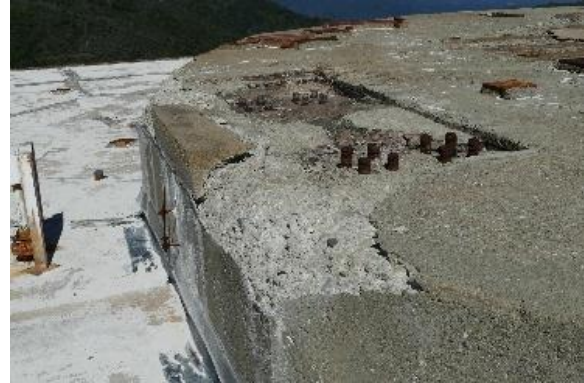
Figure 71. Concrete spalling along the edge of the concrete pedestal.

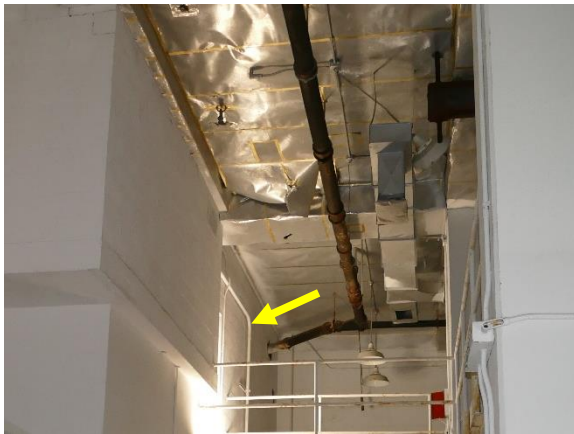
Figure 72. Cast iron drainage plumbing with widespread corrosion running into the utility shaft at the southeast corner (arrow). Photo facing south.

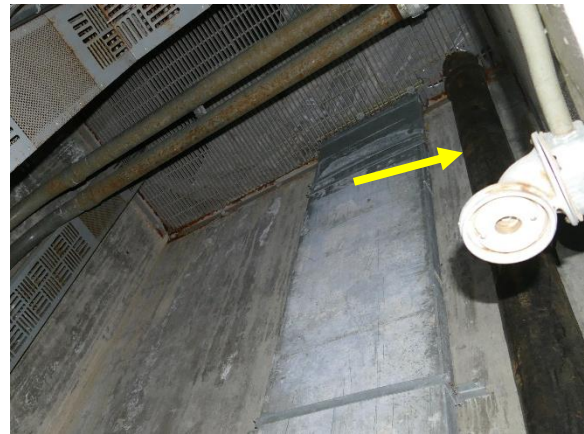
Figure 73. Cast iron drainage plumbing stack in utility shaft. Photo facing southeast.

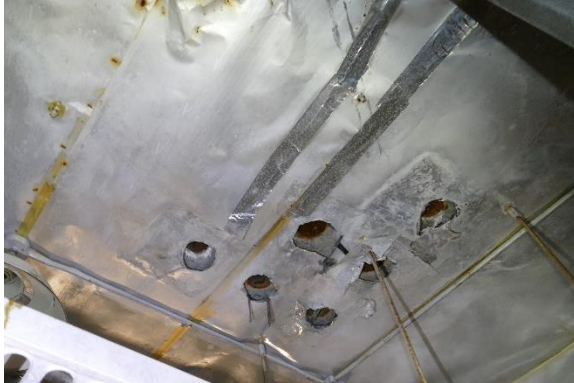
*Figure 74. Aluminum sheets installed beneath the roof slab are noted as radar shielding in the construction drawings.*

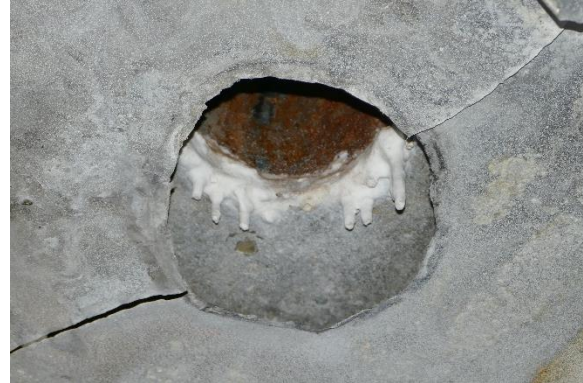
*Figure 75. Efflorescence deposits around penetration in concrete roof slab, with aluminum sheets in foreground.*

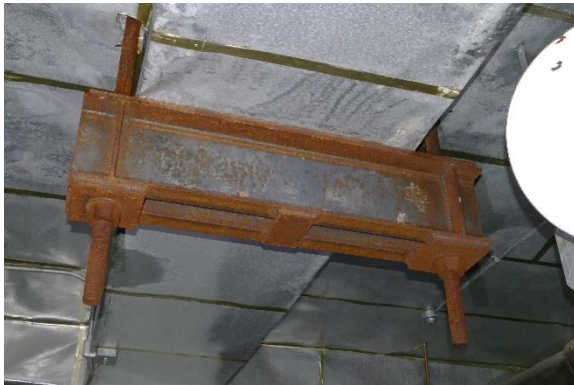
*Figure 76. Surface corrosion on steel beam clamp.*

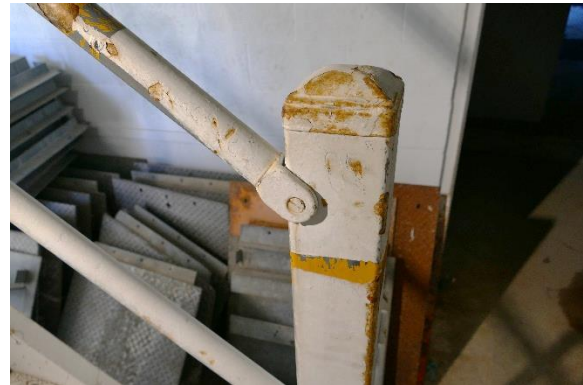
*Figure 77. Surface corrosion on metal stair handrail.*

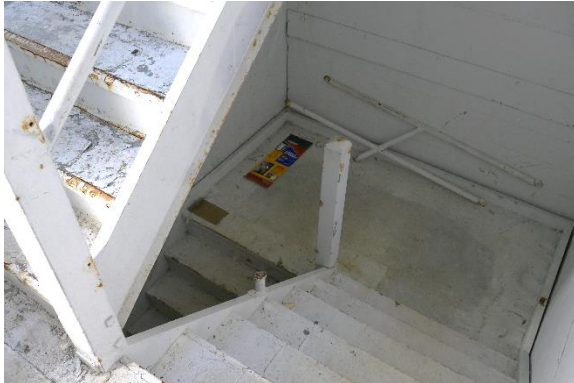
*Figure 78. Missing guardrail.*

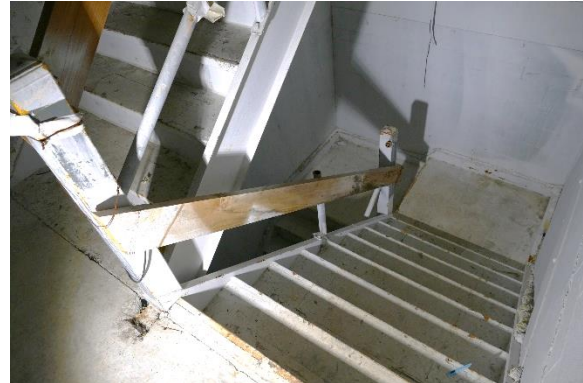
*Figure 79. Partially missing handrail with temporary wood railing.*

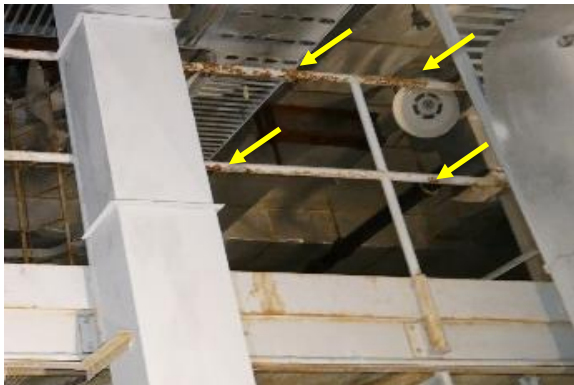
*Figure 80. Corrosion of guard rails at the mezzanine.*

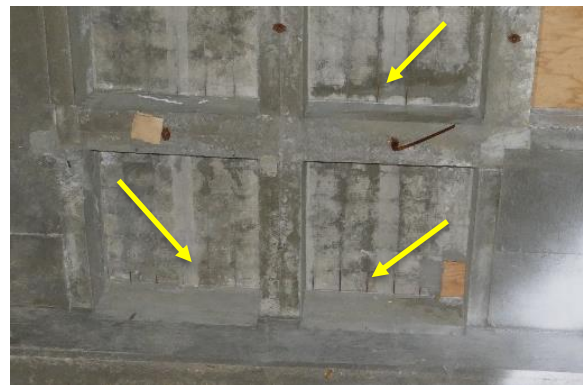
*Figure 81. Corrosion staining of reinforcing steel at the soffit of the fifth floor (arrows)*

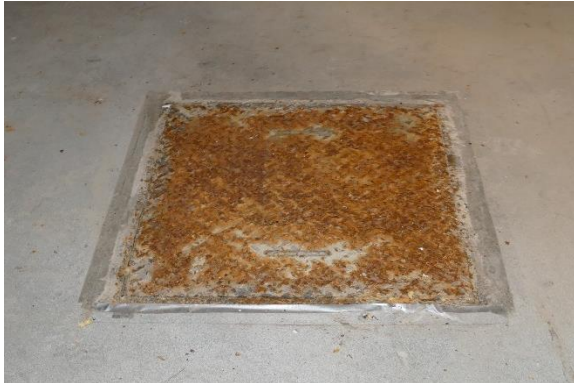
*Figure 82. Corroded metal plate covering opening in floor.*

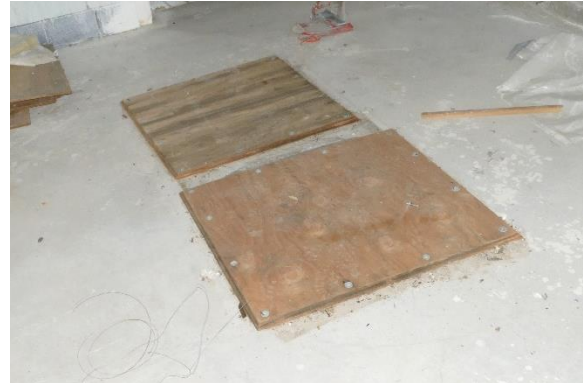
*Figure 83. Plywood covering openings in floor.*

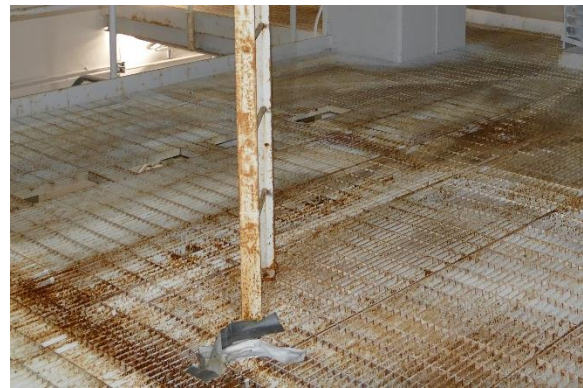
*Figure 85. Surface corrosion at mezzanine floor grating below concrete pedestal at roof above.*

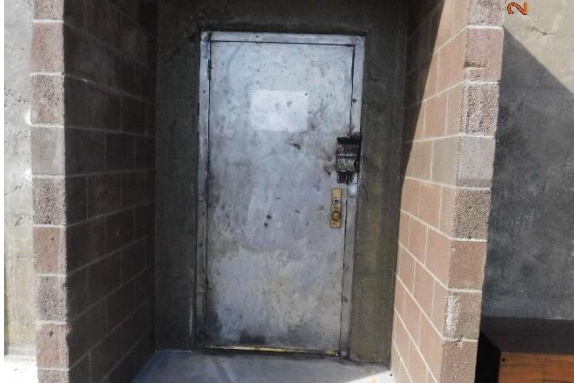
Figure 86. Steel door at south of east wall.

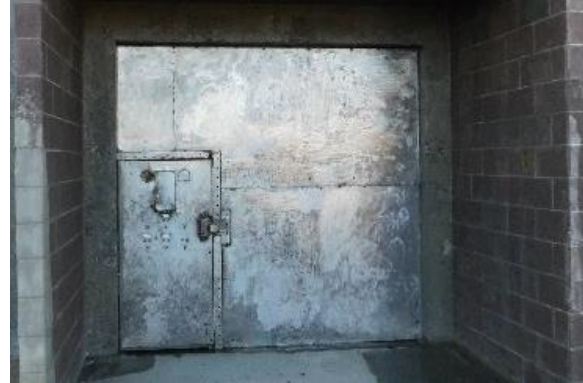
Figure 87. The west door was originally a double-leaf door, but appears to have been modified and has only a small access door in a larger metal plate.

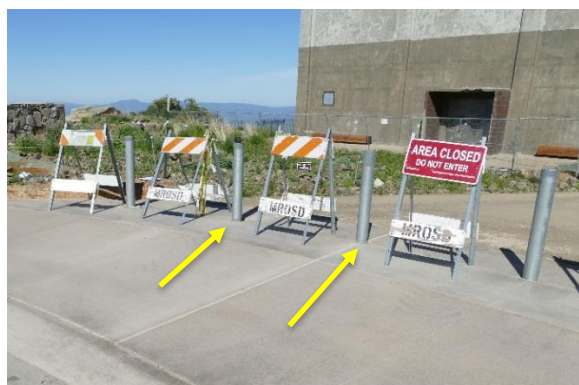
*Figure 88. Bollards along the sidewalk. Arrows indicate the two removable bollards.*

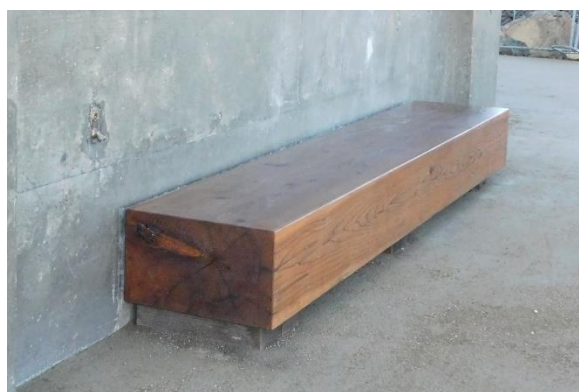
*Figure 90. Wood benches are very close to the concrete walls.*
