Midpeninsula Regional  
Open Space District

R-23-62  
Meeting 23-19  
July 26, 2023

La Honda Creek Open Space Preserve - Forest Health Project

PROJECT: 2020 OLD LOGGING ROAD EROSION INVENTORY  
 LA HONDA CREEK OSP  
 MIDPENINSULA REGIONAL OPEN SPACE DISTRICT  
 SAN MATEO COUNTY, CA

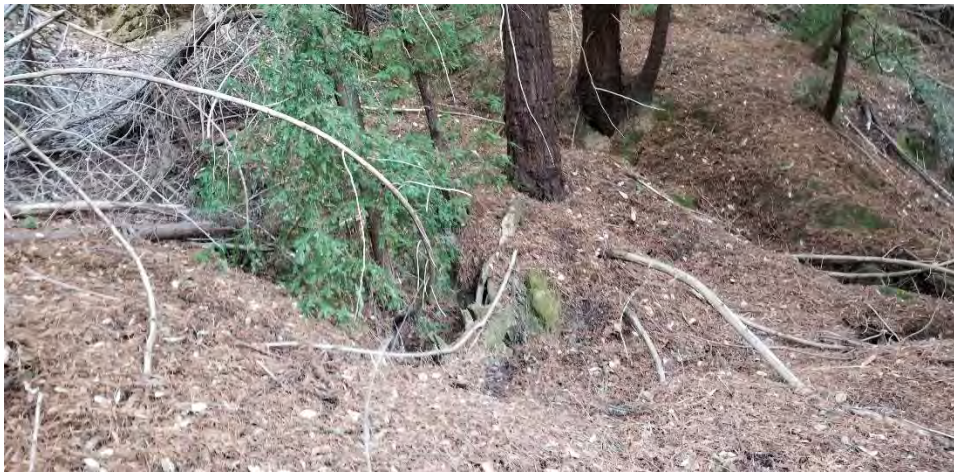
The Class III watercourse drains a 13-acre forested watershed. The active stream channel is approximately 2 to 3 feet wide with an average 25% channel grade. The crossing consists of approximately 120 to 250 cy of fill placed about 6 to 8 feet deep. The crossing is overtopped by 5 to 6 feet (~120 cy) of landslide debris originating from an upslope debris flow.

Photo 7: Two gullies at partially washed out watercourse crossing. The upper gully is from diverted stream flow coming down from MP8. The lower gully is from the watercourse.

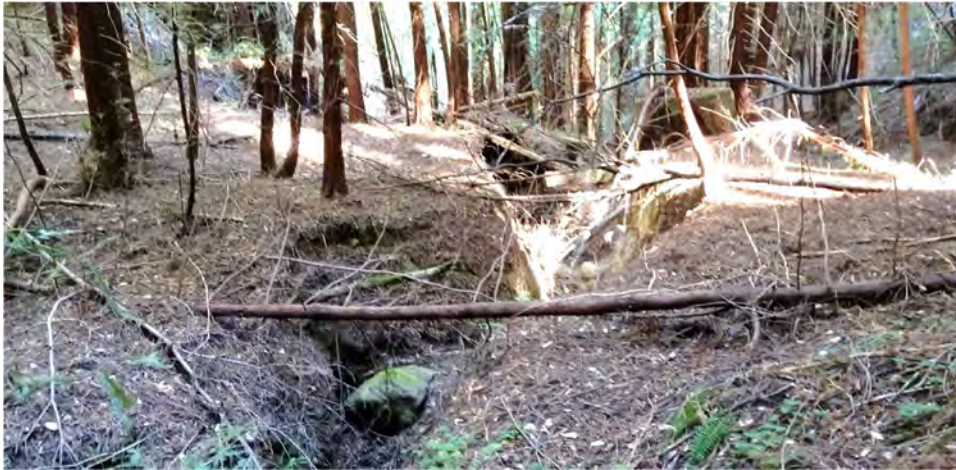
Presently the Class II watercourse flows in a shallow channel over the debris flow deposit of intermixed wood and sediment before reaching the upstream end of the Humboldt crossing. From there the stream has eroded an 80-foot-long, 5 to 15-foot-wide, 4 to 10-foot-deep channel across the old roadway, before draining underneath a root wad and across some stacked logs at the downstream end of the crossing. The road gully to the south of the crossing currently receives runoff from the small Class III tributary, adjacent sideslopes, and intercepted groundwater. The current rate of erosion within the gully appears low.

Photo 13: looking downstream at the partially washed out Humboldt crossing. Stream flow drains underneath a fallen stump just to the left of the eroded channel.

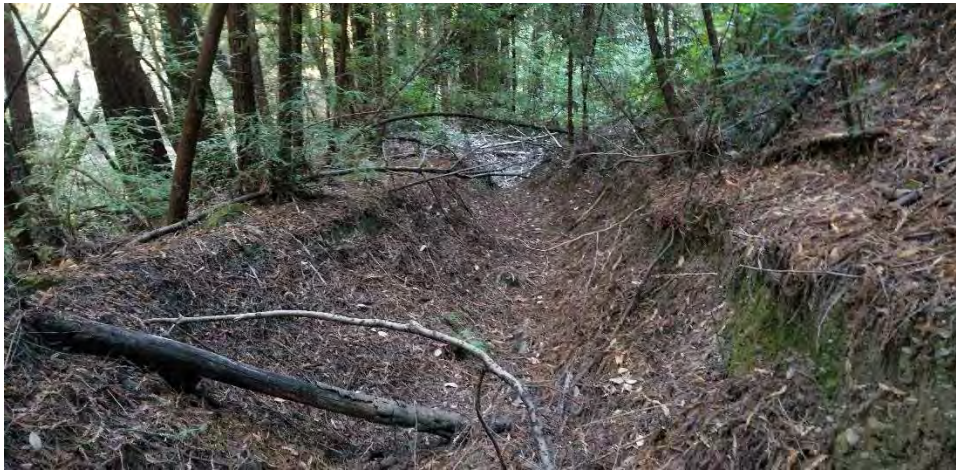
Photo 14: looking down the road at the eroded channel from diverted stream flow. This photo was taken along the lower portion of the gully where the incision is much greater. Note the heavy duff layer in the channel bottom.
