Highway 17 Wildlife Crossing Plan

Assessment of Solutions to Improve Traversability of State Highway 17
December 2012

Hwy 17 Wildlife Connectivity Project Description:

Prepared by Pathways for Wildlife, July 2014

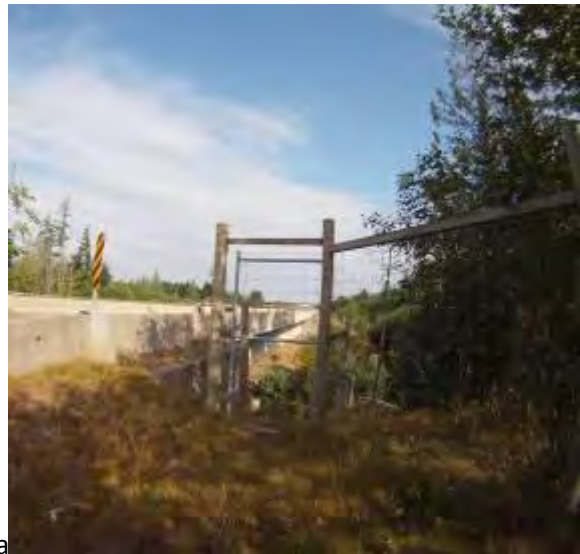
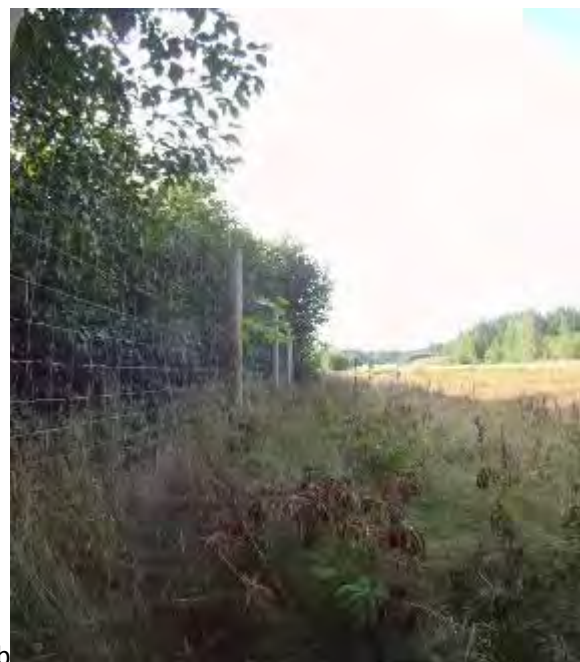
Figure 4 An eight-foot-tall fence-line in Canada. a) The fence is anchored to the bridge abutment, allowing wildlife to pass under the bridge, over a stream; b) The fence is continuous for many miles, preventing wildlife access to the highway.

Fencing along roadways is an effective way to protect people and wildlife, when it is combined with wildlife crossing opportunities and regular maintenance (Figure 4). Keeping wildlife out of the right-of-way, but providing them with a crossing alternative, is a good way to reduce harm to wildlife and people. Fencing, combined with crossing opportunities, can help do this. Fencing has two discrete functions, each at different scales: 1) keeping wildlife from accessing a stretch of road or highway, except at pre-determined crossing points and 2) keeping wildlife from passing through all segments of the fence-line. Fence-lines are the established boundary between wildlife habitat and the immediate road-side and roadway. They function only when they are extensive and intact.

As indicated above, wildlife fencing is only effective when the ends of the fence-line join landscape elements or structures that keep wildlife out (figure 4b). Other limitations on effectiveness are related to sturdiness, regularity of inspection and maintenance, height of the fence, fabric mesh-size, number and adequacy of associated crossings, and location relative to wildlife movement.

There are two components of monitoring – fence integrity and wildlife crossing response. Criteria for effectiveness include: structural integrity (year-to-year maintenance requirements), fence line integrity (wildlife are inhibited from crossing the roadway except through structures), fence line length adequacy (wildlife aren't just going around the ends, figure 4b), wildlife behavioral response (wildlife are successfully directed to crossing structures, not just blocked and repelled, figure 4a), and increase in animal and public safety for roadway.

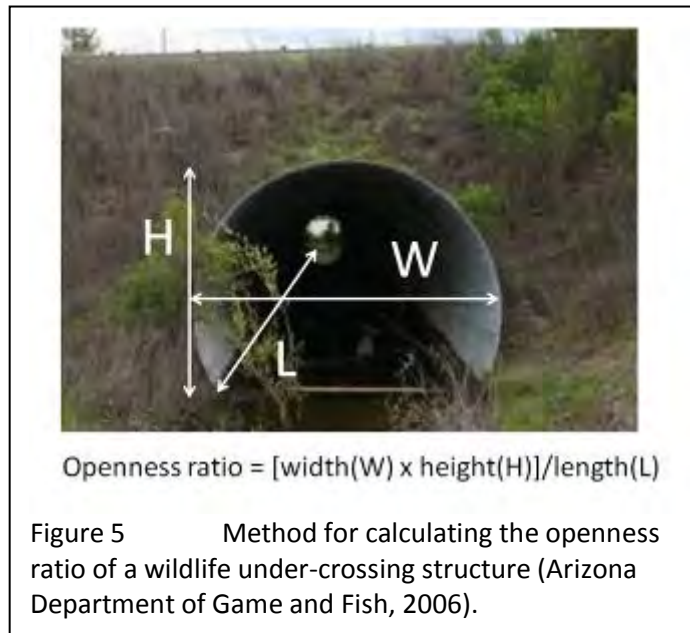
Openness ratio (OR) is used to estimate whether or not existing or proposed crossings are likely to meet the movement needs of different sizes of animals. The openness ratio can be used as a guide, but should not be used as definitive proof that a particular animal can or cannot use a structure. The ratio is illustrated in Figure 5, where the width is

multiplied times the height of the opening and the product is divided by the length of the structure. For almost all animals, the higher the OR, the better.

Sufficient size (combination of cross-sectional area and length, figure 5) and frequency (number of crossings per unit length of highway) of wildlife crossings can be calculated for groups of species found in a particular area. Although large crossings can accommodate small and large animal movement, small crossings are typically only used by small animals. In any given network of roads and highways, there are areas with sufficient culverts and bridges to provide animals of various kinds to safely cross and other areas needing retrofitting and enhancement. The main issue here is finding the right combination of higher frequency small crossings and lower frequency larger crossings to meet the needs of a wide range of species.

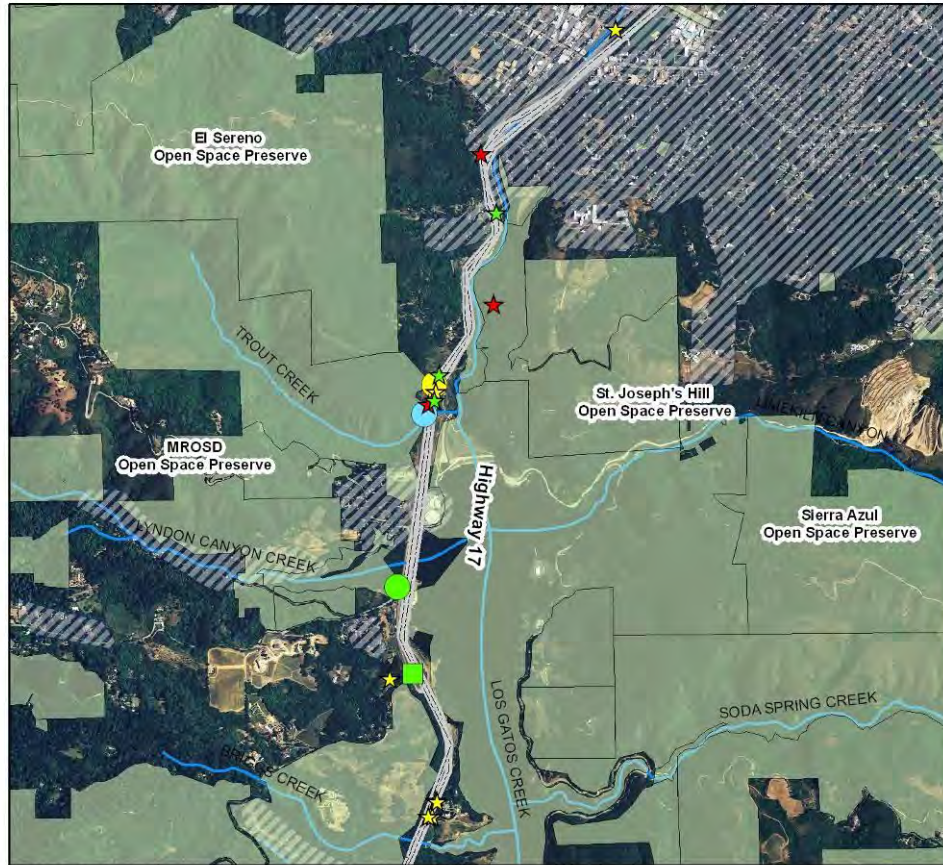
Figure 6: Highway 17 Roadkill Sites & Crossing Structures Map

Culvert 1 is the northernmost culvert under Highway 17 in the study area (Figure A11). There, a mountain lion was hit on 2-9-2011 on Highway 17, southbound. However, the culvert is not visible all the way through, with a large drop off on the east side (Figure A12). Also, during the rainy season, there is high water flow through the culvert.

Culvert 2, which is also located in the north section of the study area, is fenced in from Lexington County Park on the east side of the highway. However, the fence is down near the Highway 17 (Figure A4). Deer have been observed grazing along the side of the highway at this location where the fence is down. The culvert has no visible light through it and has a sharp incline beginning at the base going up towards the highway.

Culvert 3 is a 10 foot diameter pipe culvert which is located within the middle of the linkage, is in the midsection of the Lexington Reservoir, where it flows under Highway 17 (Figures A14 and A15). It is full of debris, including wooden planks. During the rainy season it is flooded. For maintenance, it needs to be cleaned out with soil and gravel added into the base. Possible retrofitting includes adding in a slope to the culvert so it does not get flooded from the reservoir.

Located in the north section of the linkage, Alma Bridge is a 200 ft long and 57 foot wide bridge over Highway 17 (Figure A16). It is a two lane road, with a pedestrian walkway on the north side. This could also be a potential site to add lanes as land bridge for wildlife to move across. The north side seems more viable for additional lanes than the south (Figure A17). On either side of the bridge, there is no fencing and open space leading into the hills (Figures A18 and A19).

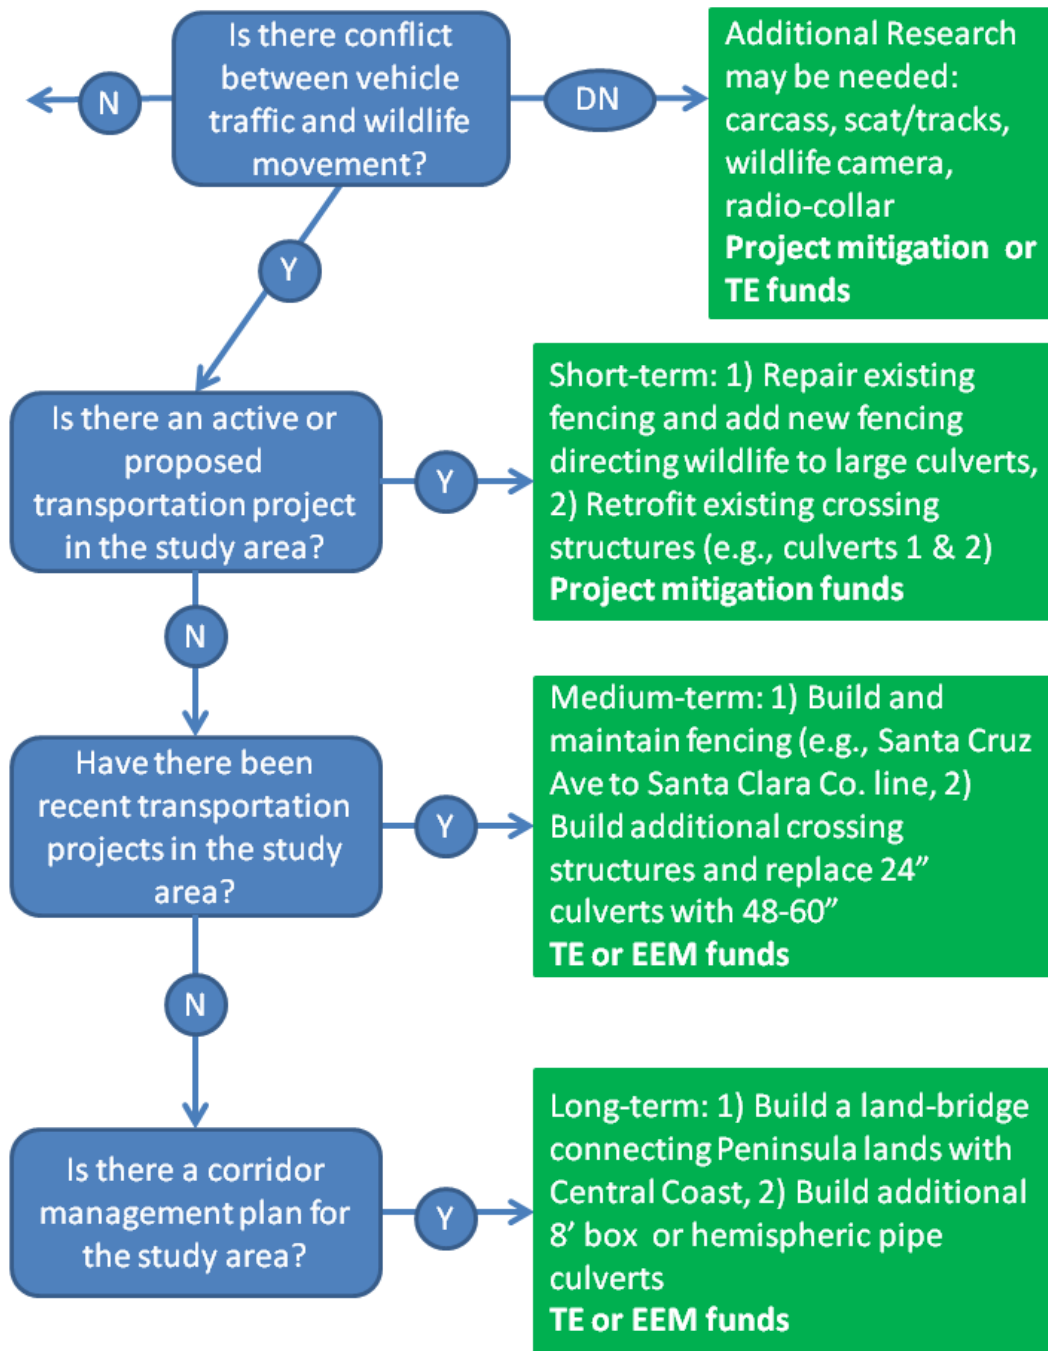
Figure 6: Wildlife-Crossing Decision Tree

Short term: 1) fencing – repair existing fencing and add new fencing directing wildlife to large culverts, like culvert 3. 2) crossing structures – retrofit culverts 1 and 2 to permit wildlife passage. Currently neither culvert seems to be capable of passing wildlife.

Medium term: 1) build and maintain fencing between Santa Cruz Ave and the Santa Clara County line directing wildlife to existing and new crossings; 2) crossing structures – build additional culverts, or replace existing 24” culverts with larger >48” – 60” culverts.

Long-term: 1) build a land-bridge to connect Peninsula lands with the Central Coast. Build additional 8’ box culverts, or similar hemispheric pipe structures, to accommodate wildlife movement.

In all time frames, monitoring is conducted for existing and recovered wildlife movement through existing and new structures to test effectiveness of mitigation structures. Monitoring information is used to adaptively manage wildlife crossing decision-making. DN = don't know.

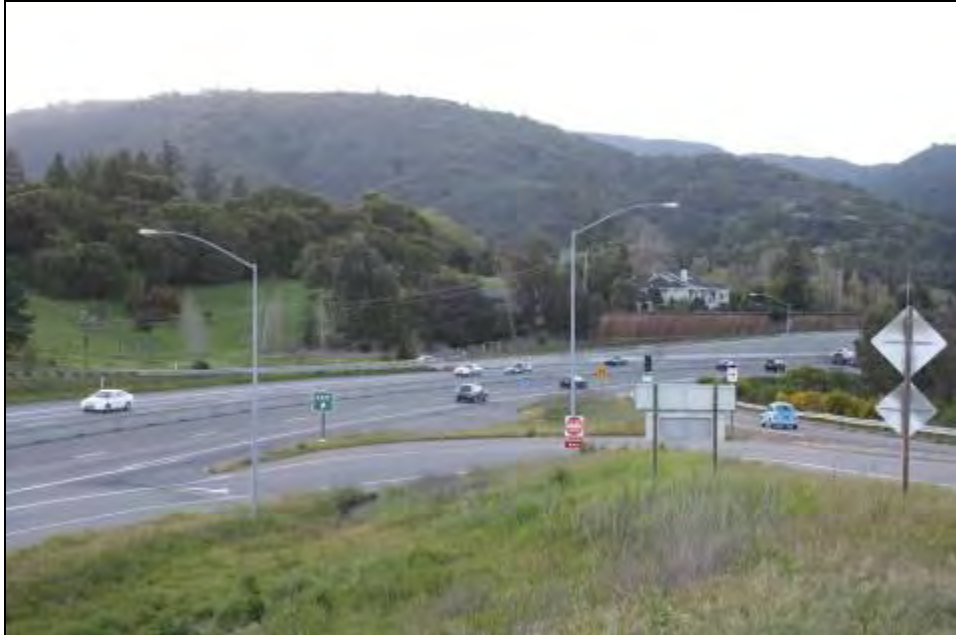
Figure A1: Concrete median in Highway 17, north view.

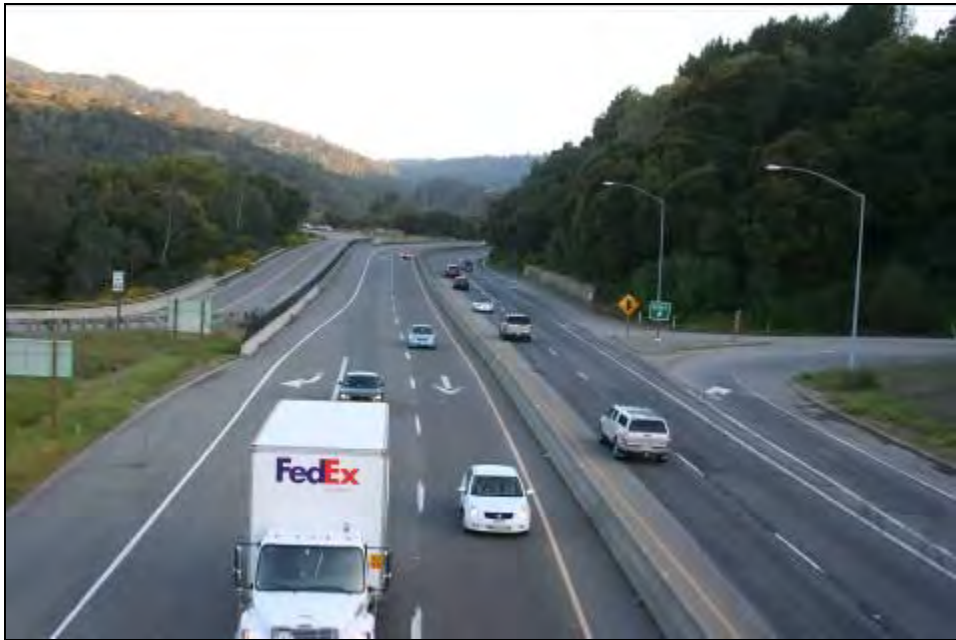
Figure A2: Concrete median in Highway 17, south view.

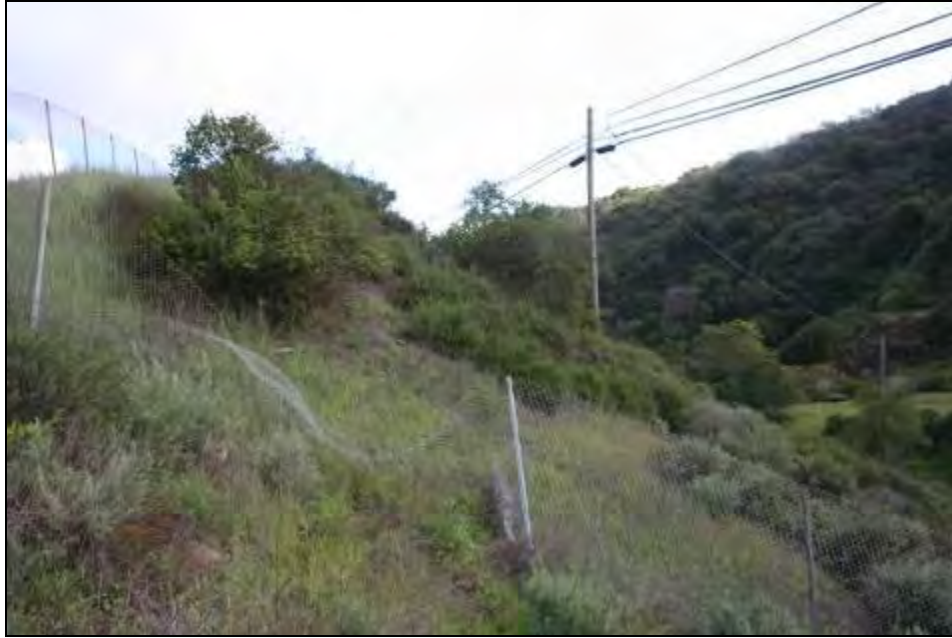
Figure A4: Fence down above Culvert 2 looking from highway down to Lexington County Park.

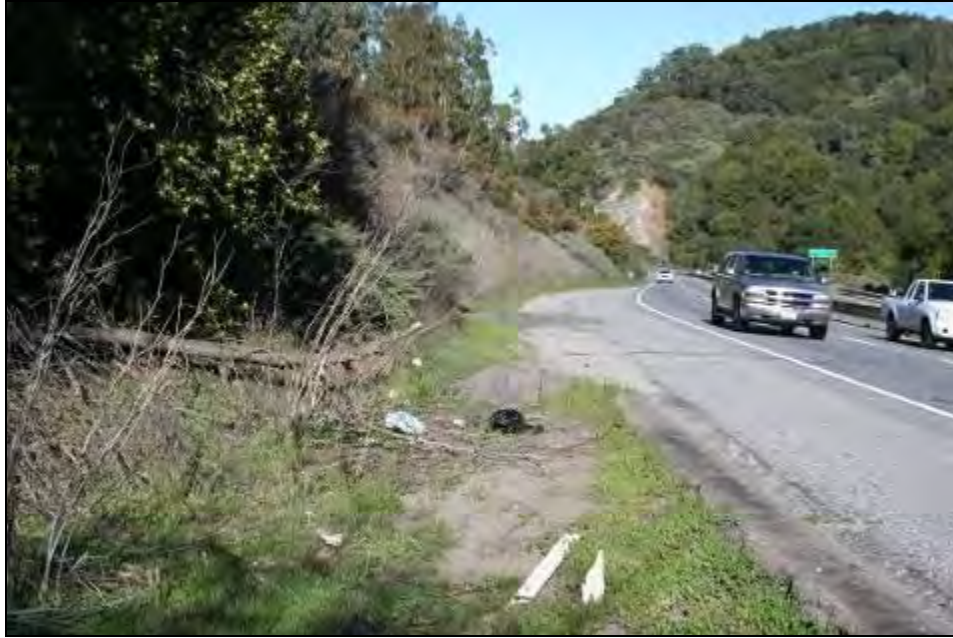
Figure A6: Site where Puma was hit at southbound Hwy 17 on 2-9-2011, northbound view.

At the site where a mountain lion was hit on 2-9-2011 on Hwy 17 southbound, two ravines converge and there is no existing fencing (Figure 2, Figures A6-A9). Extensive game trails that lead to the ravine and toward the highway suggest this topographic feature leads animals to the highway (Figure A10). At the Trout Creek Culvert 2, puma, deer, bobcat, and deer have all been hit at this location, indicating that it is a high risk area for vehicle and animal collisions, as animals are moving down the ravine into the highway.

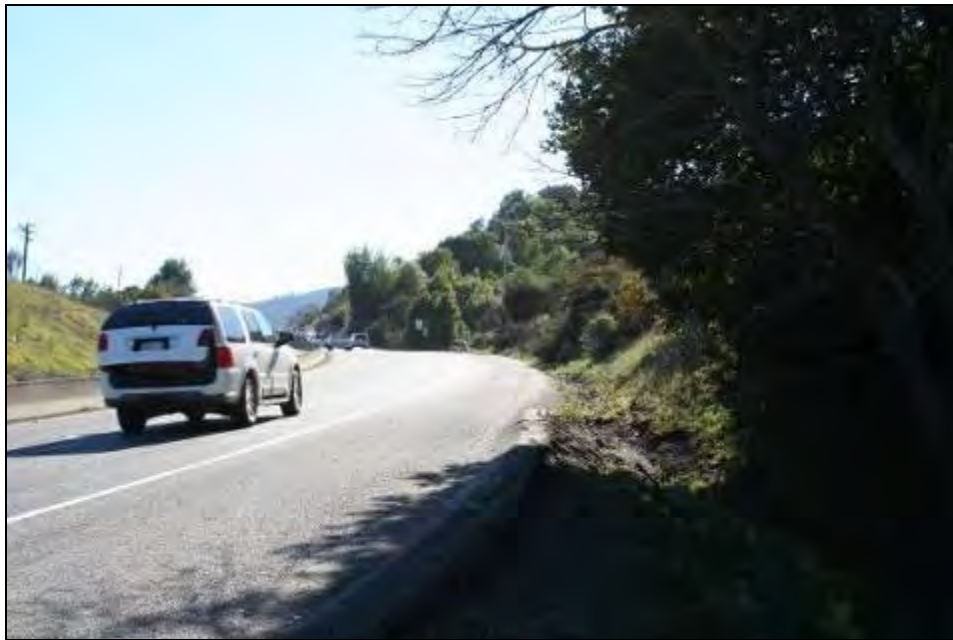
Figure A7: Site where Puma was hit at southbound Hwy 17 on 2-9-2011, southbound view.

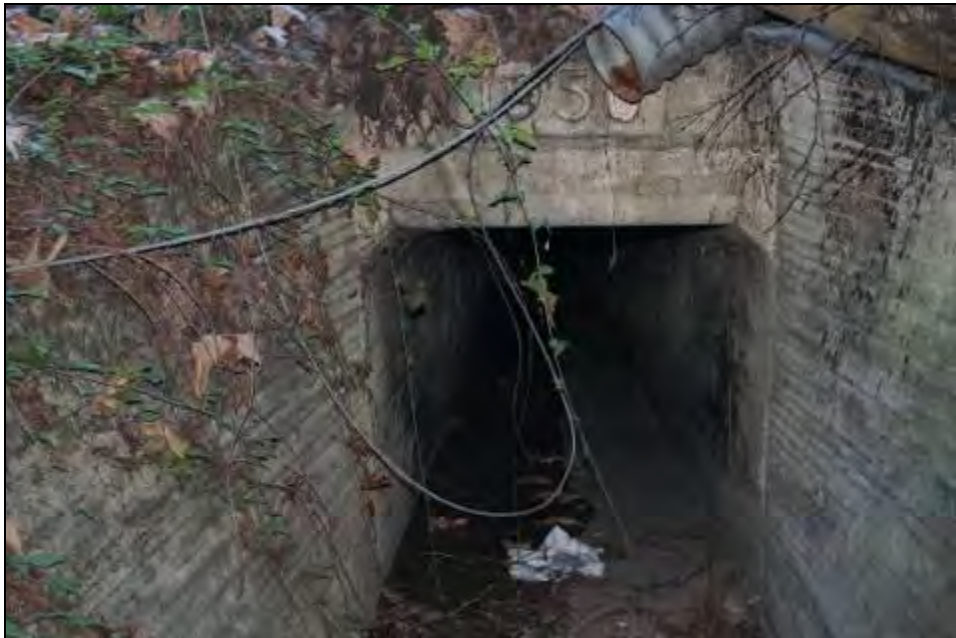
Figure A11: Culvert 1, west side, located at ravine, not visible all the way through.

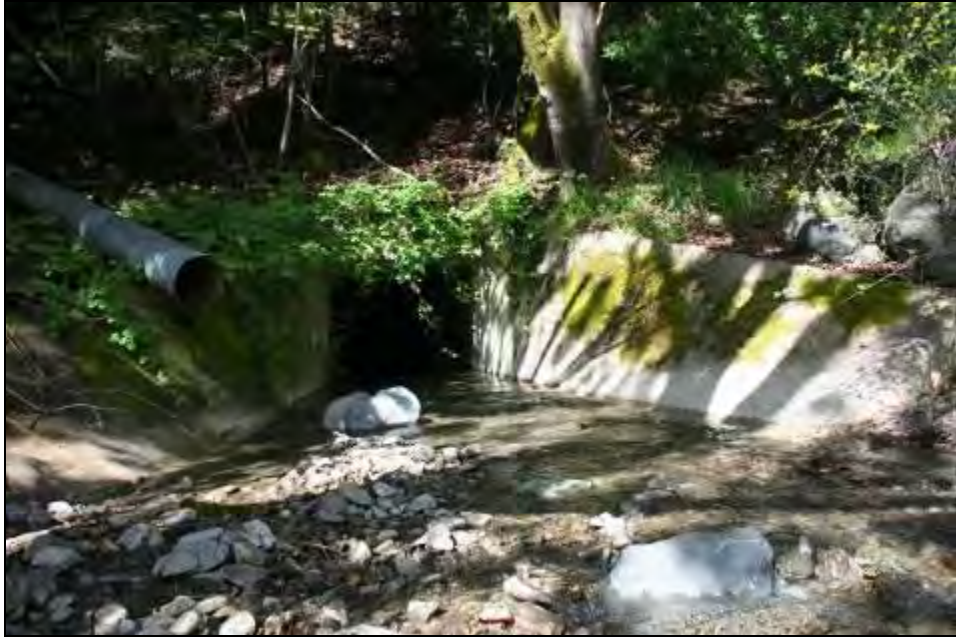
Figure A13: Culvert 2, east side, not visible through.

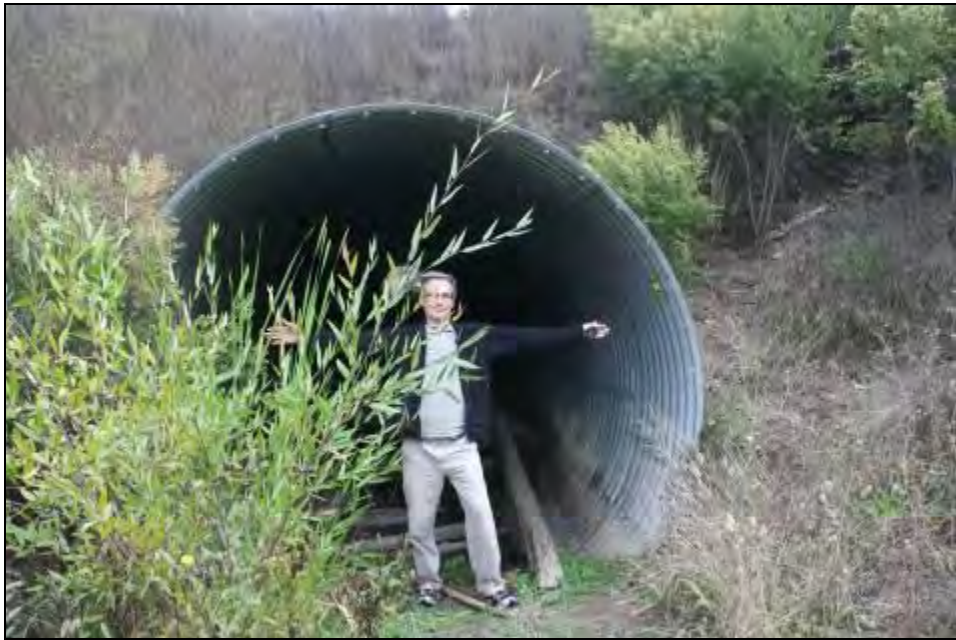
Figure A14: Culvert 3, west side, visible through.

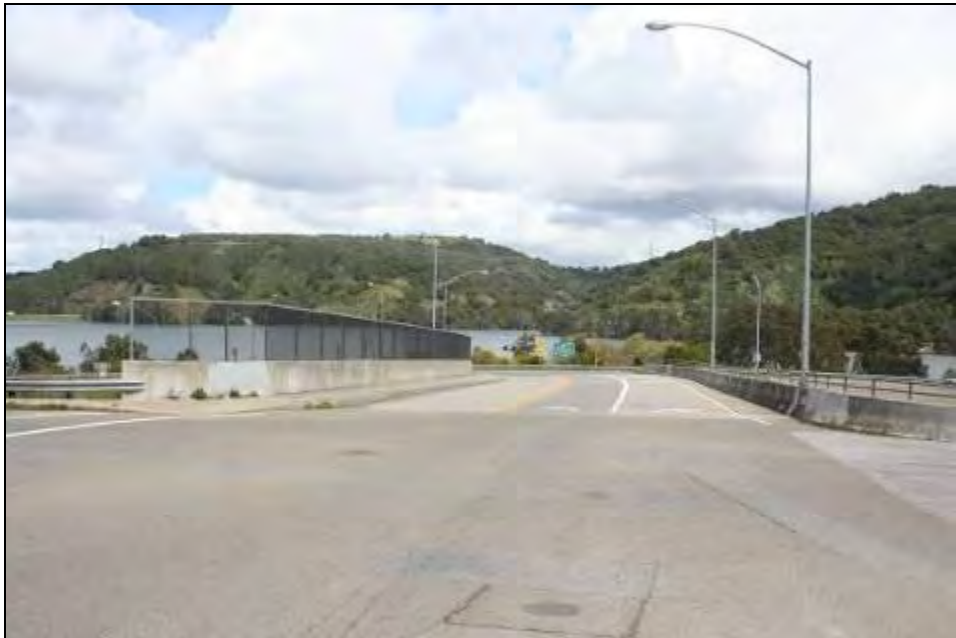
Figure A16: Alma Bridge, west side.

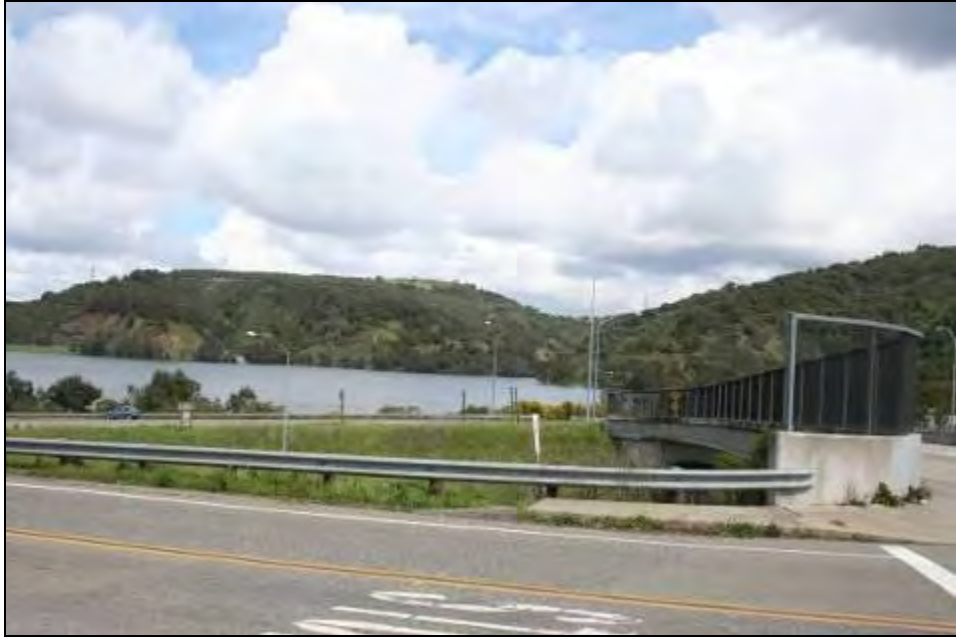
Figure A17: North side of Alma Bridge. Potential site for adding in additional lane for wildlife.

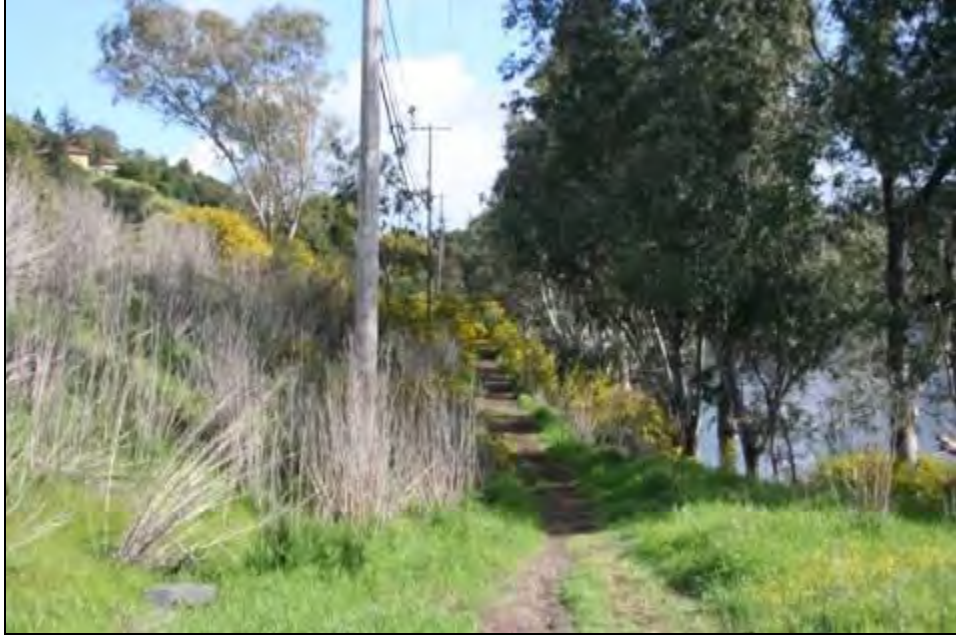
Figure A23: Trail on the east side of Culver 3, that encircles the reservoir and provides access to the Mid Peninsula Open Space Preserve.

go around Lexington Reservoir to Lexington County Park and Mid-Peninsula Regional Open Space Preserve (Figure A23).

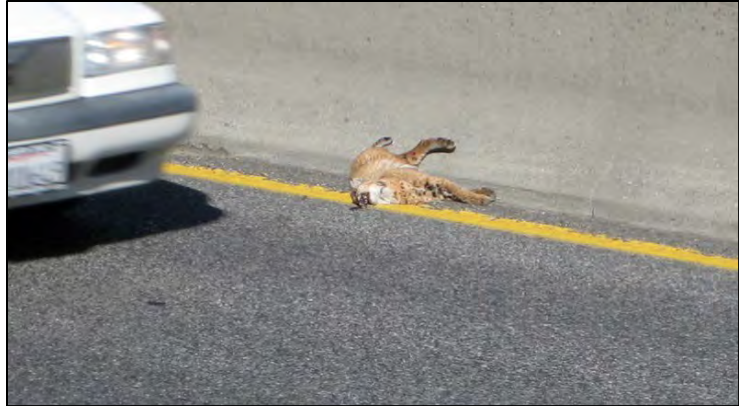
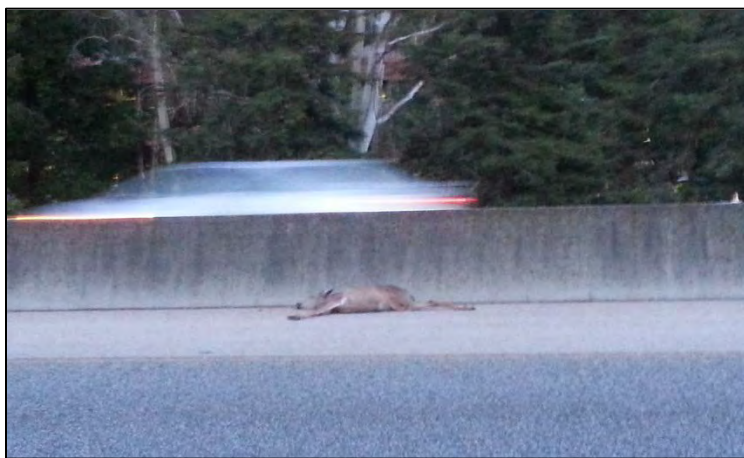
Medians, which have been installed to prevent head-on collisions between vehicles, pose a problem for wildlife that has been attempting to cross the highway. Medians are a barrier to wildlife movement across roads. Animals tend to become trapped at the median wall and have a high probability of becoming hit by a vehicle.

These medians increase the need for a wildlife crossing to make the highway permeable for wildlife movement by installing safe passages for them to travel underneath the road (*Safe Passages*, 2010). **Highway 17 lacks the appropriate culverts and bridges for animals to cross underneath the highway.** The inclusion of a wildlife crossing structure along Highway 17 would greatly increase the safety of drivers and wildlife, (*Safe Passages* 2010, *Beier* 1995).

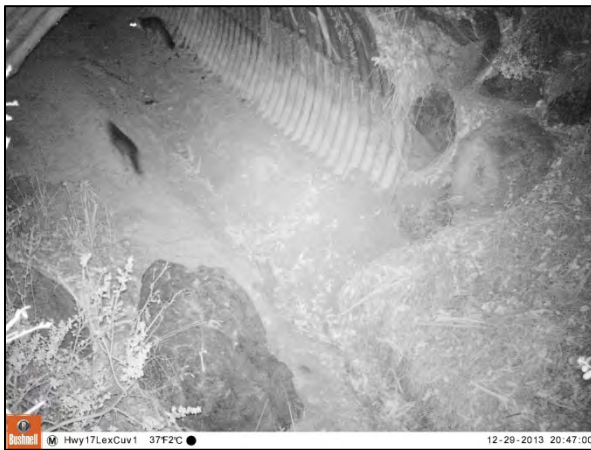
Figure 9: Two Gray fox using Lexington Culvert

A total of 257 animals have been recorded at the Lexington Culvert (Chart 1). **167 animals were recorded traveling through the culvert.** For each species, the majority of detections were of them using the culvert to travel underneath the highway.

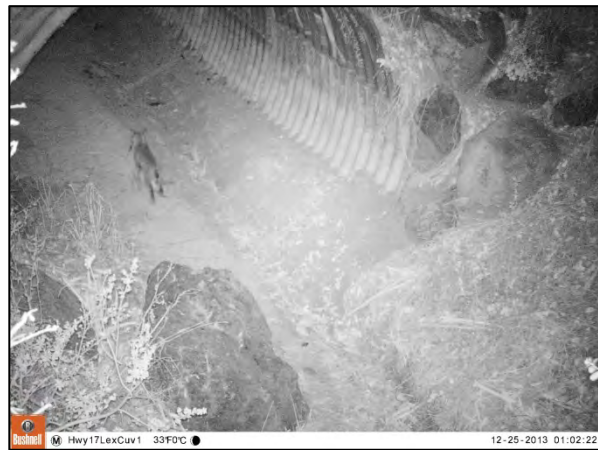
Figure 10: Bobcat with prey using Lexington Culvert
