Midpeninsula Regional
Open Space District

R-17-74
Meeting 17-15
June 28, 2017

Structure Demolition at 1150 Sears Ranch Road in La Honda Creek Open Space Preserve

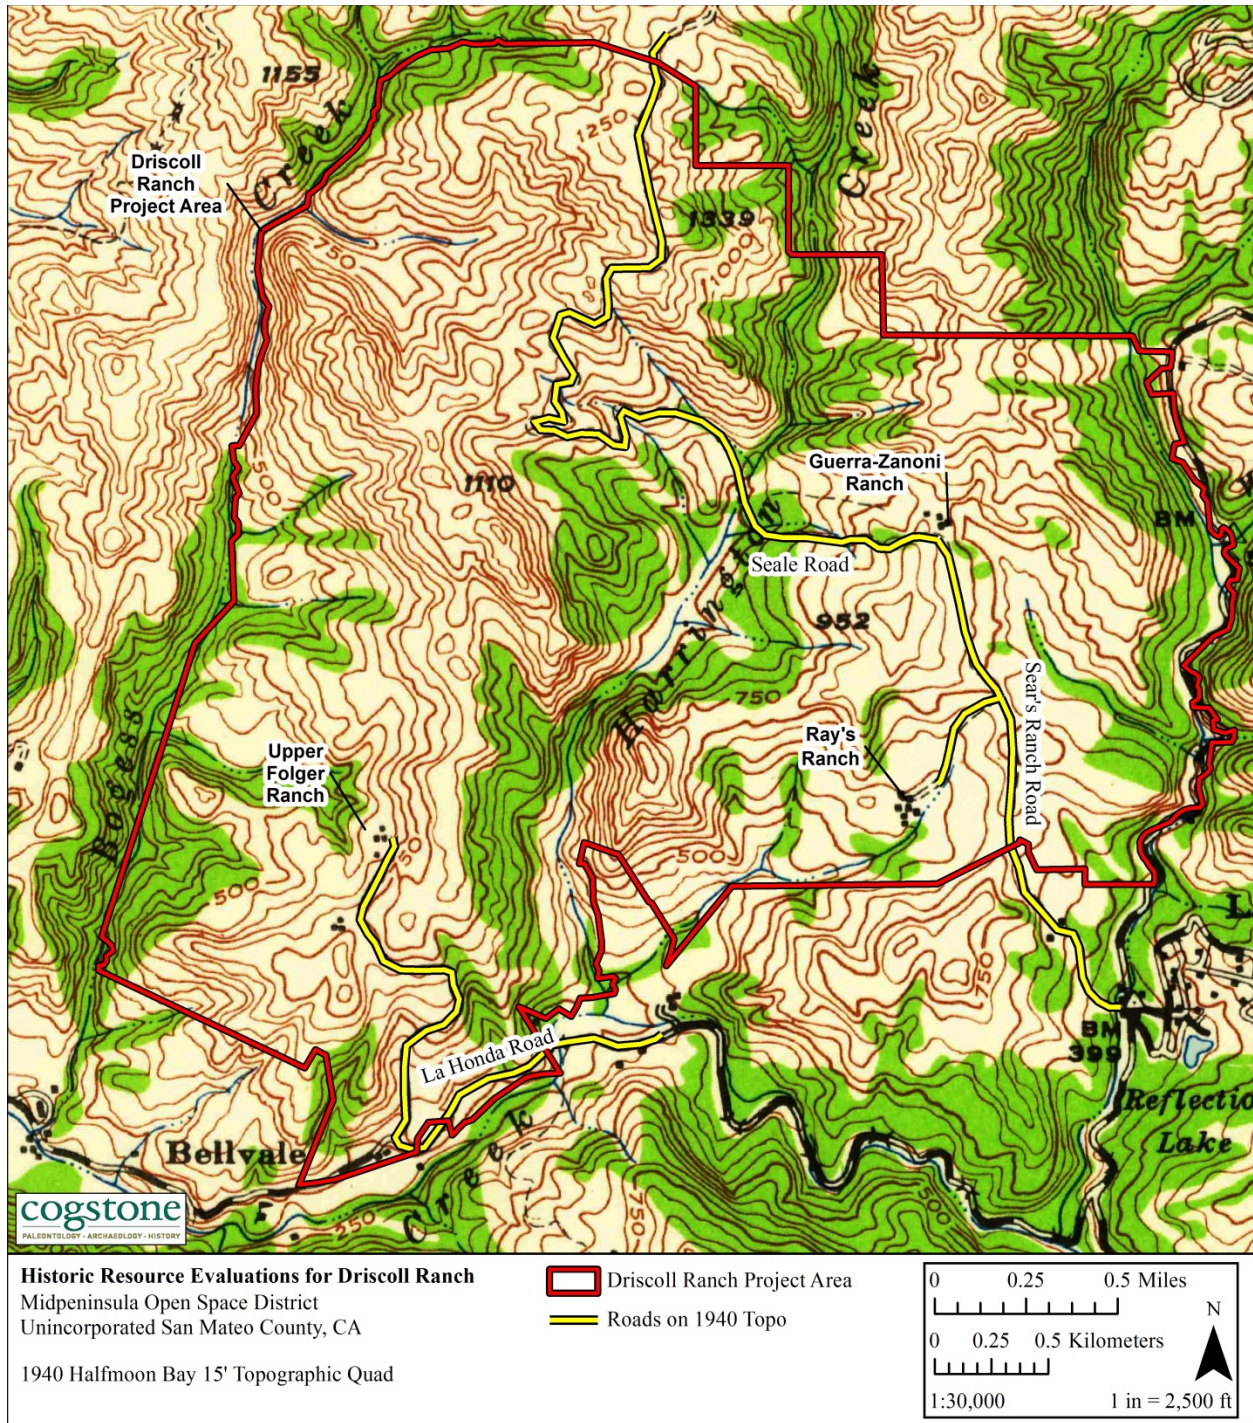
Figure 11. 1940 map showing ranches and roads

The Guerra-Zanoni Ranch is situated in the southeast $\frac{1}{4}$ of Section 10, in Township 7S, Range 4W (See Figure 2). The property first belonged to Salvador Castro, as part of the Rancho San Gregorio, as previously noted. The property as shown on the 1868 and 1877 Official Maps of San Mateo County belonged to Michael Dubbs (Figures 6 & 7). Dubbs was one of the early pioneers at La Honda (Foss 1941:7-8). In March of 1880, William Hughes purchased the Dubbs' property and in 1886 rented it to Charles Dearborn. This is the parcel that includes the present-day Guerra-Zanoni Ranch (Figure 8). Hughes owned the property until at least 1909 as shown on the 1909 Official Map of San Mateo County (Figure 9). By 1927, the Italian-Swiss brothers Julio and Felix Guerra possessed both halves (Neuman 1909; Kneese 1927). Buildings are shown on the 1902 and 1940 topographic maps (see Figures 10 and 11).

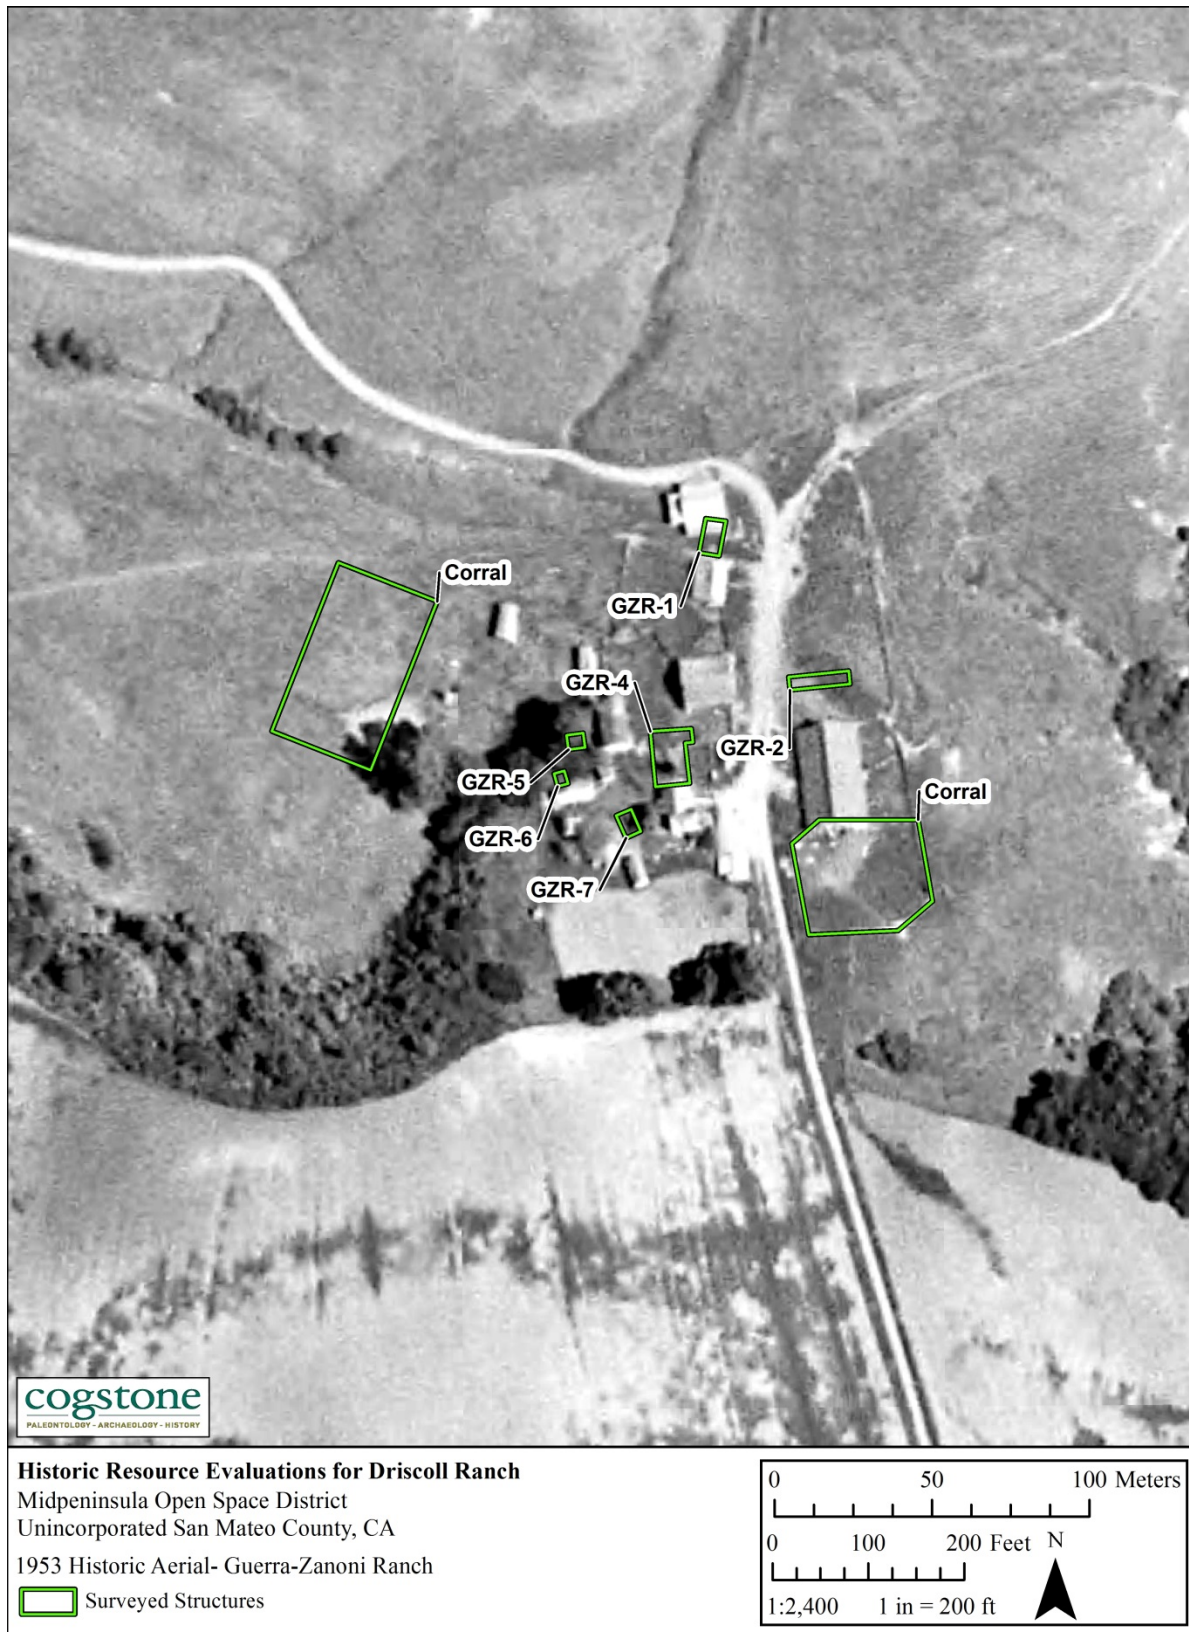
Figure 14. 1953 aerial photograph of the Guerra-Zanoni Ranch

In a recent telephone conversation with Judy Wilson (daughter of Henry Cunha), Samantha Schell learned that the Cunha family leased most of the ranches along Sears Ranch Road for many years in recent times, dairying in their early years and raising beef cattle in later years (Judy Wilson, personal communication, April 29, 2016). This implies that the Guerra-Zanoni Ranch was one that they leased. Henry Cunha and his brother started out as dairy farmers in Half Moon Bay. For 30 years, Henry also leased the Wool Ranch as part of his operations. He raised oats, hay, and beef cattle. The Cunha use of the Guerra-Zanoni Ranch, as well as of the Ray Ranch and Wool Ranch, likely occurred after the 1940s, from the 1950s to the 1980s. An aerial photograph from 1953 depicts the standing buildings and structures at that time (Figure 14)

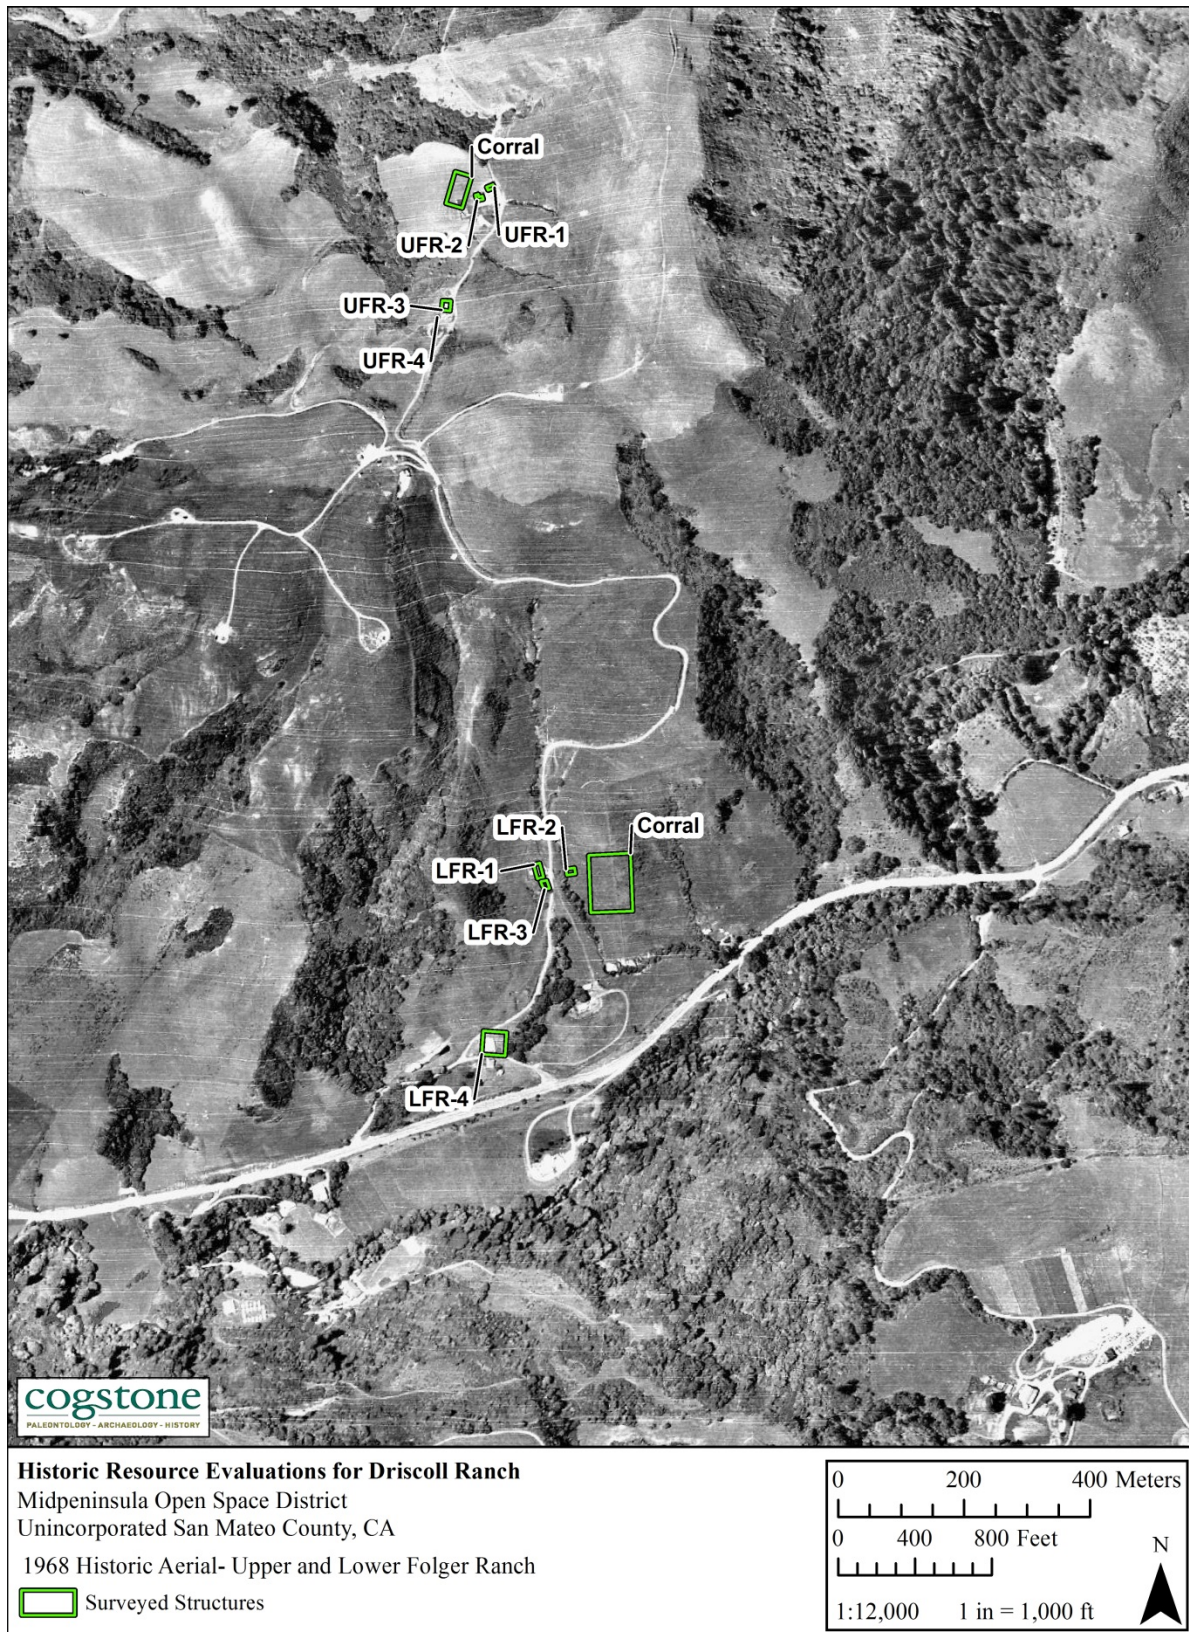
Figure 21. 1968 aerial photograph showing Lower and Upper Folger ranches

The same list of property owners applies to the Lower Folger Ranch, from Salvador Castro, to Alfred Woodhams, to James W. Bell to Robert and Manuel Silva, to Carter Lane, to Peter Folger in 1967, and eventually to Rudy Driscoll. But the buildings and structures that currently comprise the Lower Folger Ranch appeared later in time than those at the Upper Folger Ranch. By 1960, the small barn on the west side of the road appeared in an aerial photograph and by 1968 all of the Lower Folger Ranch buildings were in place (NETR 1960; 1968) (Figure 21). By 1960, Carter Lane owned this and the Upper Folger Ranch property.

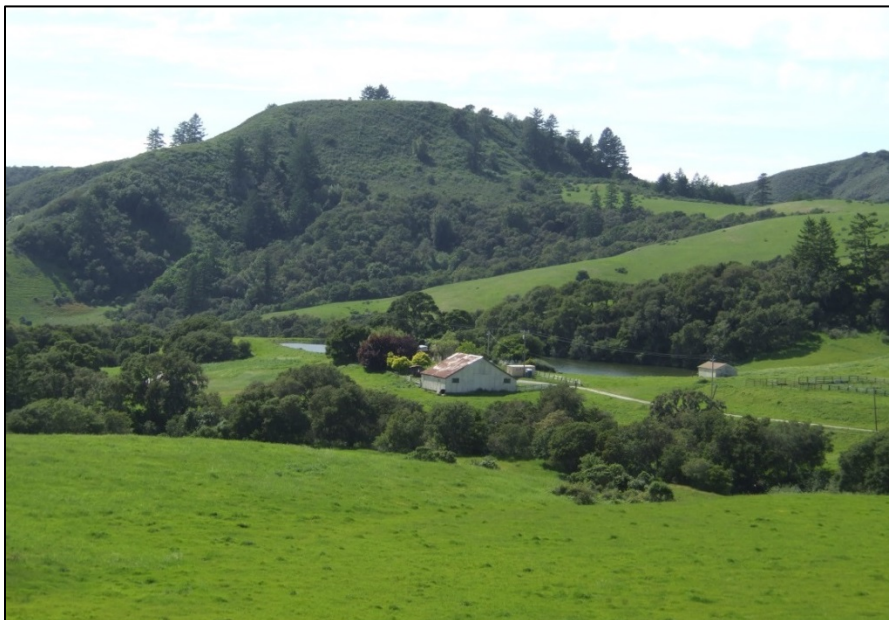
Figure 22. Overview of Ray's Ranch, view to west-northwest

The Ray Ranch complex currently is composed of ten buildings and structures (Figure 22). Included are two large open-sided barns for feeding cattle, two corrals (one round and one rectangular), and one plywood garden shed that are considered less than 45 years old. One barn and both corrals are shown in Figures 23 and 24 but are not further described, nor evaluated in this report because they are not yet 45 years old. The two barns, shown as RR-1 and RR-9, on Figure 13 were in place by 1980 and the corrals (RR-3 and RR-4) were not constructed until after 1980, based on aerial photographs (NETR 1980). The garden shed is not shown on the figure, but stands at the edge of the yard just southeast of the house (RR-6).

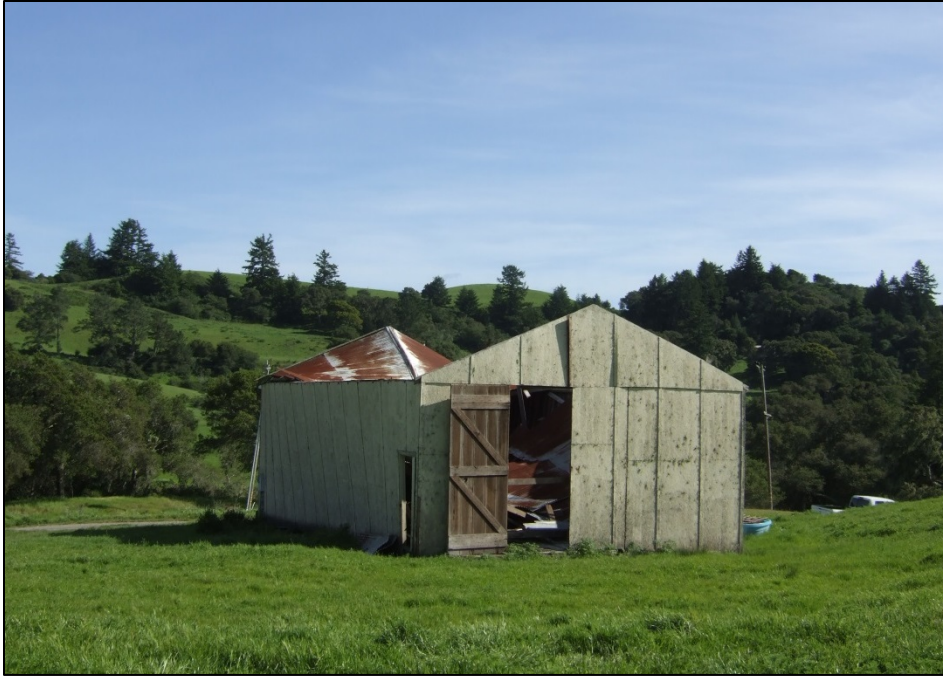
Figure 26. RR-2, Large Shed or Workshop, north and east elevations

The structure stands on small truncated pyramidal concrete piers that rest on the ground surface. Beneath the more modern plywood-type exterior sheathing, one can see from the interior that the plywood covers wooden walls composed of 1 by 12 inch boards and that the floor is of stout wood boards and joists. Much of the roof has caved in and the structure as a whole appears ready to collapse within a few years. All of the observed nails on the structure are steel wire drawn nails. RR-2 was present by at least 1953, based on an aerial photograph from that year (NETR 1953).

The RR-2 structure retains its integrity of location, setting, and association, but has lost its integrity of materials, workmanship, design, and feeling. The building is currently in a state of partial collapse. Much of the roof has caved in, falling in on itself. It is sided in particle board type sheets on the exterior, which is replacement siding. Beneath the current siding, the bones of the structure are visible and they are substantial, old lumber, beginning with the flooring and joists. Modifications to and deterioration of the structure is substantial. Its integrity is seriously compromised.

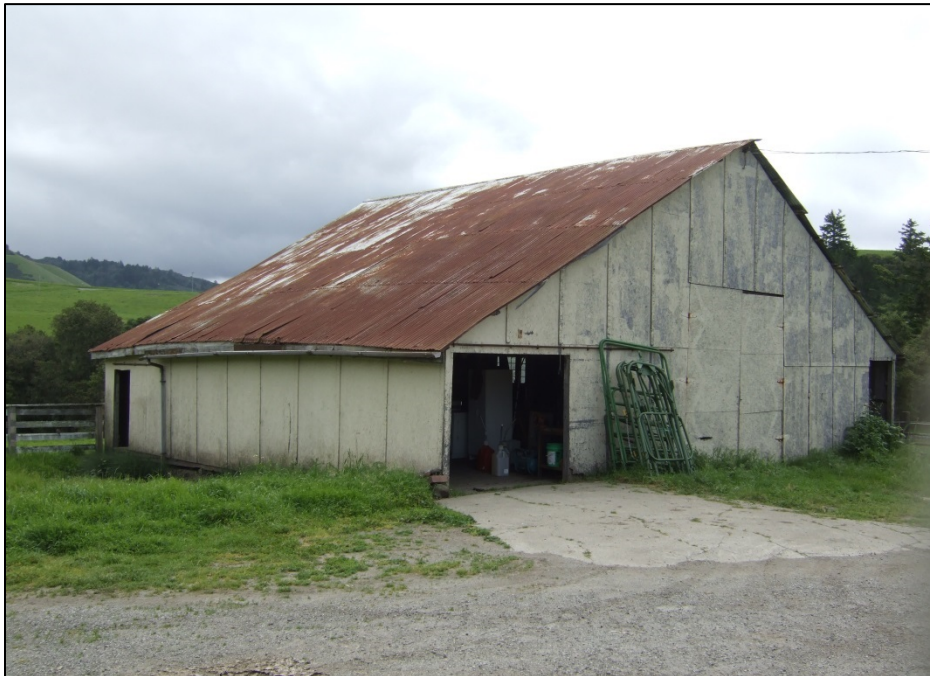
Figure 28. RR-5, Large Barn, west and north elevations

The RR-5 barn retains its integrity of location, setting, feeling, and association, but has lost its integrity of materials, workmanship, and design. The structure is currently in fair condition but has had a few modifications. It is sided in particle board type sheets on the exterior, which is replacement siding. Beneath the current siding, the bones of the structure are visible and they are substantial, old lumber, beginning with the flooring and joists. Some of the building's windows are replacements, and one window opening has been blinded. One large doorway on the west elevation is missing its suspended, rolling or sliding wooden door on the west elevation. The lower segment of the south wall, east corner is missing, exposing the foundation to wind, water, and cold. Near here, an entire plywood panel has fallen off the structure's exterior, leading to greater deterioration inside and out. Modifications to and deterioration of the structure are mostly reversible, but they are affecting its integrity as long as they remain.

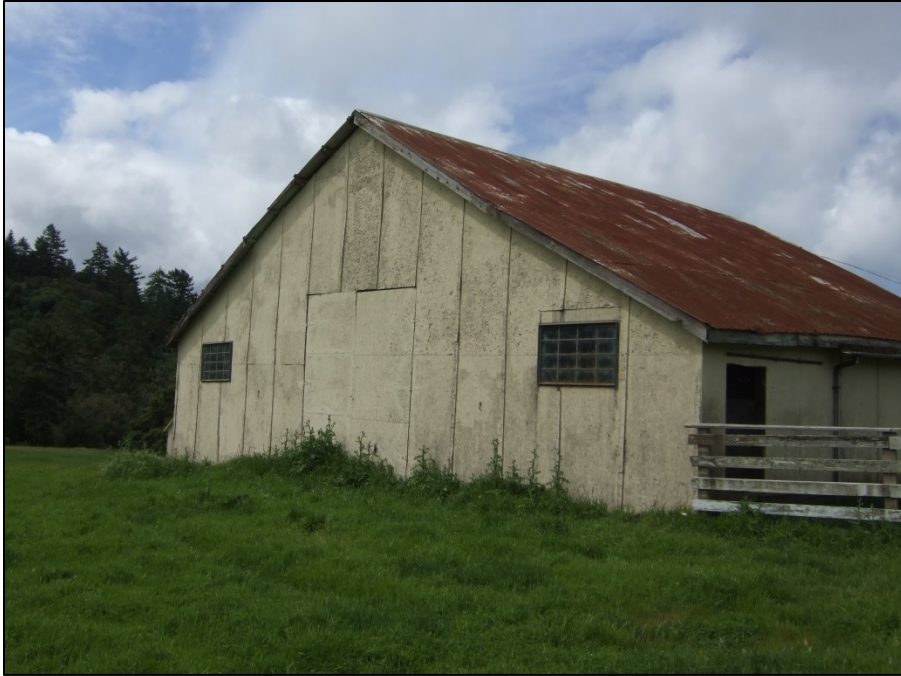
Figure 29. RR-5, Large Barn, east and north elevations

The front (west) elevation has tall, central, strap-hinged double doors and a wide, shorter door at the north end, where a sliding door, suspended from a metal rail once existed. At its south end, the west elevation is pierced by a small access door. The barn's north elevation is plain except for one narrow doorway, which once had a sliding wood or metal door in front of it. The rear or east elevation has central double, strap-hinged wood doors clad in plywood sheets and one window symmetrically spaced at each end. The windows are possibly old replacement windows, as the northern one fills a space that was originally a larger opening. The windows are possibly hopper type windows, with metal frames and faux muntins, meant to look like 16-pane windows. The south elevation is plain and has just one tiny blinded window at its west end. As with RR-2, this barn is set upon truncated pyramidal piers of concrete, space a few feet apart all around the base of the barn.

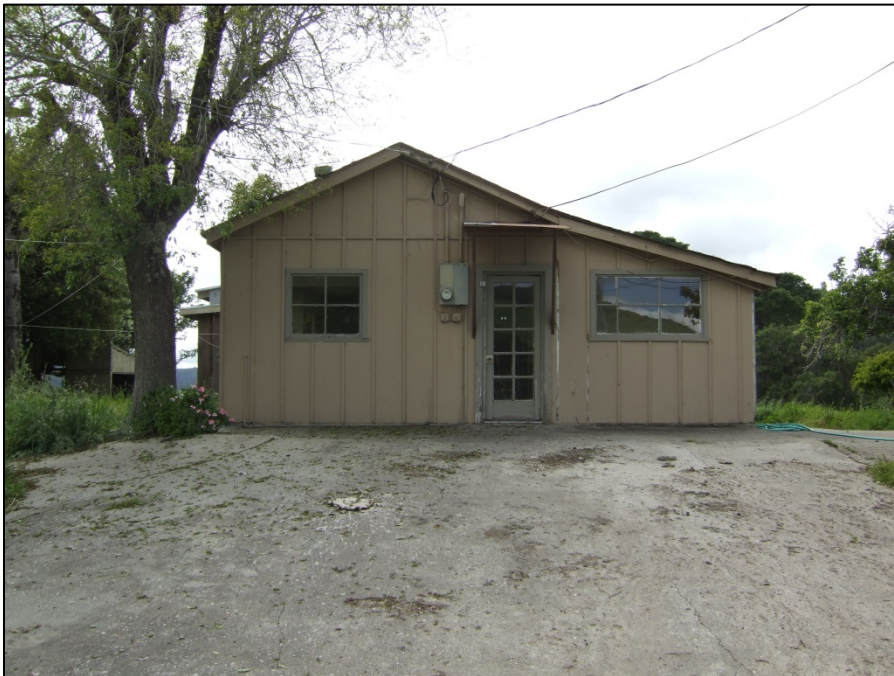
Figure 30. RR-6, Ranch house, east elevation

RR-6, ranch house, was present at Ray's Ranch by at least 1953, based on an aerial photograph from that year (NETR 1953). It is evident from the shape and location that the original house from the mid-1900s is still within the existing structure to some degree, but the many replacement windows, the variety of sidings, and the rather crude addition to the south and west elevations has considerably modified the original building to the point where it is difficult to discern its original form and style.

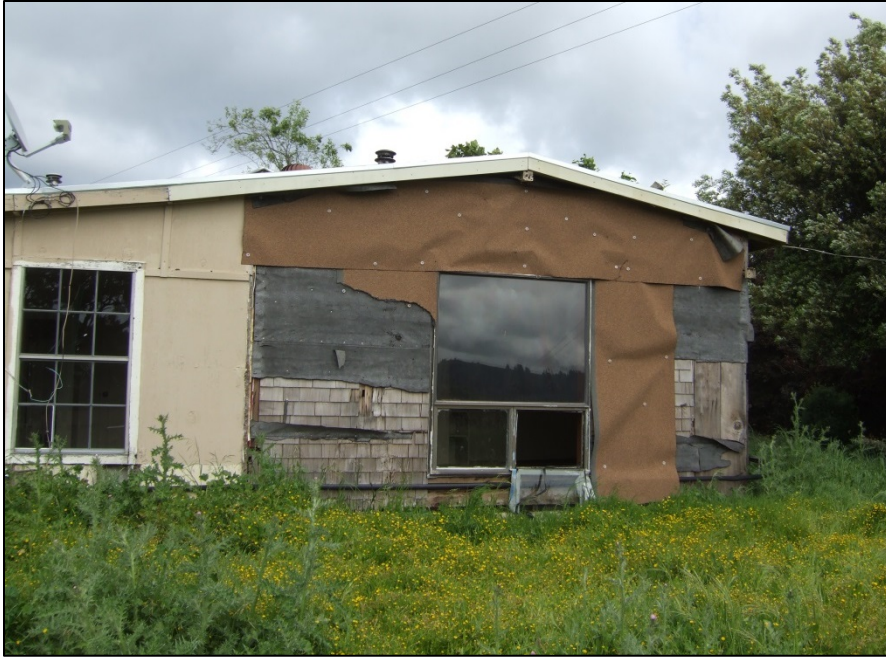
Figure 31. RR-6, ranch house, west elevation

The west elevation of the house is clad in T1-11 siding, wood shingles, and composition roofing sheets (Figure 31). It is fitted with a large metal frame sash window on the north and a picture window in the south half, which appears to be an addition. This window consists of a large fixed upper pane with two, possibly movable lower panes. The south elevation is clad in bare, horizontal 1 by 12 inch boards on its west, projecting bay and plywood sheeting on the east half. The projecting bay has a door opening at its east end, with a porch cover above it, then along the recessed eastern portion of the elevation there are a large and a small aluminum slider, with a 10-light wooden door near the east end. The house is surrounded by a fenced yard area, with a large wooden animal pen, a plywood garden shed, a number of domestic fruit and ornamental trees, as well as many domestic flowering plants.

The RR-6 single-family house retains its integrity of location, setting, and association, but has lost its integrity of materials, workmanship, design, and feeling. This building has been extensively altered. First, there are several kinds of replacement siding – plywood sheets, plywood board and batten, wood shingles, composition roofing sheets, T1-11 siding, and horizontal boards – on the exterior. A number of modern replacement windows in metal frames with faux muntins are set in the walls. One door is completely missing from its opening. Two additions have been made to the house. The first is a crude porch roof added to the front of the house, over the front door. The second is a crudely-made bay on the southwest corner of the original house. One door within this bay has broken apart, leaving the inner half in the opening.

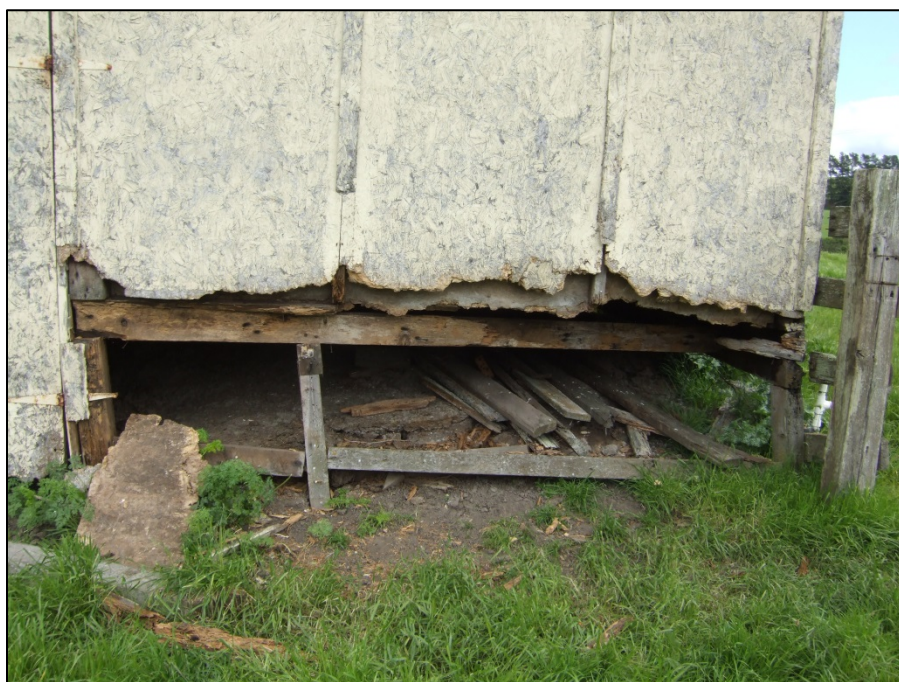
Figure 34. RR-7, Shed or Workshop, close-up of west elevation damage

The east elevation is the front of the building, which is plain, with a large wood door at the south end and a small wood frame slider window at center. The north elevation is plain and devoid of any openings. The west elevation is fitted with a large wood door at its north end, similar to the door on the east elevation, fastened by means of strap hinges (Figure 33). Along its lower section, much of the west wall is gone, exposing some of its internal structure and exhibiting damage to the building (Figure 34). Its foundations here appear to be bare wood posts standing

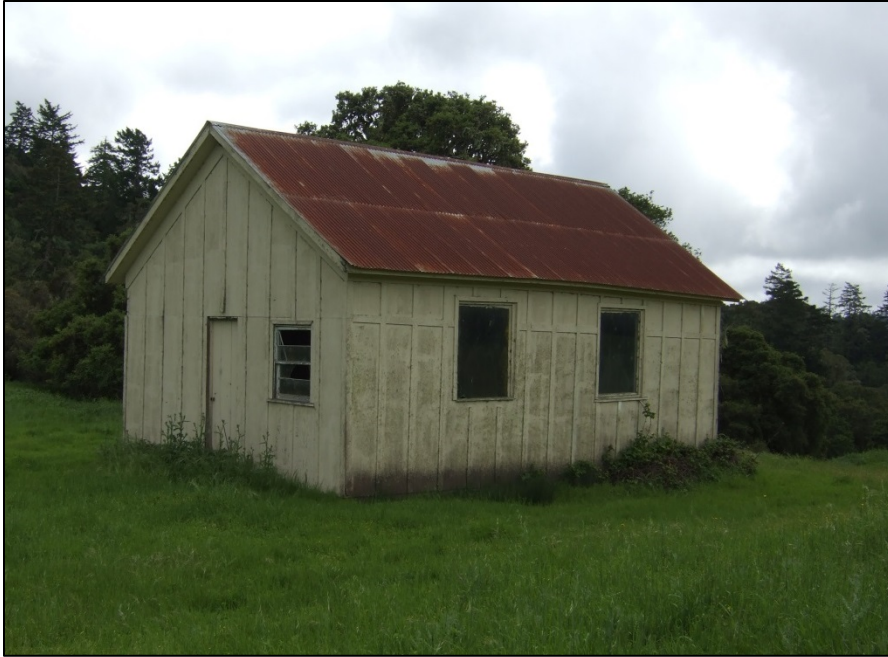
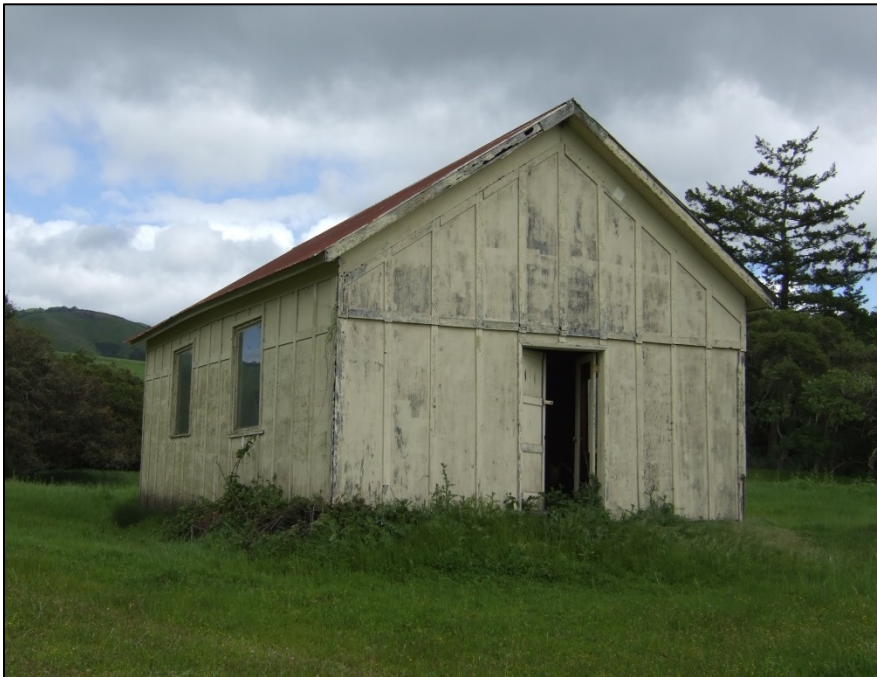
Figure 35. RR-8, possible Bunkhouse, east and north elevations

The RR-8 building is more intact than most of the others at Ray's Ranch. It has many windows and only human-sized doors, suggesting its possible use as living quarters for ranch hands or ranch owners, or as work space for inside activities (Figure 35). It is a one-story building, rectangular in plan, of plain, utilitarian style. It is front-gabled, east-facing, and oriented east-west, located south of the ranch house and big barn (RR-5). The roof is moderate in pitch, clad in corrugated metal, with narrow overhang and boxed eaves and wide fascia board along the tops of the walls. Exterior wall siding is heavy plywood-like sheets with battens, nailed over original wide wood boards.

The east (front) elevation has a central wooden entry door and a wood frame 2/2 sash window. The north elevation has two large single-pane, wood frame windows that appear fixed. The west elevation has a central double door of wood, while the south elevation is fitted with an aluminum frame replacement slider of medium size. The building may contain two interior rooms. RR-8,

a possible bunkhouse, was present at Ray's Ranch by at least 1953, based on an aerial photograph from that year (NETR 1953).

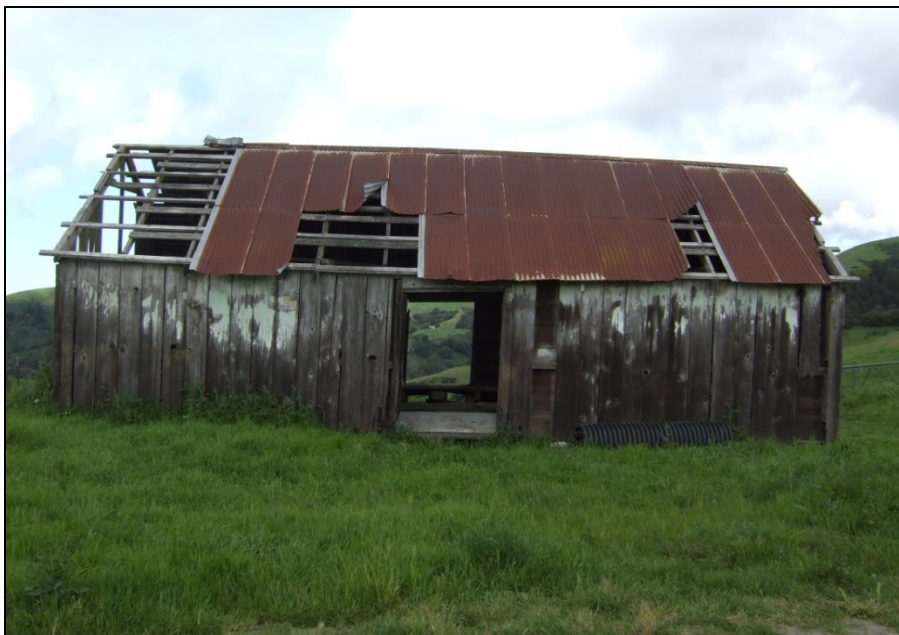
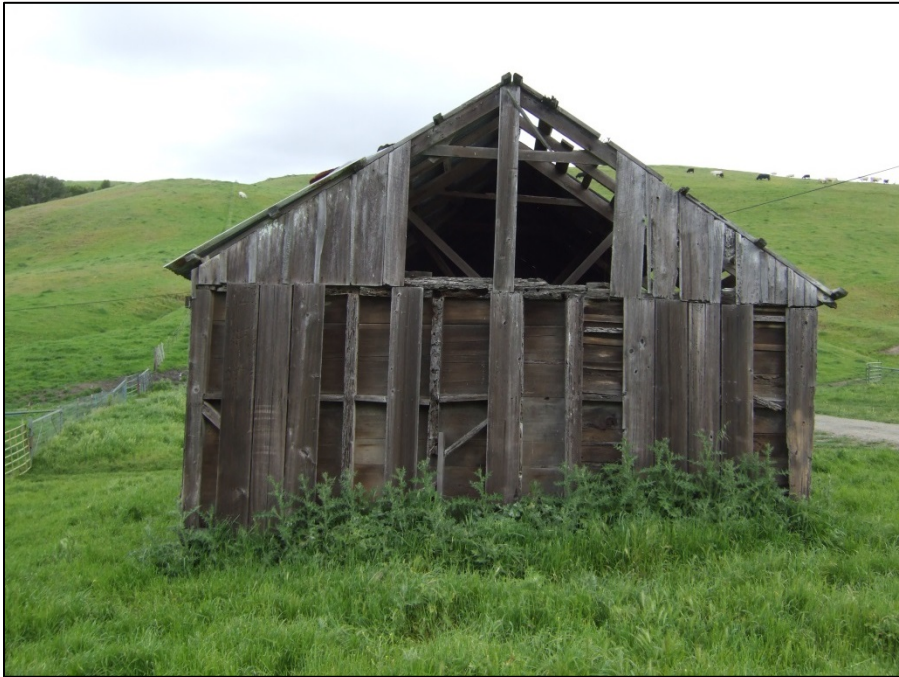
Figure 39. GZR-1, small barn, east elevation

with one large central doorway. It has several horizontal boards nailed across the top, above the doorway. The barn's south elevation has the same siding and construction, though most of the exterior boards are gone, leaving the interior board wall and wall studs exposed to the elements.

The barn's floor is also composed of large boards supported by massive joists. This building is thought to have stood at the ranch since at least 1940, based on a map from that year, and based on the building's stout construction members (USGS 1940).

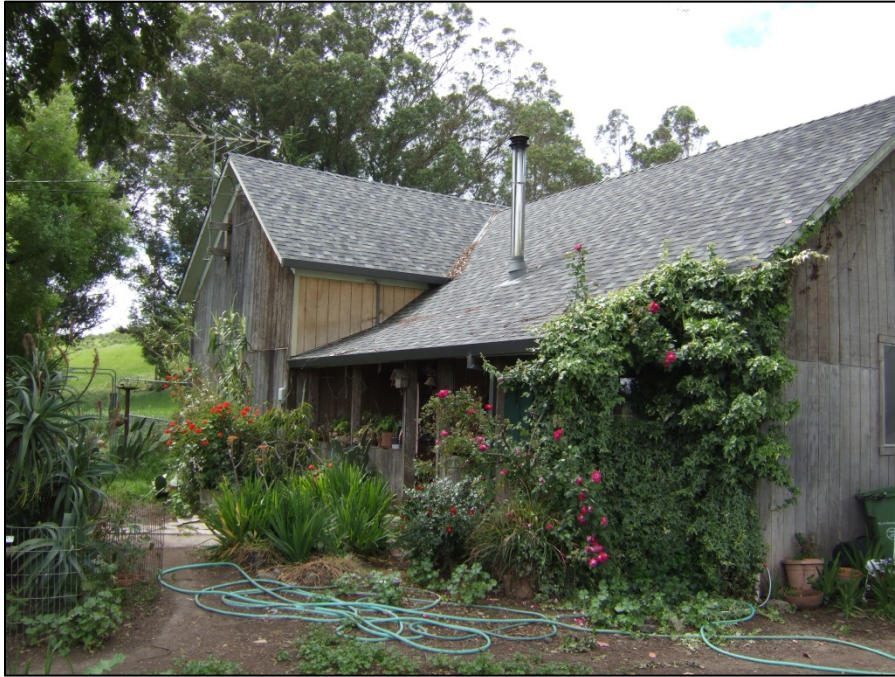
Figure 41. GZR-4, ranch house, east and north elevations

The house at Guerra-Zanoni Ranch appears to have undergone alterations and additions over the years. It almost appears to be two small houses joined together (Figure 41). The house is currently occupied and this ranch is used primarily for sheltering rescue dogs and cattle grazing. It is a one-story, east-facing building, oriented north-south, and roughly rectangular in plan. The roof is cross-gabled and steep in pitch, covered in composition shingles. It has a narrow overhang with boxed eaves and wide frieze beneath it. The house exterior is sided in modern, but rustic-looking wood siding, similar to T1-11, first produced in the 1970s.

The front (east) elevation of GZR-4 is composed of two halves – first the projecting, more vertical and front-gabled bay, possibly the older, original part of the house on the south side. It is tall enough to have a second story, but there are no windows or other openings in the upper part of the exterior. Second is the adjoining north half of the elevation, which is recessed, with a wide, covered porch across the front. Here the off-center front entryway stands, with a wood panel style door. All of the three windows on the east are metal-framed sash types. The porch is composed of salvaged boards, with two concrete steps leading up to it.

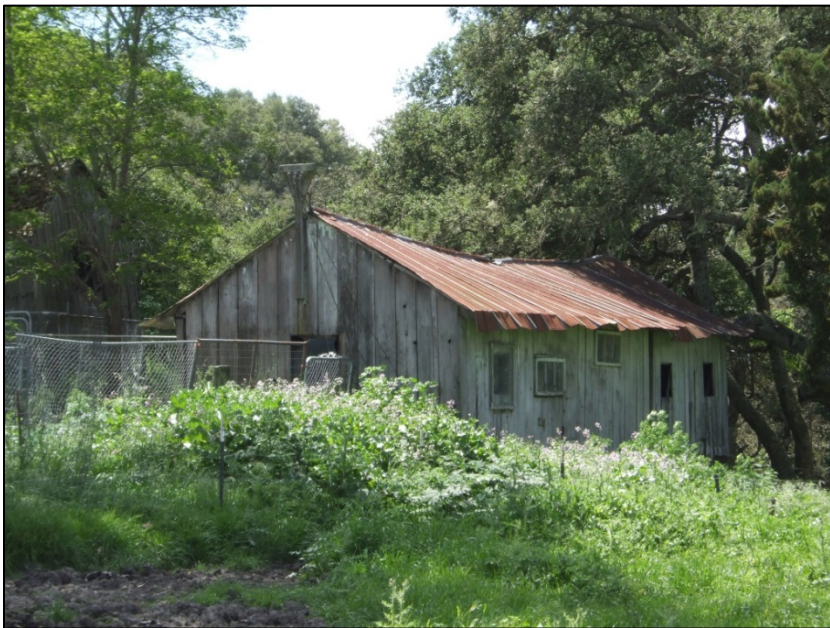
Figure 43. GZR-5, shed, east and north elevations
GZR-6: Cabin

West of the house and at the edge of the rear yard are two small wood structures. GZR-5 may have served as a shed or workshop (Figure 43). It is one story in height, with a low-pitched, side-gabled roof. The shed is south-facing, oriented east-west. Corrugated metal covers the roof, while all exterior walls are clad 1 by 12 boards, as with GZR-1 barn. The east elevation has no openings, while the north elevation has five small windows that appear to be original and are possibly hopper types. This structure has been present since at least 1953 (NETR 1953).

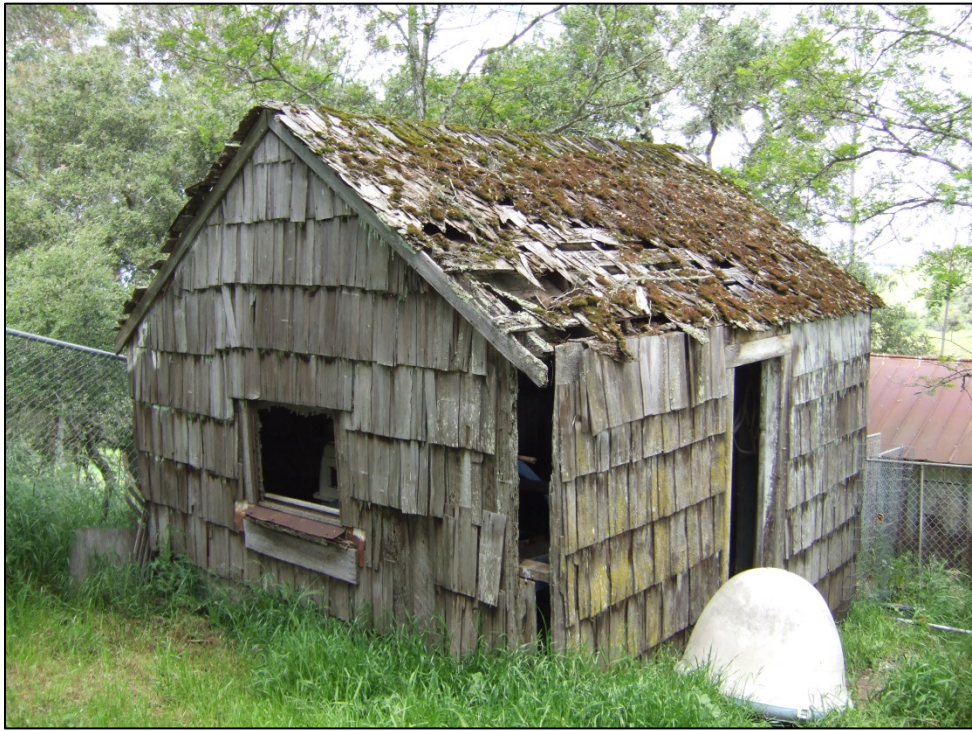
Figure 44. GZR-6, small cabin, south and east elevations

vernacular in style, with a roof of moderate pitch, covered with wood shingles at one time, but many of which are now missing. It faces east, and is oriented north-south. The structure's east elevation has an entryway and its south elevation has a window. At present, the cabin appears to be used for storage. It is thought to have been on the property since at least 1953 (NETR 1953). While it is in poor condition, it does not appear to have been modified to any extent.

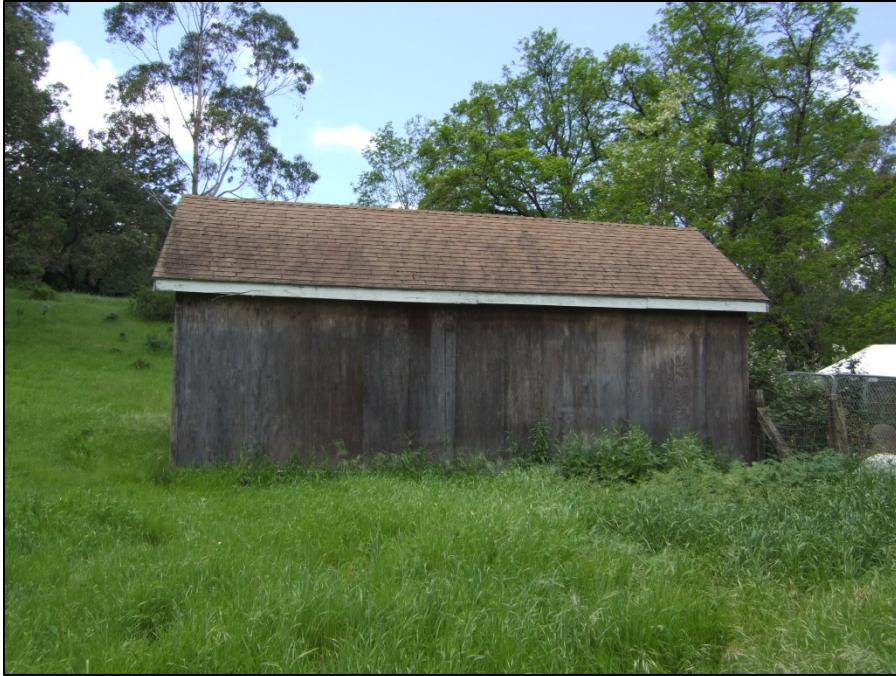
Figure 45. GZR-7, storage shed, east elevation

GZR-7 is an outbuilding approximately 15' x 20' dating from the 1930s, possibly earlier. The east side of the building has the original structural material, while the west wall and the roof (comp shingles) appears to have been rebuilt recently. The exterior is a plywood material. The roof and western wall are in fair condition, but the post and pier structure is in poor condition. Dry rot is present on the timber sills that sit directly on the soils, which may have migrated into the building through foot traffic or storm water. It will take a significant amount of work to remove the wood and earth to prevent further dry rot. The structure does not show signs of significant failure. Even though the structure may remain for several more year, staff has concerns about the user safety and liability to the District. The costs of replacing the affected materials, constructing new posts and piers, and other structural elements may outweigh the benefits. Due to the reasons that the structure neither waterproof or animal proof, staff recommends demolishing the structure and replacing it with a smaller storage structure. The exception to the recommendation would be if the structure were to be used for the purpose of keeping livestock or other animals (i.e. not maintained or occupied by people).

The shed known as GZR-7 may have stood on the property since at least 1953 (NETR 1953). If so, the structure has been modified since that time. This one-story, plywood-clad structure is north-facing, with no windows or doors on the west, south, and east sides (Figure 45). It is a plain, utilitarian building, front-gabled with moderately-pitched roof covered in composition shingles. It has a narrow overhang and exposed rafters. Its walls are clad in sheets of plywood, which may or may not be covering older siding. Nothing on the outside of the structure suggests it is from the 1950s, other than its style.

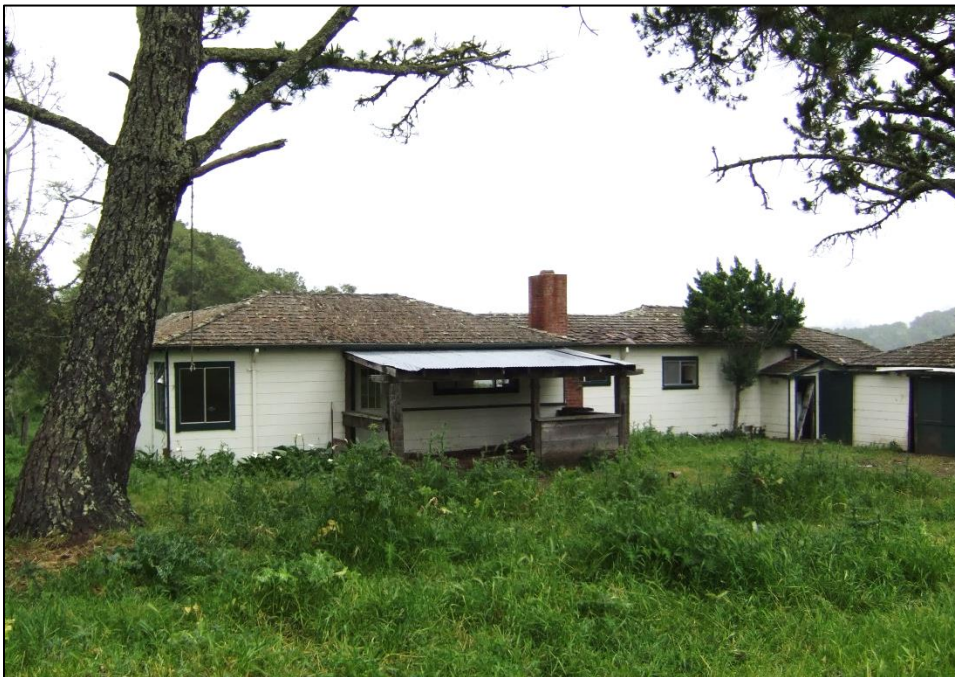
Figure 48. WR-2, ranch house, northwest elevation

roofs are all of low pitch, covered in shake shingles, and form narrow overhangs around the house. Most of the siding on the house is now replacement aluminum siding, in a pattern mimicking wood drop siding. In one location on the south side of the house, actual wood siding of the same width as the metal pattern is present. The garage retains its original wood drop siding on its rear elevation.

On the northwest (front) elevation, the main bay projects approximately 5 feet to the northwest. It has a central wooden door with nine lights, an aluminum slider at its north end, with wood trim, and a large horizontal, six-pane window south of the front door that may or may not be fixed. A rough, homemade porch was added to the front of this bay, comprised of large sized boards and posts, with wooden eaves covered with corrugated metal. At the southwest corner of this front bay stands a massive brick fireplace and chimney. The middle section of the front elevation is recessed and is fitted with two wood-trimmed windows, one being similar to the large one on the front bay, with six horizontal panes, and the other being an aluminum slider. Further south, a small structure has been added to the elevation to house the water heater. This structure looks suspiciously like an outhouse that has been reused and relocated. It has a shed roof also covered in shake shingles. It abuts a third bay on the front, which also projects to the northwest. The projecting segment may be an addition that articulates with an originally detached garage.

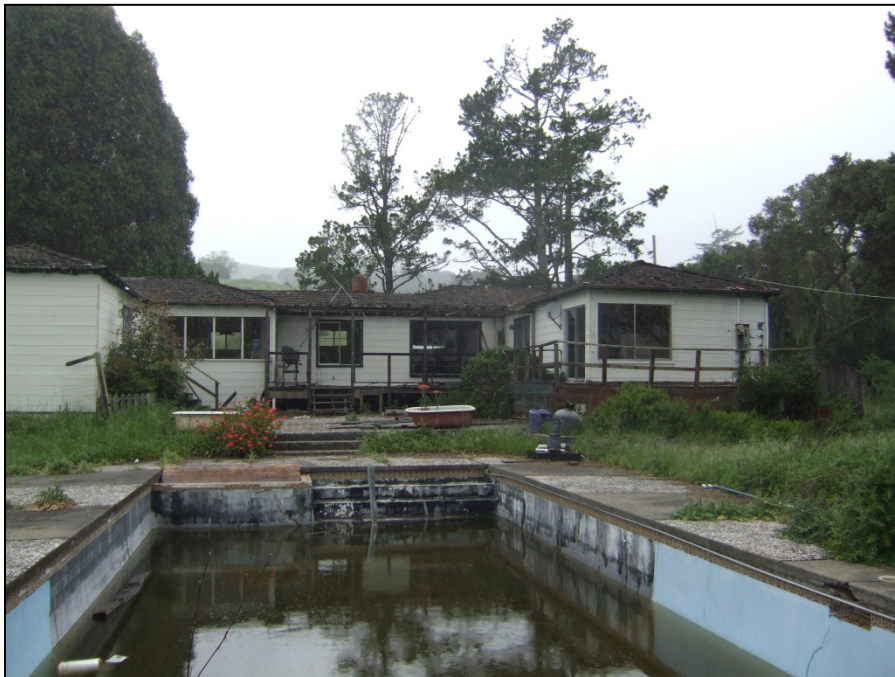
Figure 49. WR-2, ranch house and pool, rear elevation

The rear (southeast) elevation forms a U shape, with projecting bays at north and south ends and a wooden deck surrounding more than half of the exterior (Figure 49). The northern two-thirds of this elevation are filled with large picture windows, aluminum sliders, sliding glass doors and other fixed windows, to take advantage of the pool area and of the view. While the house appeared on an aerial map from 1953, the back yard swimming pool was not in place until sometime between 1960 and 1991, probably not until at least the 1980s by the looks of its tiles and general appearance. The projecting southern bay may be a later addition as it looks somewhat incongruous and there is a break in the siding on its southwest elevation. In this area, the wood roof trim is different and some of the siding is actual wood rather than aluminum.

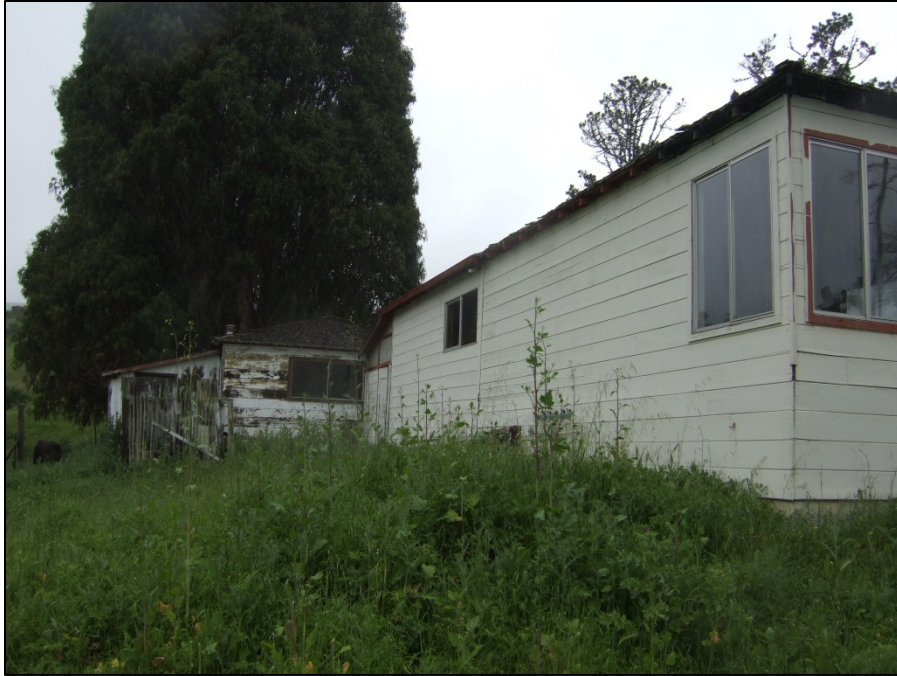
Figure 50. WR-2, ranch house additions, on southwest elevation

The southwest elevation of the house is an alignment of additions, starting with the bay just described above, followed by one original section of the house, then northwest of that the addition that joined the house to the garage, then the southeast and southwest elevations of the garage (which is sided in actual wood drop siding), ending at a shed-like addition added to the northwest side of the garage, possibly for additional automobile storage (Figure 50).

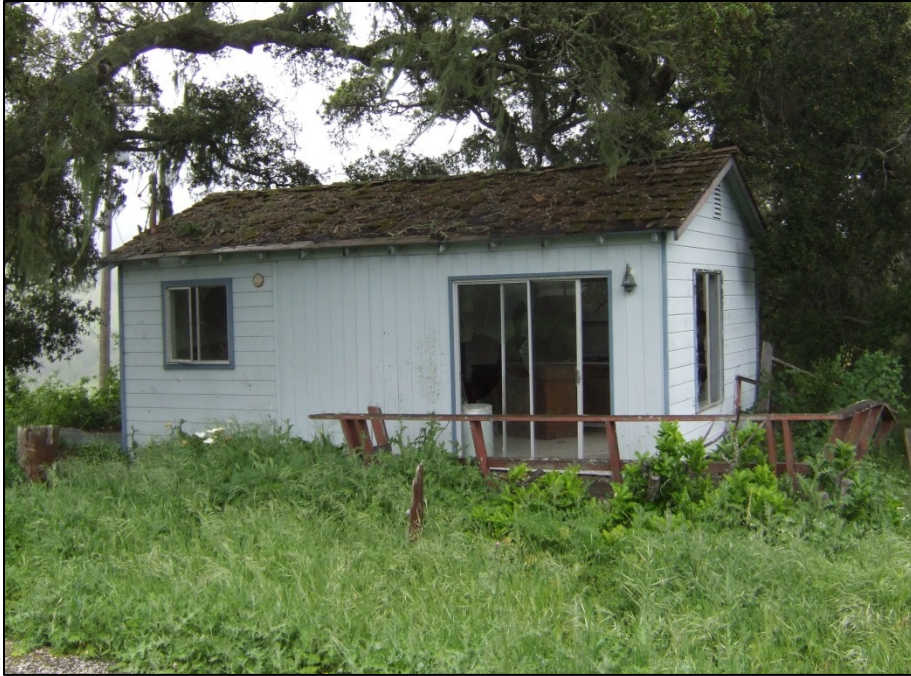
Figure 51. WR-3, cottage, northwest and southwest elevations

WR-3 is a cottage or guest house in the rear yard of the ranch house, near the pool (Figure 51). It is plain, of one story, with side-gabled roof of moderate pitch, covered in wood shake shingles. It is rectangular in plan, facing northwest, towards the pool and is oriented north-south. The cottage is sided in a combination of aluminum siding of the same pattern as the main house, with a panel of T1-11 siding across much of the front elevation. Its front entrance is a sliding glass door, accessed by means of a small, low wooden deck with railing. Aluminum sliders are set in the northwest and southwest elevations. The cabin likely dates from the period when the main house was re-sided, perhaps in the 1970s or 1980s, as was not present on the earlier maps and aerial photographs (NETR 1953, 1960).
