Midpeninsula Regional
Open Space District

R-17-74
Meeting 17-15
June 28, 2017

Structure Demolition at 1150 Sears Ranch Road in La Honda Creek Open Space Preserve

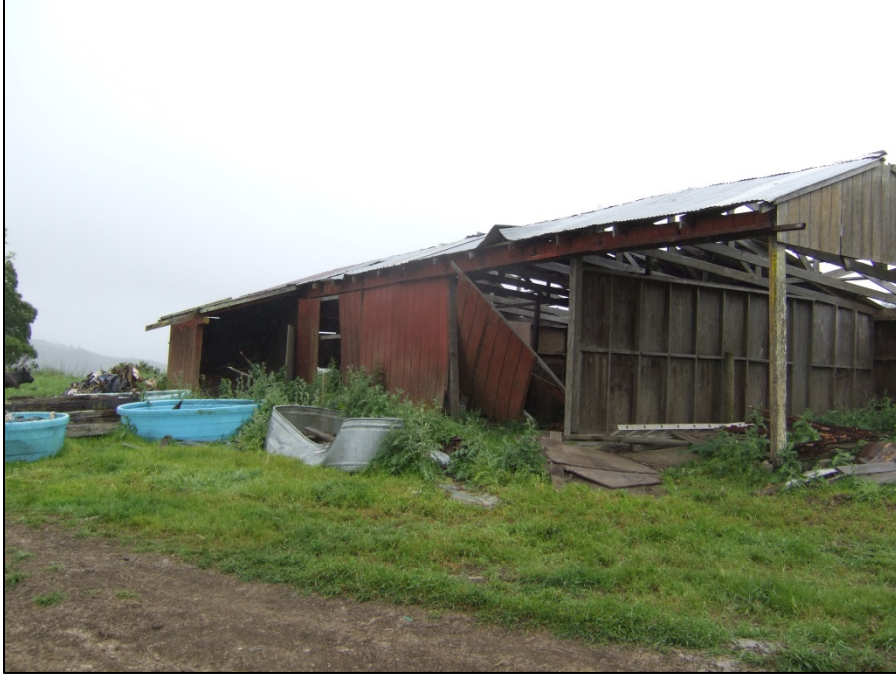
Figure 52. WR-4, large barn, northeast elevation

The large, partially collapsed barn located to the northwest of the ranch house is known as the Upper Wool Barn, here referred to as WR-4 (Figure 52). It is a single story barn, rectangular in plan with multiple interior rooms, northeast-facing, and oriented southeast-northwest. It is very close to the dirt road that provides access to the Wool Ranch. It is side-gabled, with a roof of moderate pitch, covered in corrugated metal. Exterior walls are composed of a very stout T1-11 type wood siding, with interior walls composed of plywood sheets. The front (northeast) elevation is missing much of its surface, but what is there is composed of the heavy, large sheets of the T1-11. At the southeast end, a projecting enclosure or shelter extends approximately 6 feet to the northeast and is open across its northeast elevation.

The northwest elevation of the barn is mostly intact and retains all of its siding. It has no doors or windows. The barn was in place at this location by 1953 (NETR 1953) but its siding suggests the barn was re-sided at a later date. The corrals located across the road from this barn first showed up on the 1991 aerial photograph (NETR 1991).

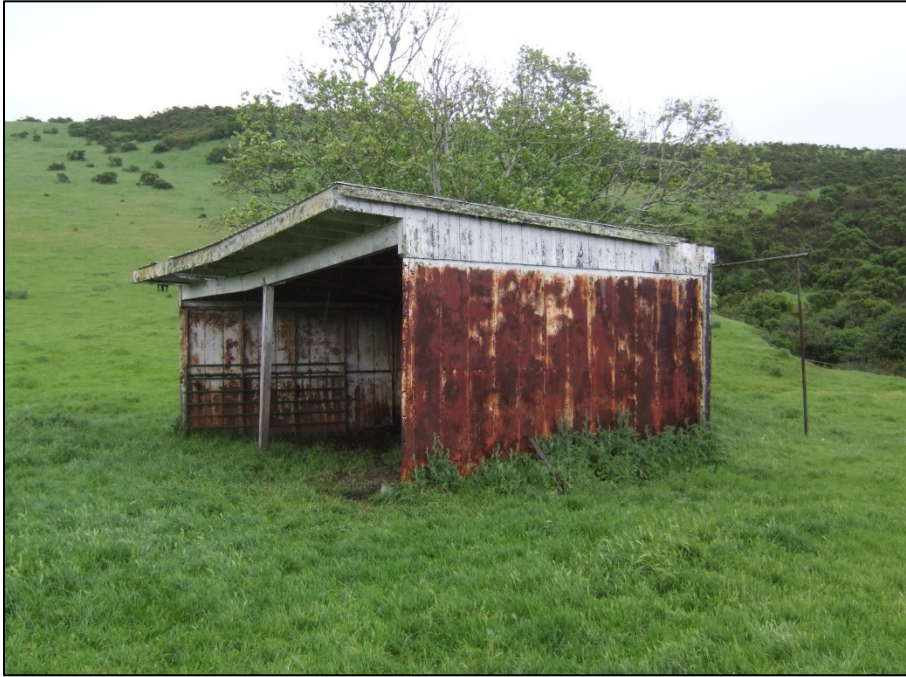
Figure 54. UFR-1 animal shelter, north and west elevations

UFR-1 is a metal and wood animal shelter located at the north end of this small complex. It faces north, and is oriented east-west. The structure is one story in height, rectangular in plan, with a low-pitched shed roof (Figure 54). It is enclosed on three sides by sheet metal vertical siding and open on the north side to allow cows to easily shelter here. The roof covering is unknown, but it projects to the north for several feet, providing shelter above the wide open elevation. The walls are composed of sheet metal, with the upper part of the east and west walls covered with heavy T1-11 type siding.

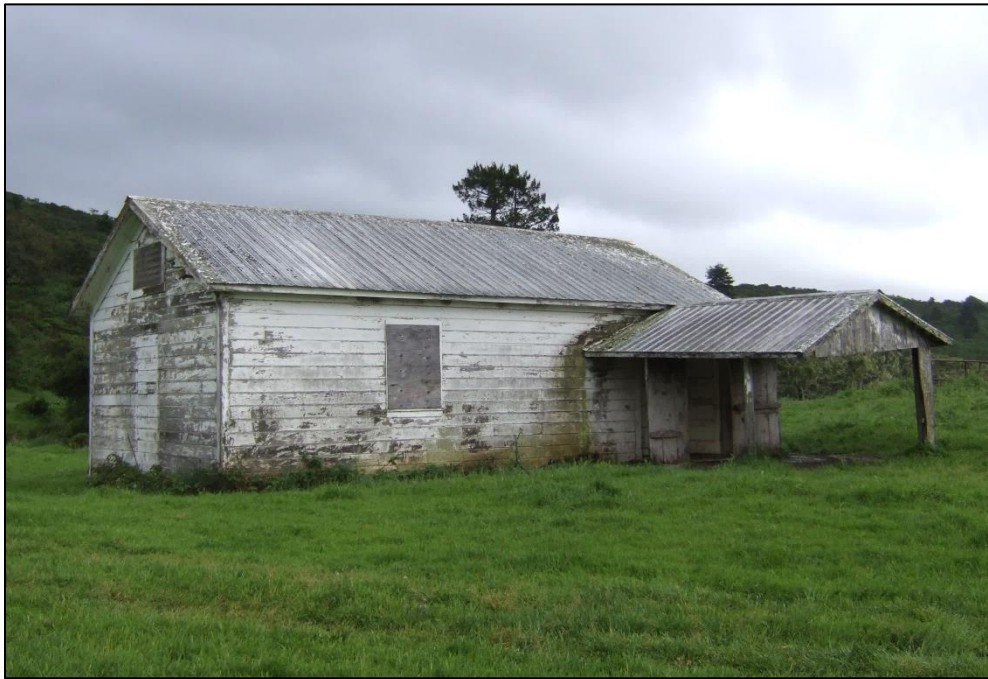
Figure 55. UFR-2, cabin or ranch house, north and east elevations

The east elevation has a large louvered vent in its gable and the clear outline of a former doorway that has been filled with wood siding. The south elevation is plain, with two openings. At the center is a sliding glass door that definitely is a later addition or replacement. The second is a small window near the west end, devoid of glass and boarded up. It had a wood frame. The building foundation is visible on this elevation and consists of short wood posts standing on bare ground. The building has been at this location since at least 1953 and possibly earlier, during the 1940s (NETR 1953; USGS 1940).

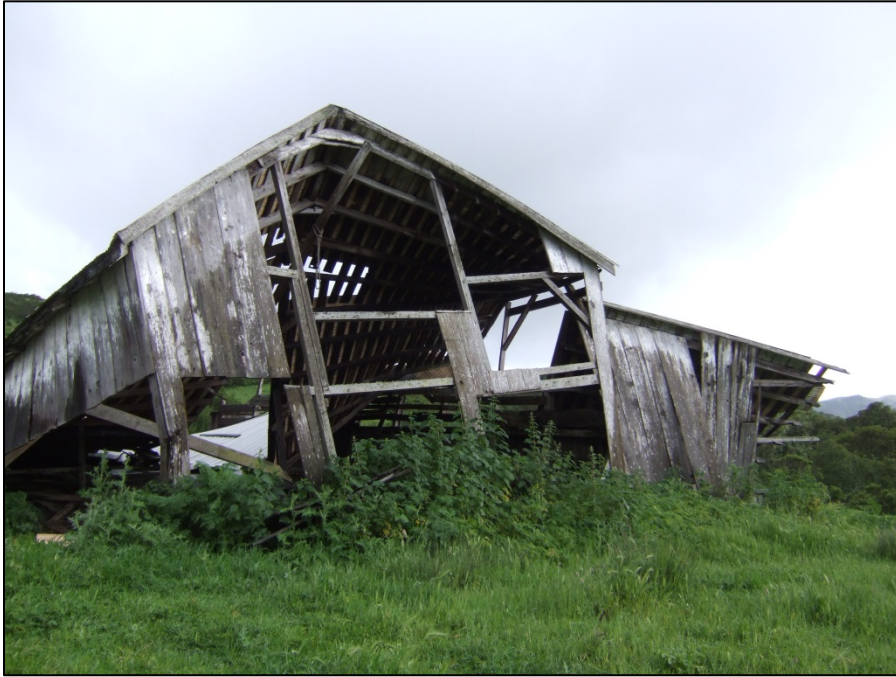
Figure 57. UFR-3, collapsed barn, north elevation

This large, collapsed hay barn lies approximately 500 feet south of the cabin and animal shelter, described above (Figure 57). It is a wood frame structure, rectangular in plan, with taller center bay flanked by lower, sloped wings. The roof was front-gabled and covered in corrugated metal. Presumably, the structure was north-facing, but possibly its main entrance was to the east, adjacent to the road into the ranch. Its walls were clad in vertical 1 by 12-inch boards. This building has stood at the ranch probably since 1940 (NETR 1953; USGS 1940).

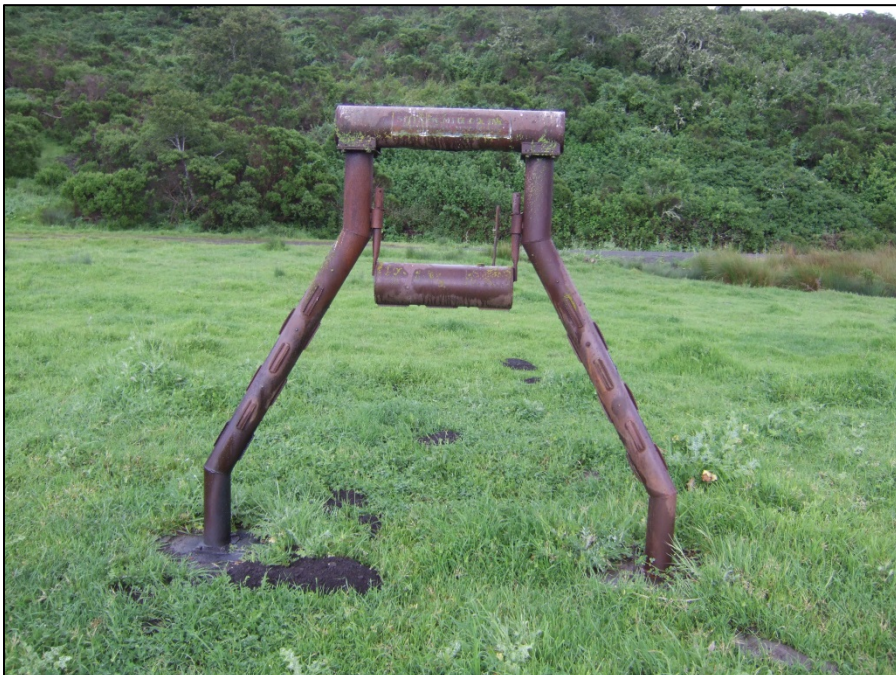
Figure 58. UFR-4, Sittner cattle oiler, view to east

In the clearing just south of this barn, a feature labeled UPR-4 has been identified as a cattle oiler. This is used to apply oil to cows' skin in order to repel flies and to comb their old hair off with attached metal curry combs (Figure 58). The device retains a stenciled mark "SITTNER MFG. CO. INC./ SHERIDAN, WYOMING." The mark indicates that the oiler was a product of Ed Sittner. Sittner invented the cattle oiler in Nebraska and in 1971 moved to Sheridan, Wyoming. This oiler, then, post-dates 1970 (Casper Star Tribune 2003).

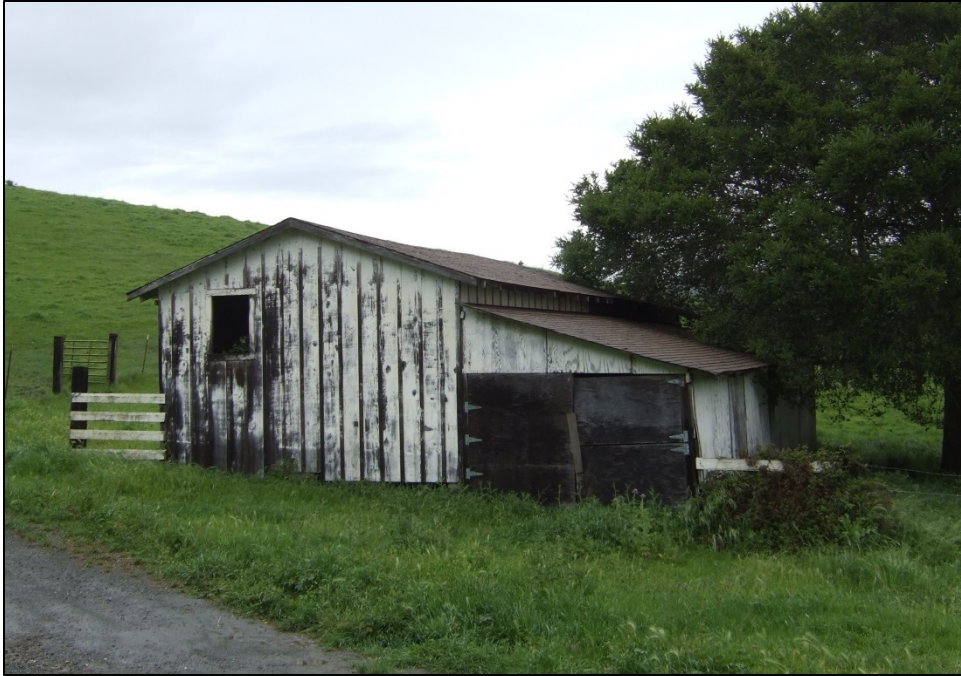
Figure 62. LFR-2, barn, west and south elevations

the south addition is composed of plywood sheets. An opening is located high on the wall near the barn's north end, possibly used for loading hay into the barn. Wide double doors of plywood are attached to the front of the addition by large strap hinges, providing access to this bay. The south elevation of the addition is plain, with one central window, and siding of large plywood sheets. The north elevation has one small opening in its east half. It is clad in the same board and batten as the front along its west half, then covered with plywood along the east half. The barn articulates with fencing on two sides, which encloses a pasture in which three large rectangular, modern corrals stand. These are east of the barn.

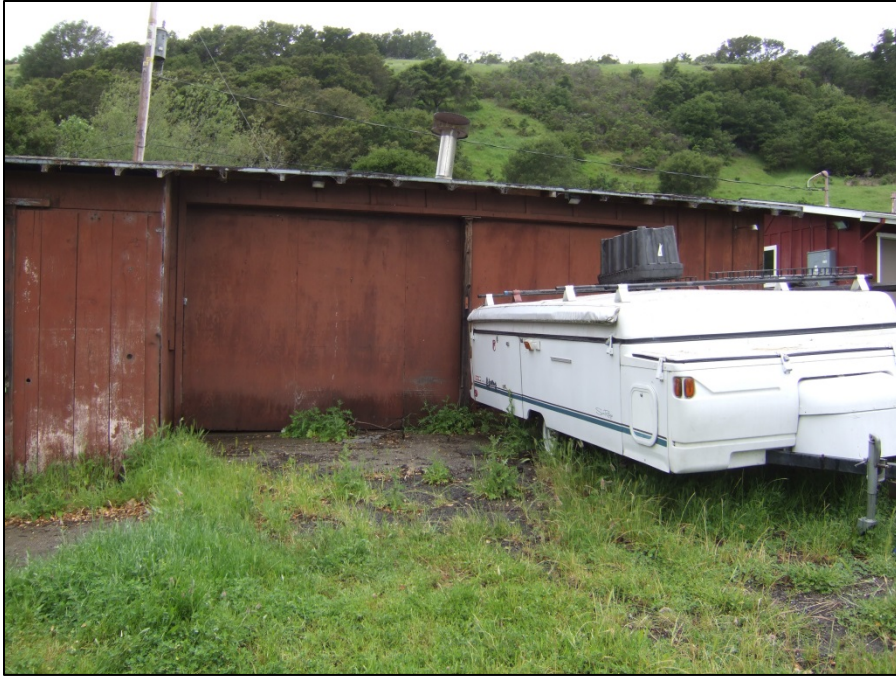
Figure 63. LFR-3, workshop/shed, east elevation

To the south of the house, a roughly rectangular structure stands, fitted with large doors on its east elevation, suggesting storage for automobiles or farm equipment (Figure 63). It is a single story, utilitarian, vernacular structure that faces east and is oriented north-south. It has a side-gabled, low-pitch roof covered in composition shingles. It has a moderate overhang and exposed eaves. The structure is sided in plywood, some of it in sheets, some of it applied as board and batten.

The east (front) elevation has a south bay that projects a few feet to the east and has a large sliding door suspended from railing. North of this bay, within the recessed north half of the

elevation are two more large plywood pivot-type doors, also automobile or machinery size.

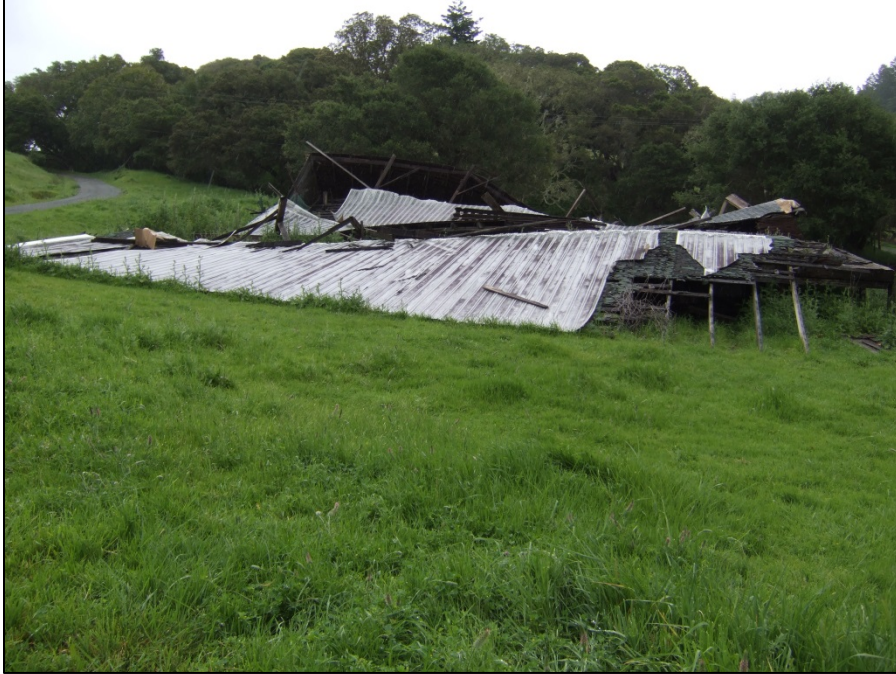
A collapsed, large barn remains south of the Lower Folger Ranch complex, just off the main access road, and at the location of a former intersection of dirt roads. The barn was of wood construction, with a corrugated metal roof (Figure 64). It may have stood at this location since at least 1953, when it stood just across another dirt road from two other buildings no longer present. Based on its location and proximity to other buildings, it is possible that the barn stood on Tichnor property, rather than on Folger land. Not much more can be said about it.

Figure 64. LFR-4, collapsed hay barn

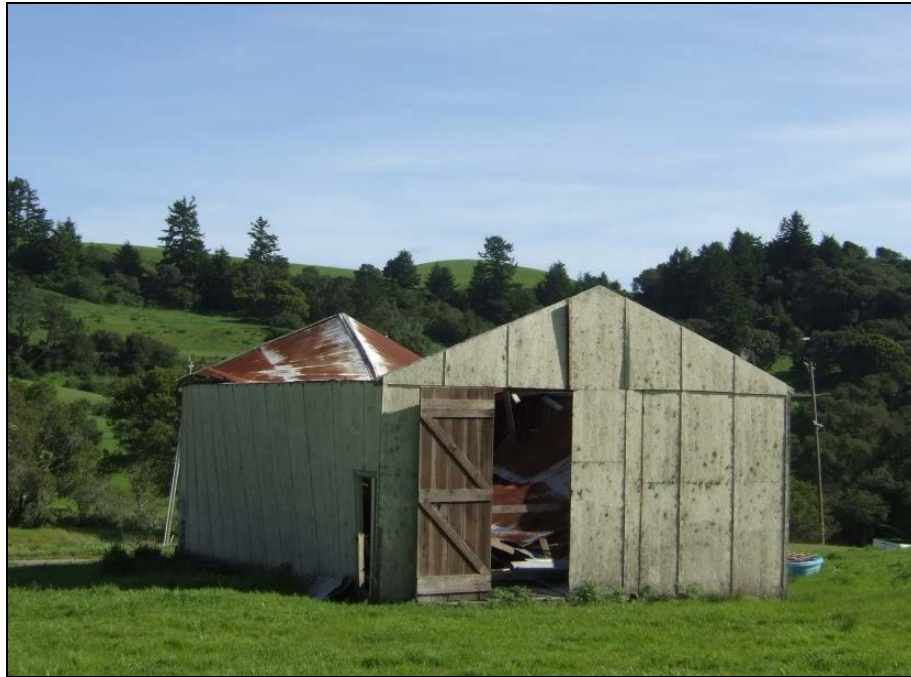
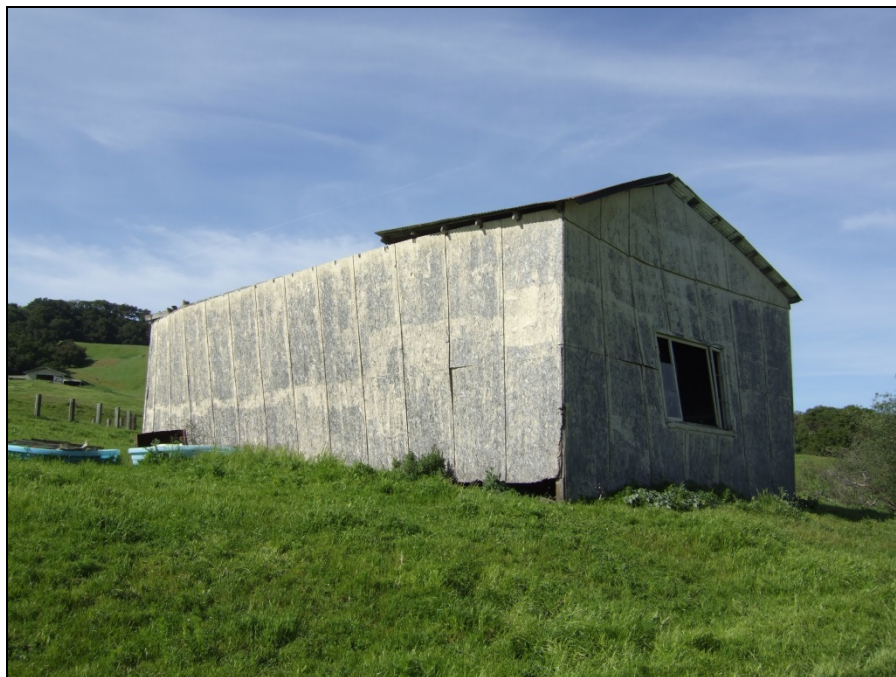
The RR-2 structure retains its integrity of location, setting, and association, but has lost its integrity of materials, workmanship, design, and feeling. The building is currently in a state of partial collapse. Much of the roof has caved in, falling in on itself. It is sided in particle board type sheets on the exterior, which is replacement siding. Beneath the current siding, the bones of the structure are visible and they are substantial, old lumber, beginning with the flooring and joists. Modifications to and deterioration of the structure is substantial. Its integrity is seriously compromised.

RR-2, Large Shed or Workshop, north and east elevations

RR-2, Large Shed or Workshop, west and south elevations

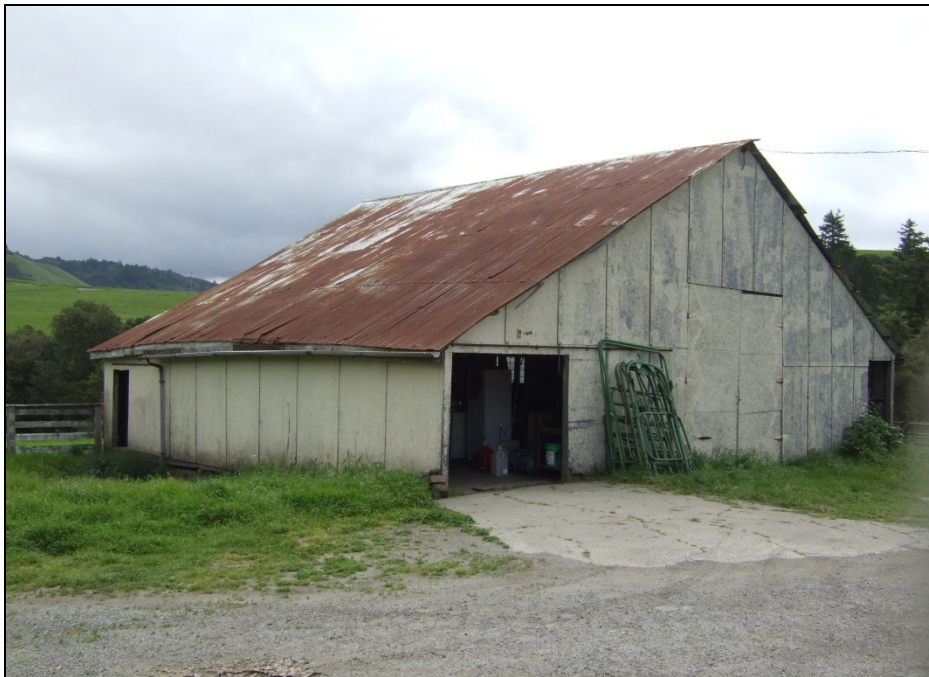
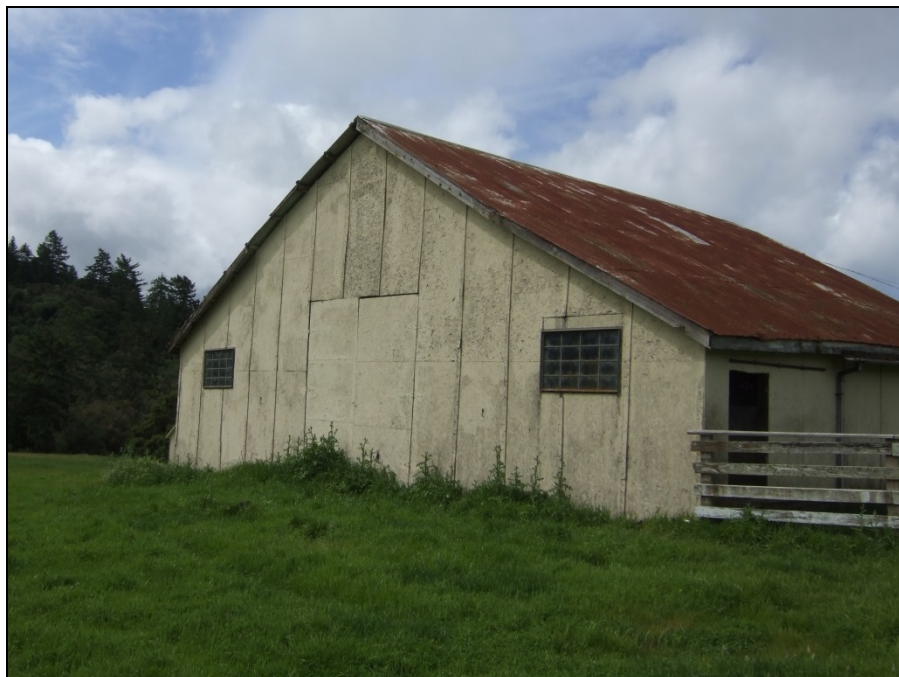
The RR-5 barn retains its integrity of location, setting, feeling, and association, but has lost its integrity of materials, workmanship, and design. The structure is currently in fair condition but has had a few modifications. It is sided in particle board type sheets on the exterior, which is replacement siding. Beneath the current siding, the bones of the structure are visible and they are substantial, old lumber, beginning with the flooring and joists. Some of the building's windows are replacements, and one window opening has been blinded. One large doorway on the west elevation is missing its suspended, rolling or sliding wooden door on the west elevation. The lower segment of the south wall, east corner is missing, exposing the foundation to wind, water, and cold. Near here, an entire plywood panel has fallen off the structure's exterior, leading to greater deterioration inside and out. Modifications to and deterioration of the structure are mostly reversible, but they are affecting its integrity as long as they remain.

RR-5, Large Barn, west and north elevations

RR-5, Large Barn, east and north elevations

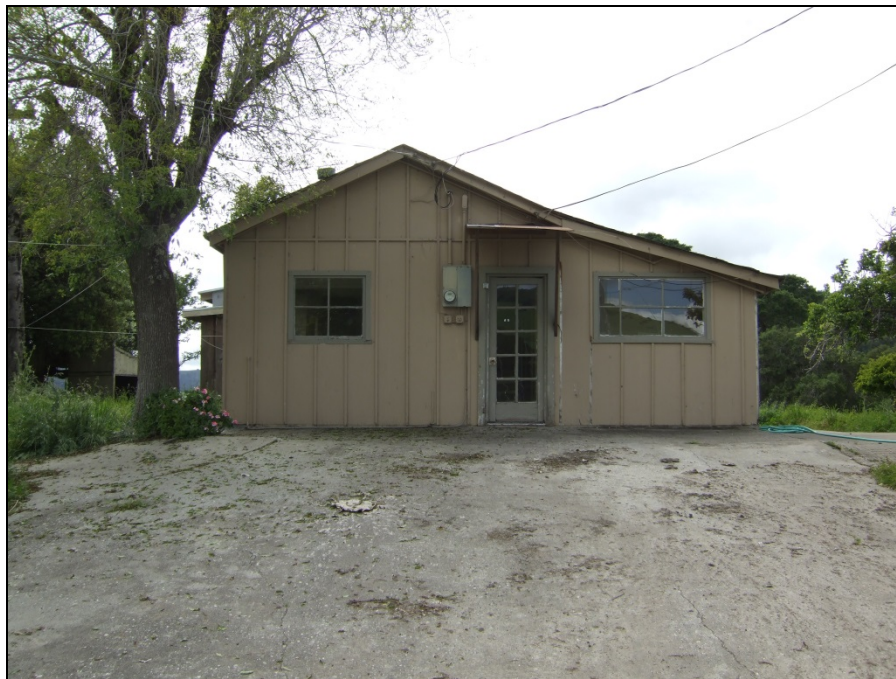
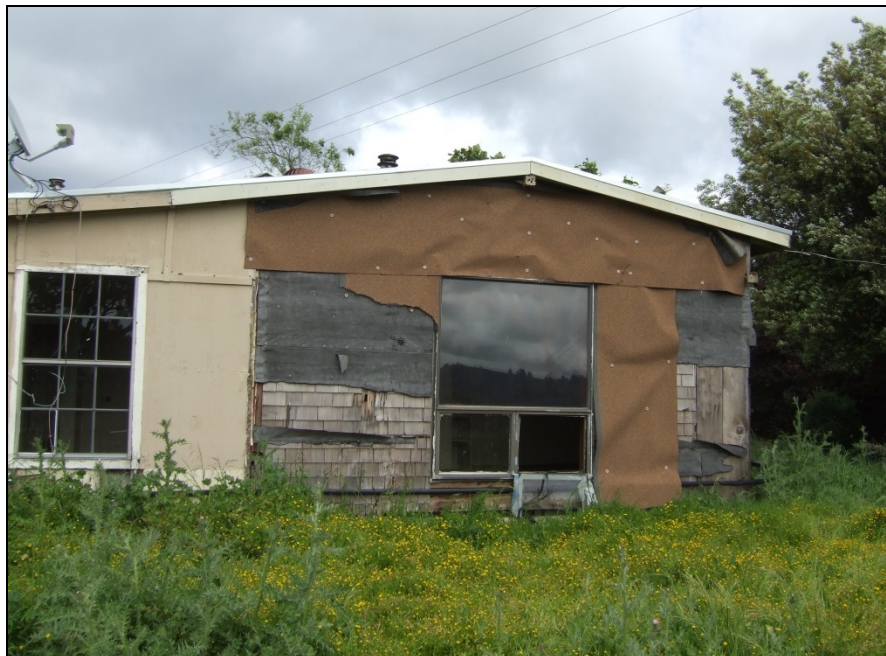
The RR-6 single-family house retains its integrity of location, setting, and association, but has lost its integrity of materials, workmanship, design, and feeling. This building has been extensively altered. First, there are several kinds of replacement siding – plywood sheets, plywood board and batten, wood shingles, composition roofing sheets, T1-11 siding, and horizontal boards – on the exterior. A number of modern replacement windows in metal frames with faux muntins are set in the walls. One door is completely missing from its opening. Two additions have been made to the house. The first is a crude porch roof added to the front of the house, over the front door. The second is a crudely-made bay on the southwest corner of the original house. One door within this bay has broken apart, leaving the inner half in the opening.

Modifications to and deterioration of the structure is substantial, affecting its integrity.

RR-6, Ranch house, east elevation

RR-6, ranch house, west elevation

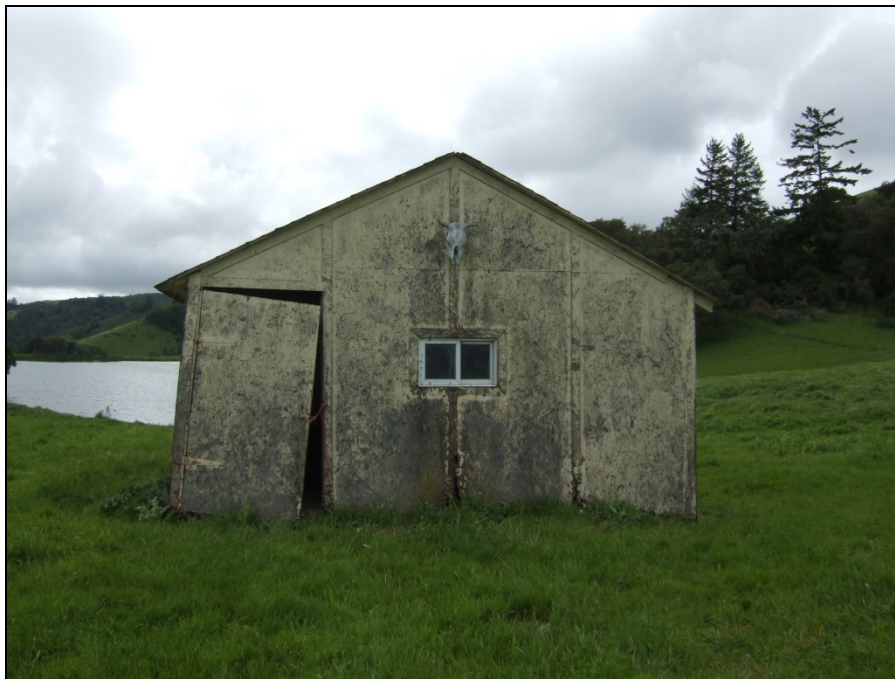
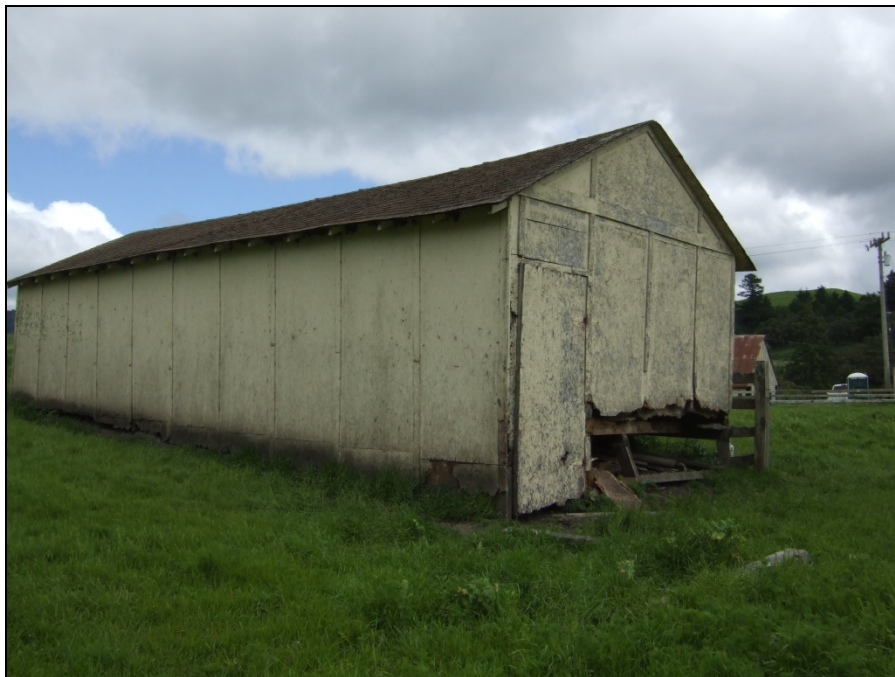
The RR-7 structure retains its integrity of location, setting, and association, but has lost its integrity of materials, workmanship, design, and feeling. The building is currently in poor condition. It is completely sided in replacement particle board like material. Along its west elevation, a lower portion of the siding is gone, leaving its primitive foundations and interior exposed to the elements. Beneath the current siding, the substantial wood bones of the structure are visible and they are old lumber, beginning with the flooring and joists. Modifications to and

deterioration of the structure may not be fatal, possibly reversible, but they do affect its integrity.

RR-7, Shed or Workshop, east elevation

RR-7, Shed or Workshop, north and west elevations

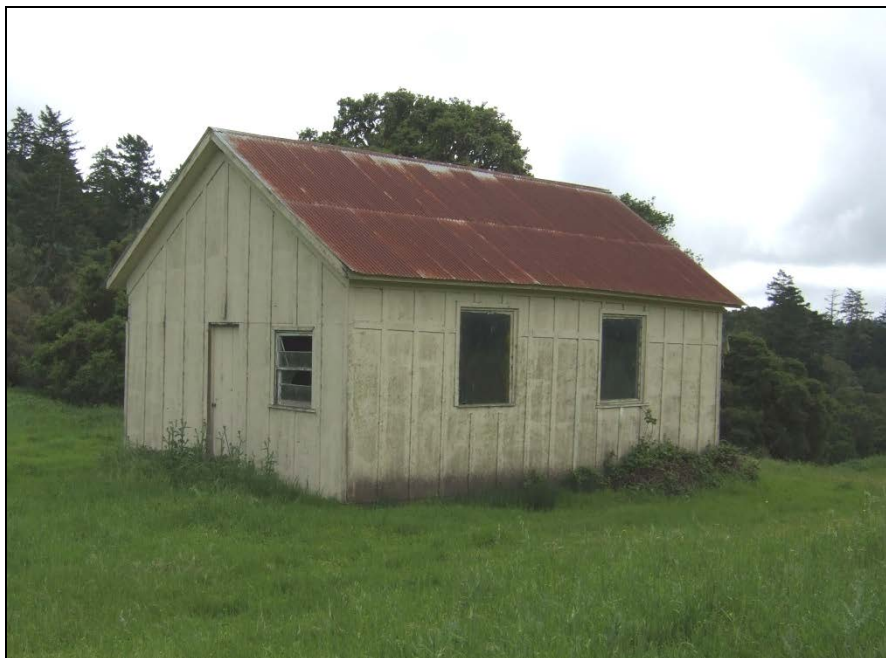
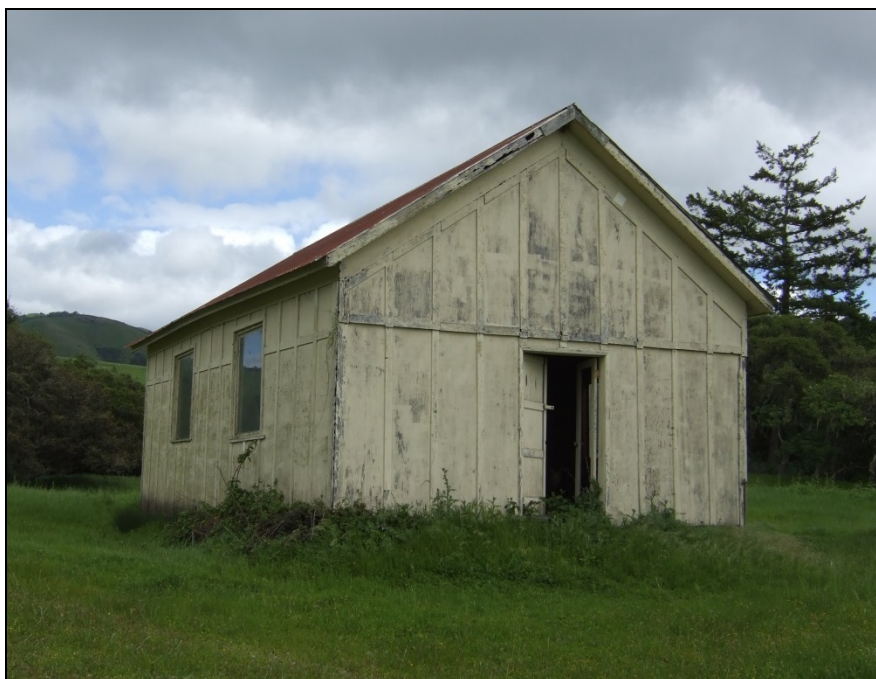
The RR-8 bunkhouse retains its integrity of location, setting, feeling, and association, but has lost its integrity of materials, workmanship, and design. The building is in relatively good condition, though it is sided in replacement particle board type sheets on the exterior, laid over the older substantial wood structure beneath. One aluminum frame replacement slider has been added to the building. Its integrity has been compromised.

RR-8, possible Bunkhouse, east and north elevations

RR-8, possible Bunkhouse, north and west elevations

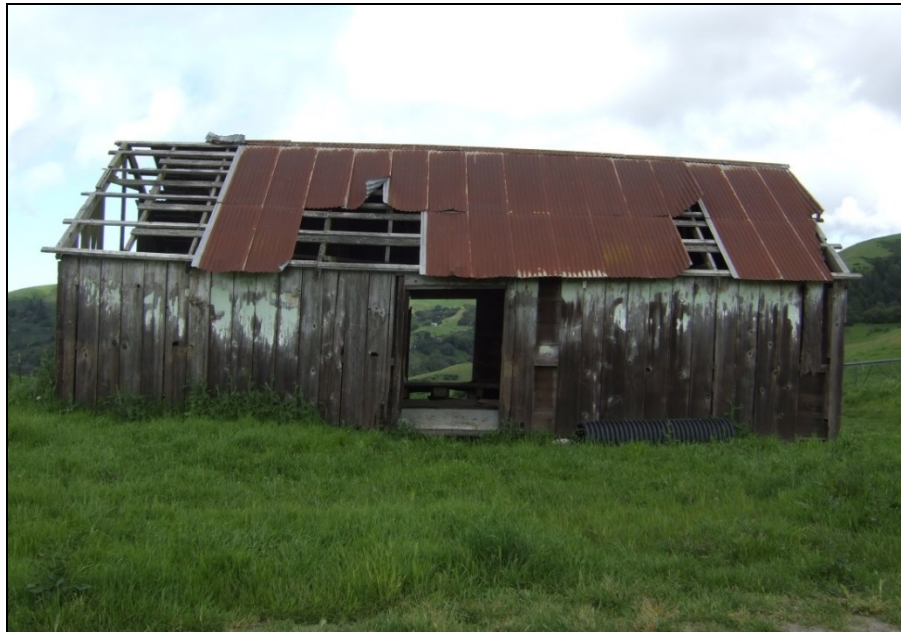
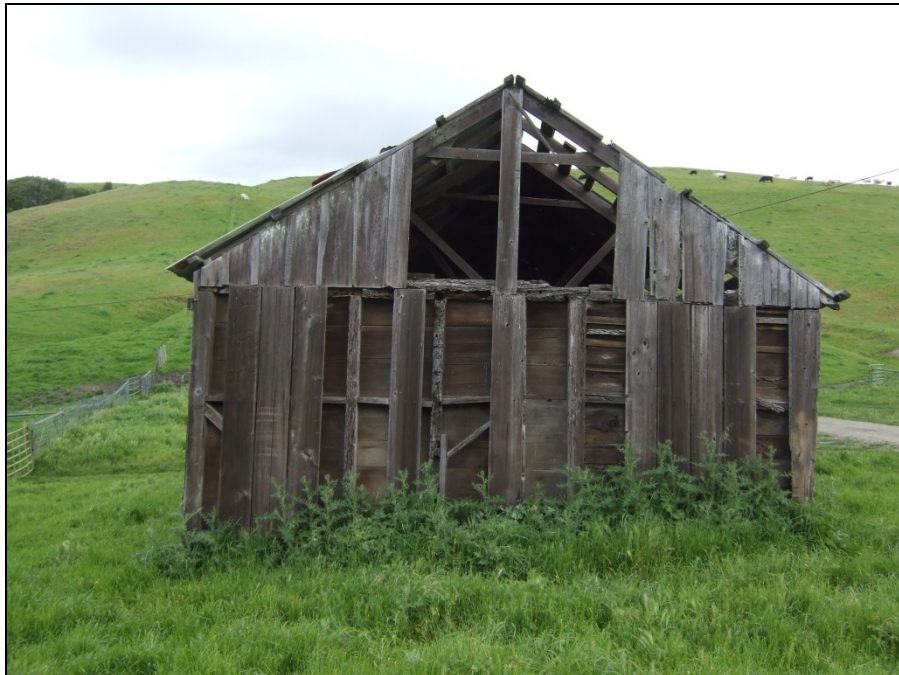
The GZR-1 barn retains its integrity of location, materials, design, and workmanship, but has lost its integrity of setting, feeling, and association. The building is still composed of its original materials – mostly wide boards and heavy timbers beneath the floor and for wall supports. The barn has been allowed to deteriorate to a great degree, with sections of roofing gone, as well as boards from exterior walls. The interior is filled with debris and miscellaneous items. The barn has not been greatly modified, but is badly deteriorated, which significantly affects its integrity.

GZR-1, small barn, east elevation

GZR-1, small barn, south elevation

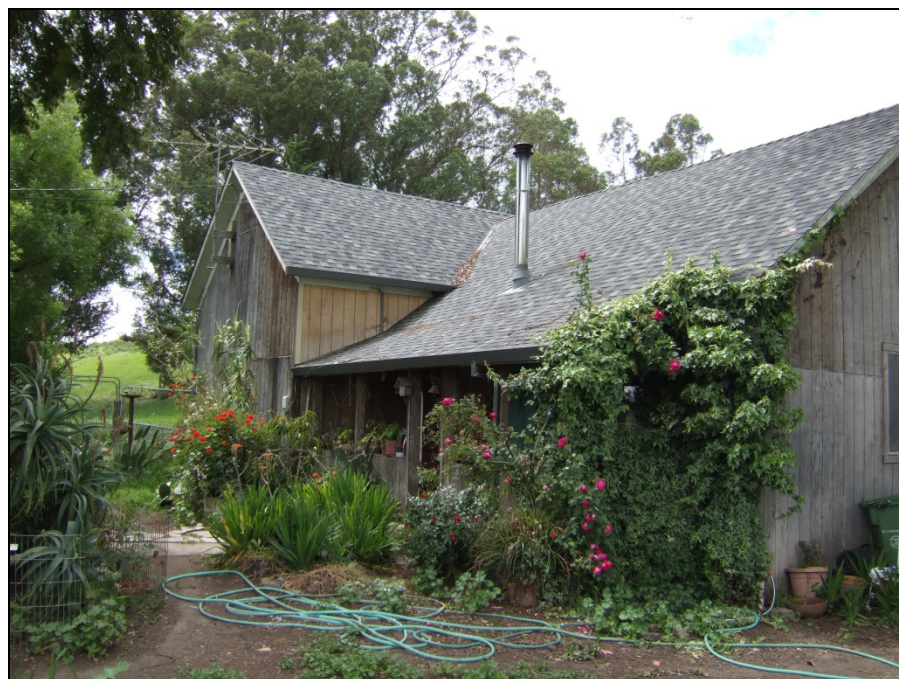
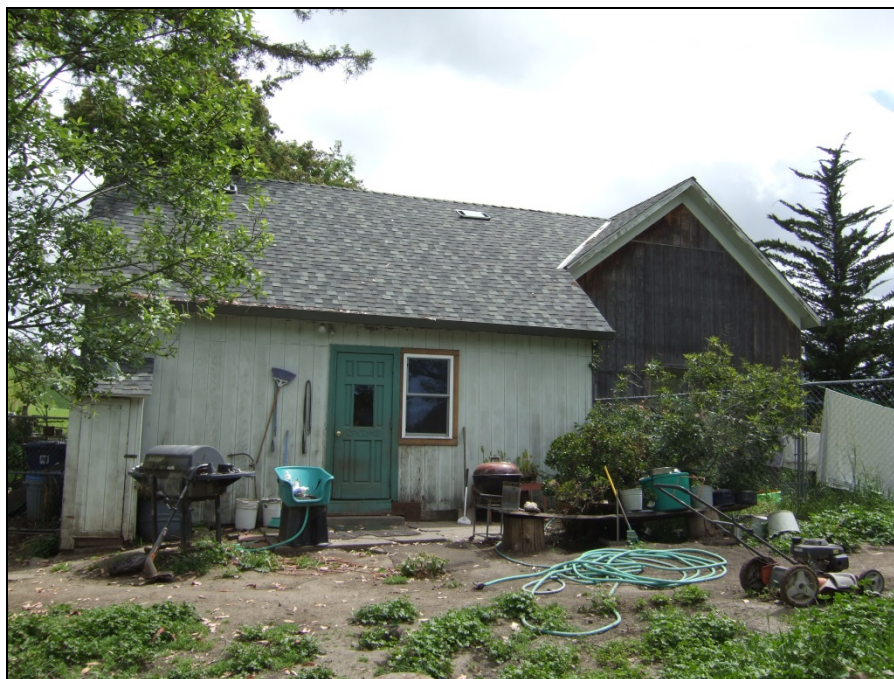
The GZR-4 ranch house retains its integrity of location, but has lost its integrity of materials, design, workmanship, setting, feeling, and association. The building now appears to be two smaller houses joined together at some time. Presumably, one of them is the original house on the ranch. Alterations beyond the fusing of the houses include replacement siding of modern rustic wood appearing T1-11, which became available in the 1970s, and adding a few replacement aluminum sliders. The house has been greatly modified over time, significantly affecting its integrity.

GZR-4, ranch house, east and north elevations, view to southwest

GZR-4, ranch house, west (rear) elevation, view to east

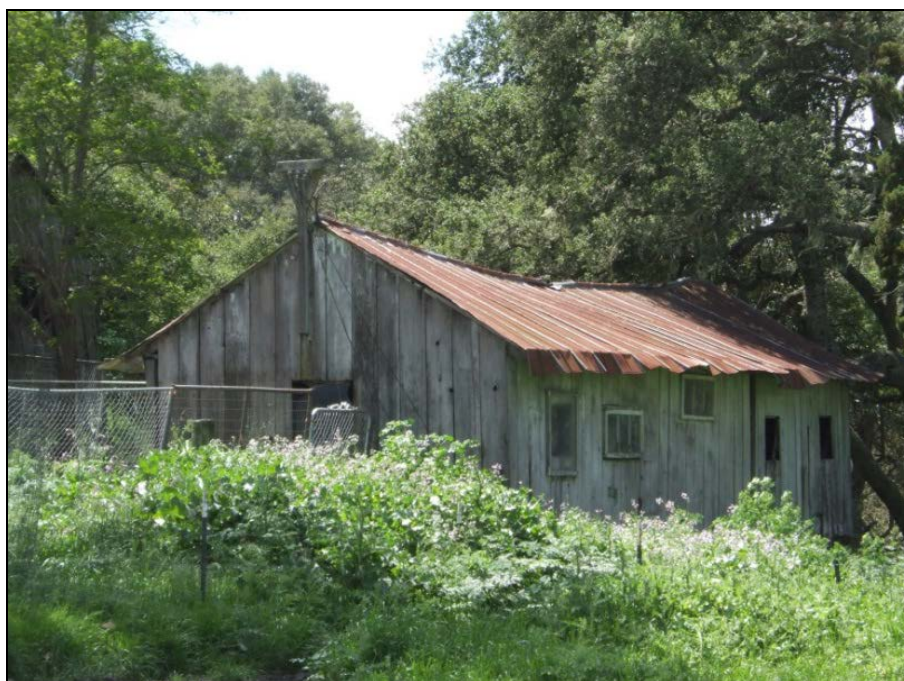
The GZR-5 shed or workshop retains its integrity of materials, design, workmanship, location, and association, but has lost its integrity of setting and feeling. It is somewhat dilapidated, with broken window and drooping roof, but otherwise retains its original fabric and many parts.

GZR-5, shed, east and north elevations, view to southwest

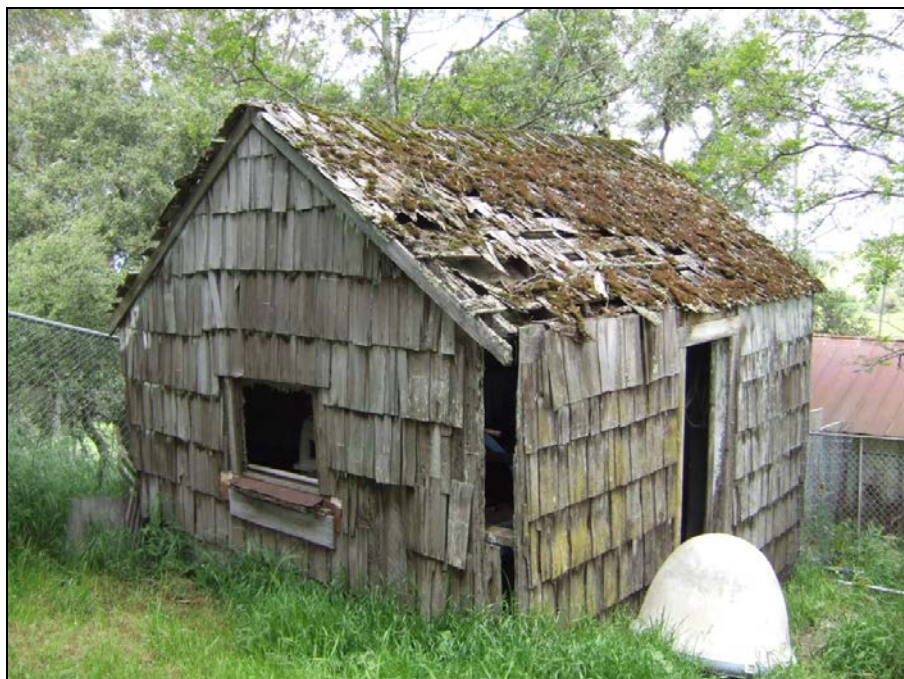
The GZR-6 cabin retains its integrity of materials, design, workmanship, location, setting, and association, but has lost its integrity of feeling. It is somewhat dilapidated, having been allowed to deteriorate. It is missing some of its roof shingles and its siding. Its doors and windows are gone, leaving the interior to be exposed to weather and further decline. But it does still retain its original materials and overall design.

GZR-6, small cabin, south and east elevations, view to north-northwest

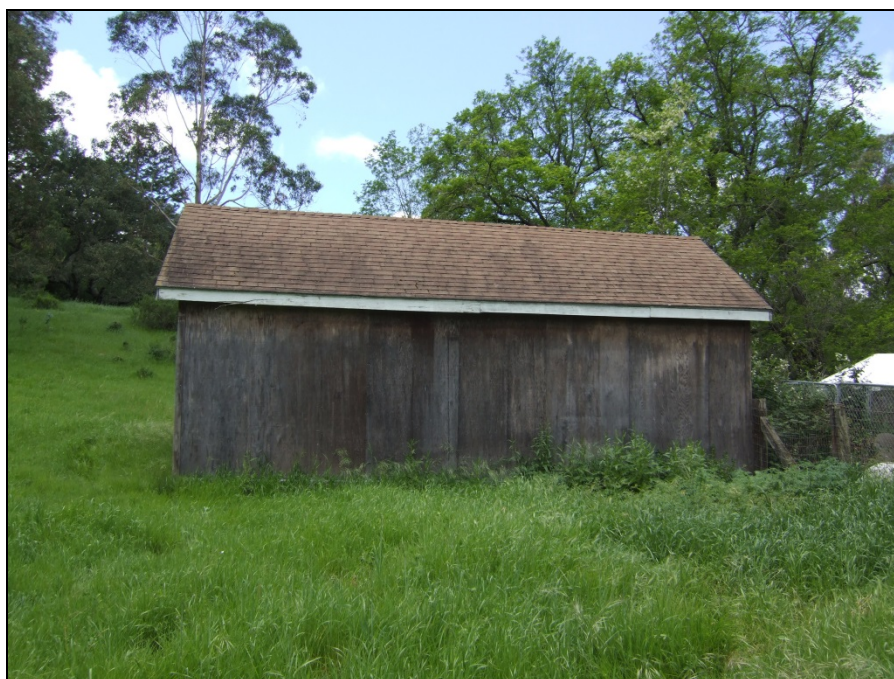
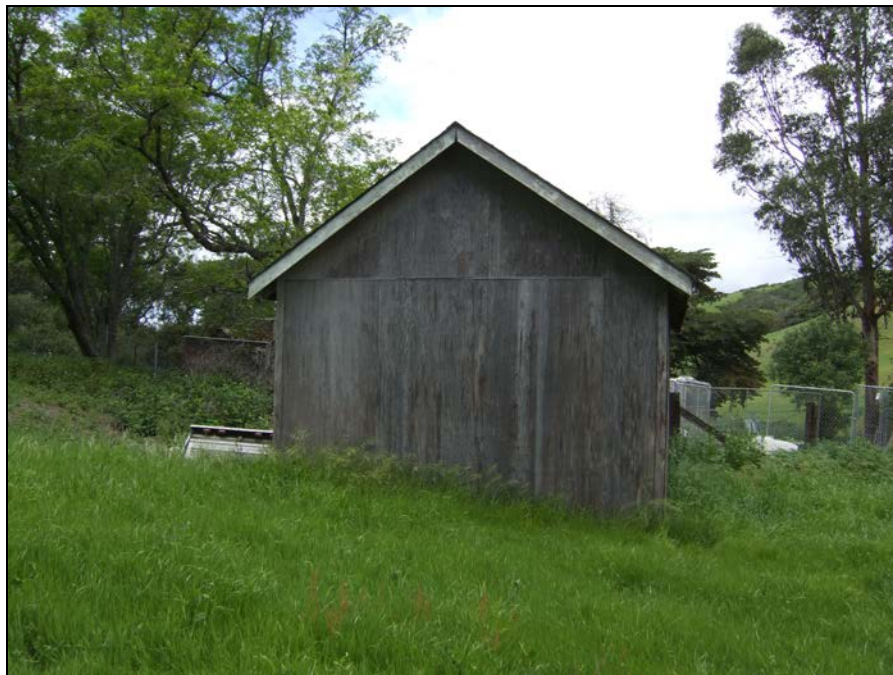
The GZR-7 storage shed retains its integrity of location, setting, and association, but has lost its integrity of materials, design, workmanship, and feeling. It is in good condition, having been well-maintained over time, with replacement composition shingle roof and plywood siding. It does not presently have any openings other than one door on its north elevation. In the past, it may have had more openings, which have been covered over with the later siding.

The shed known as GZR-7 may have stood on the property since at least 1953 (NETR 1953). If so, the structure has been modified since that time. This one-story, plywood-clad structure is north-facing, with no windows or doors on the west, south, and east sides. It is a plain, utilitarian building, front-gabled with moderately-pitched roof covered in composition shingles. It has a narrow overhang and exposed rafters. Its walls are clad in sheets of plywood, which may or may not be covering older siding. Nothing on the outside of the structure suggests it is from the 1950s, other than its style.

GZR-7, storage shed, east elevation, view to west

GZR-7, storage shed, south elevation, view to north

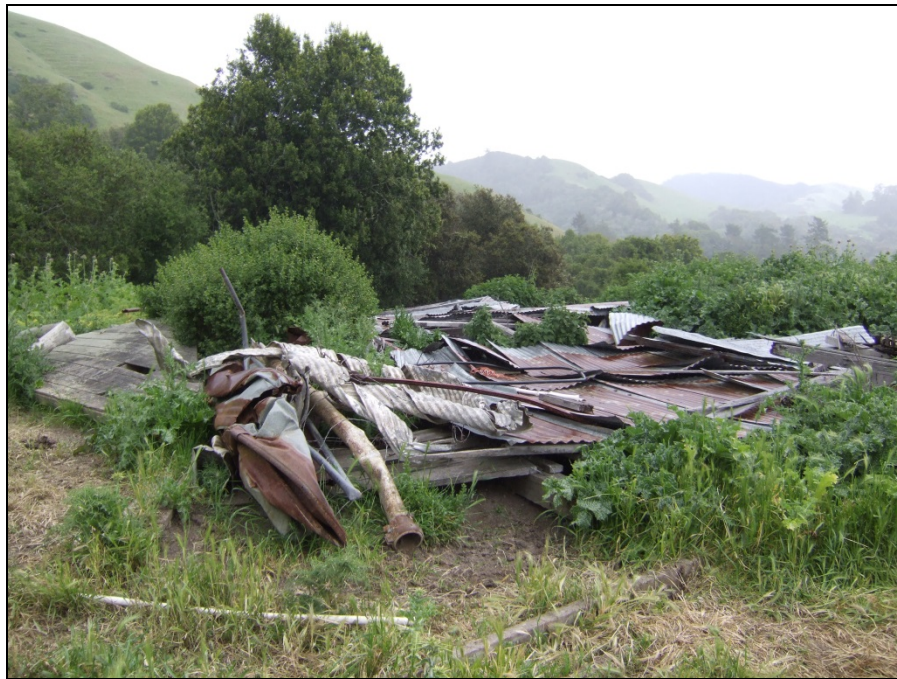
WR-1, collapsed barn/shop, view to southeast

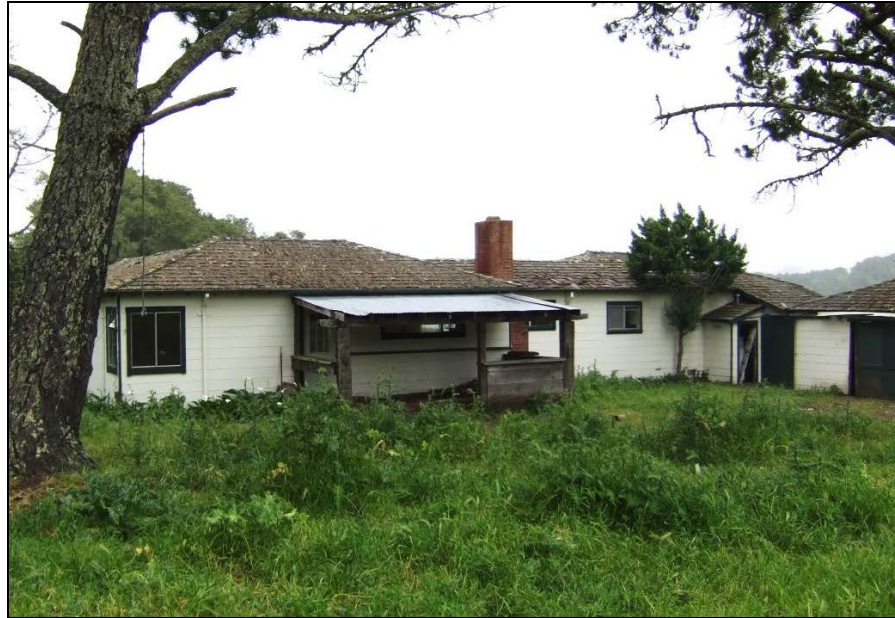
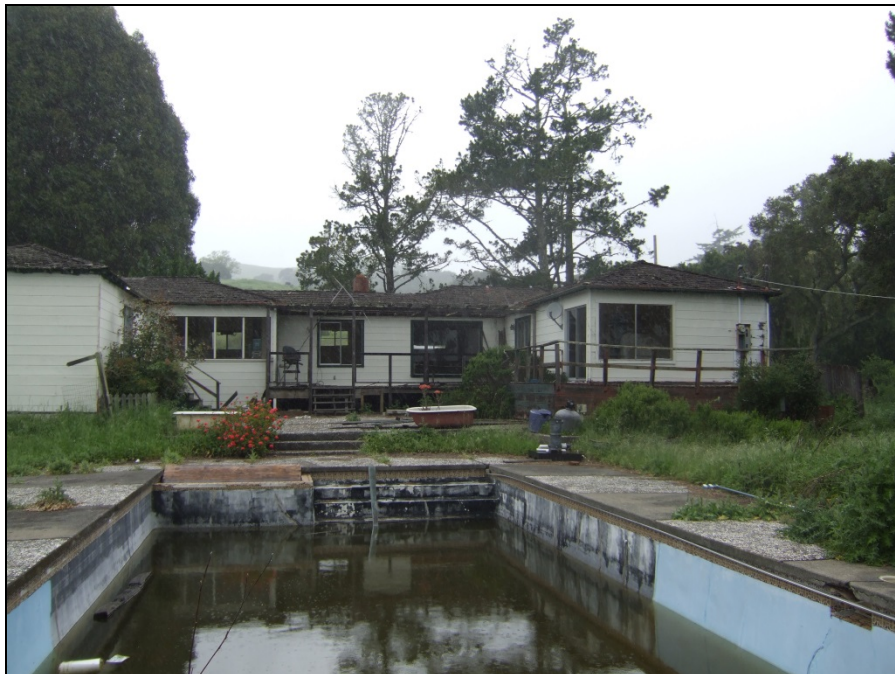
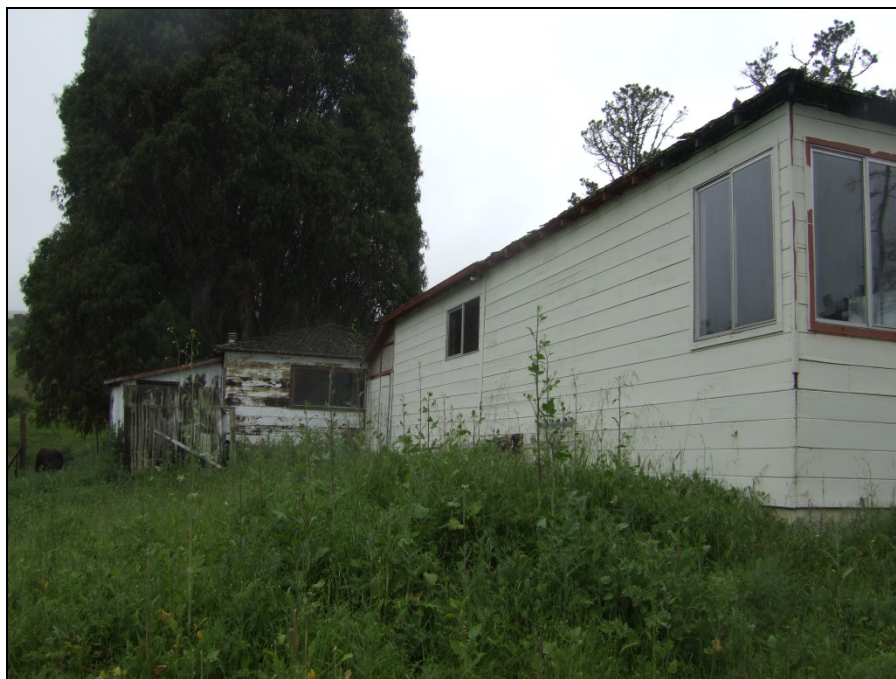
The WR-2 ranch house retains its integrity of location, and setting, but has lost its integrity of materials, design, workmanship, feeling and association. It is now sided in replacement aluminum, has several additions, including an outhouse that abuts the house to house the water heater, an added section to join the garage to the house, an added bay to one corner of the rear of the house, and an added crude heavy lumber front porch over the front entryway. A swimming pool was added in the rear yard by 1991. The integrity of the house has been seriously compromised by the many alterations and additions.

WR-2, ranch house, northwest elevation

WR-2, ranch house and pool, rear elevation

WR-2, ranch house additions, on southwest elevation

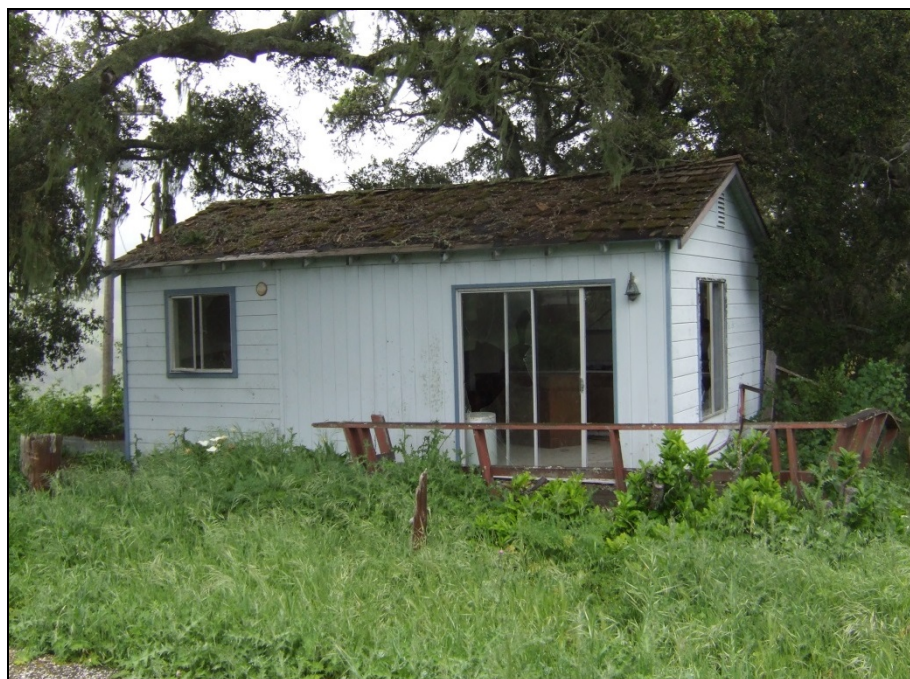
The WR-3 cottage retains its integrity of materials, design, workmanship, feeling, association location, and setting. The cottage retains all of its integrity and is in good condition in that regard.

WR-3, cottage, northwest and southwest elevations
