Midpeninsula Regional
Open Space District

R-17-74
Meeting 17-15
June 28, 2017

Structure Demolition at 1150 Sears Ranch Road in La Honda Creek Open Space Preserve

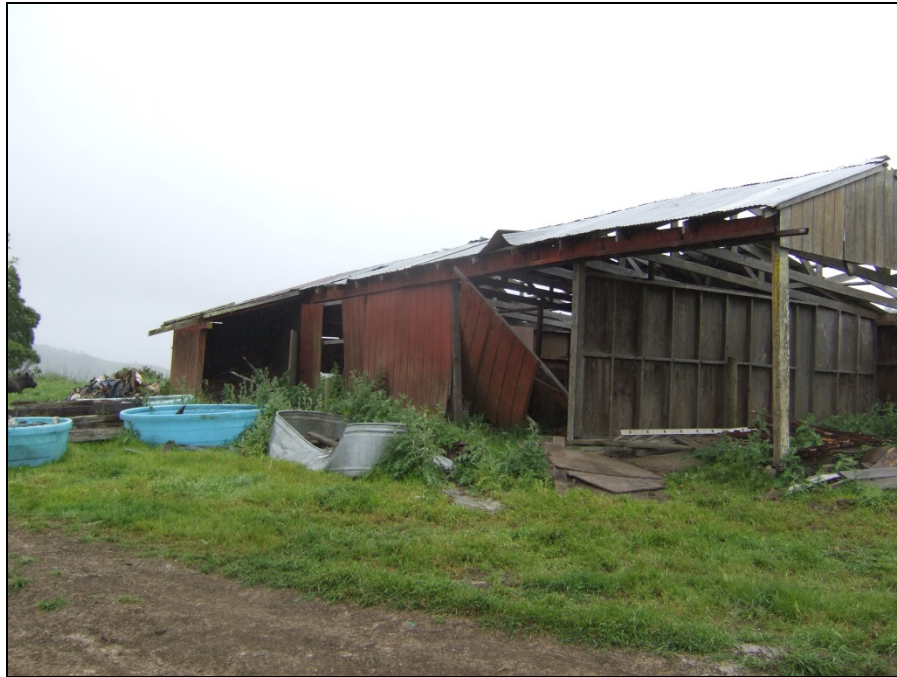
The WR-4 barn retains its integrity of materials, location, and setting, but has lost its integrity of design, workmanship, feeling, and association. The barn has been left in disrepair and is therefore in bad condition now, from neglect. Its integrity has been seriously compromised as a result.

WR-4, large barn, northeast elevation

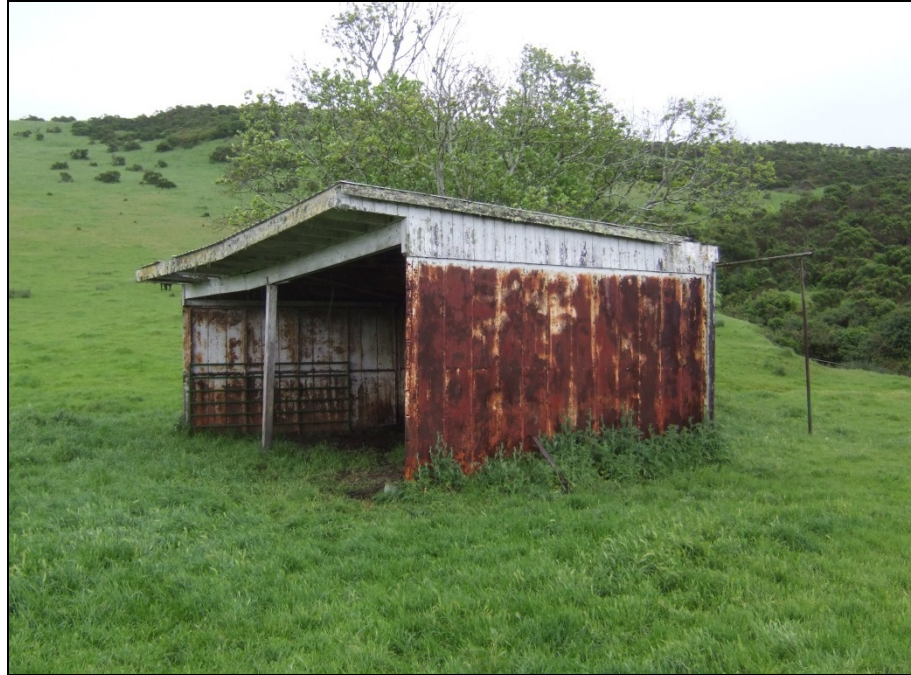
The UFR-1 structure retains its integrity of materials, design, workmanship, feeling, location, and setting, but has lost its integrity of association. The shelter remains in good condition, with one alteration being the addition of strips of T1-11 to the top of two elevations. Its integrity has not been seriously compromised.

UFR-1 metal animal shelter, north and west elevations

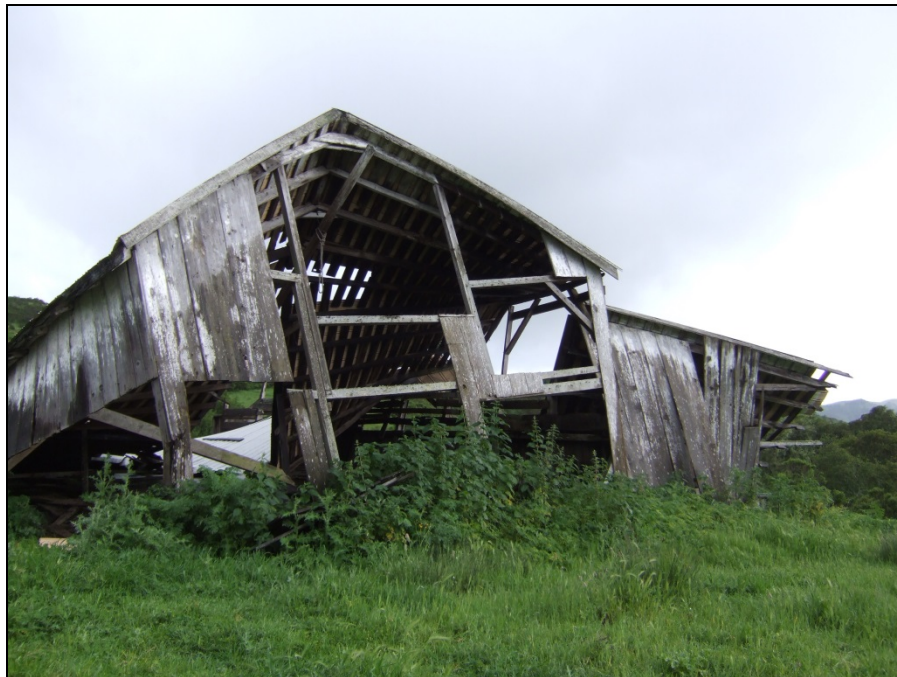
The UFR-3 structure retains its integrity of location and setting, but has lost its integrity of materials, design, workmanship, feeling, and association. The barn retains most of its original materials but due to its partial collapse is in extreme disrepair and in bad condition. Due to its neglect and collapse, the barn's integrity has been seriously compromised.

UFR-3, collapsed barn, north elevation

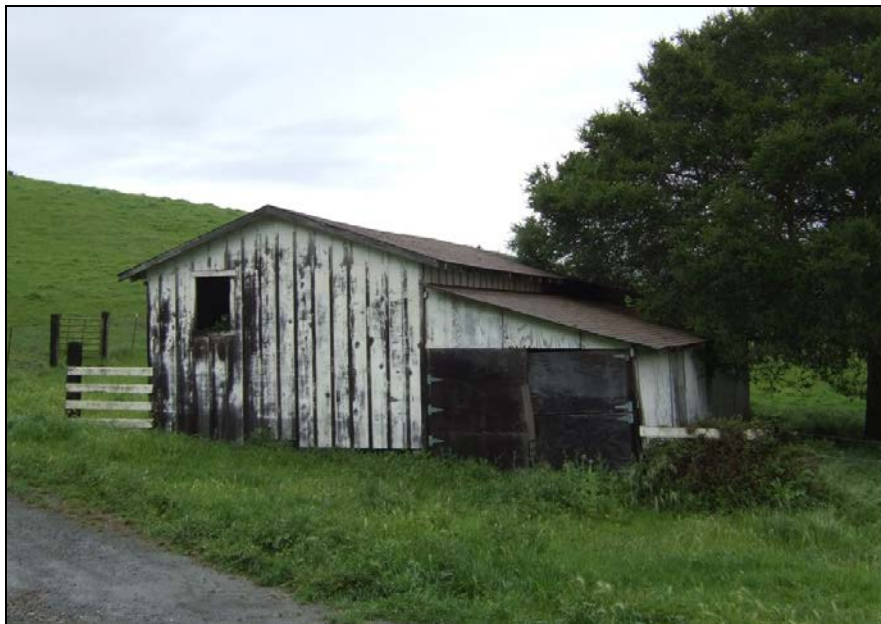
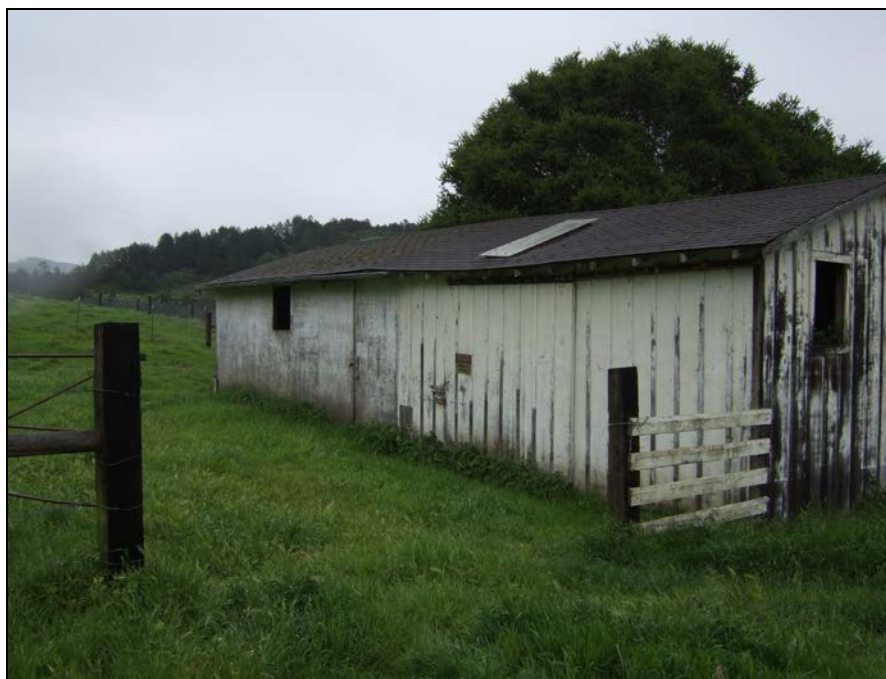
The LFR-2 structure retains its integrity of location and setting, but has lost its integrity of materials, design, workmanship, feeling, and association. The barn has been subject to a few alterations and additions over time. A shed roof, low addition has been added to the entire south elevation of the original barn, which may have been done many years ago. Replacement siding consisting of plywood has been placed along the north elevation. For these reasons, the barn's integrity has been compromised.

LFR-2, animal barn, west and south elevations

LFR-2, animal barn, west and north elevations

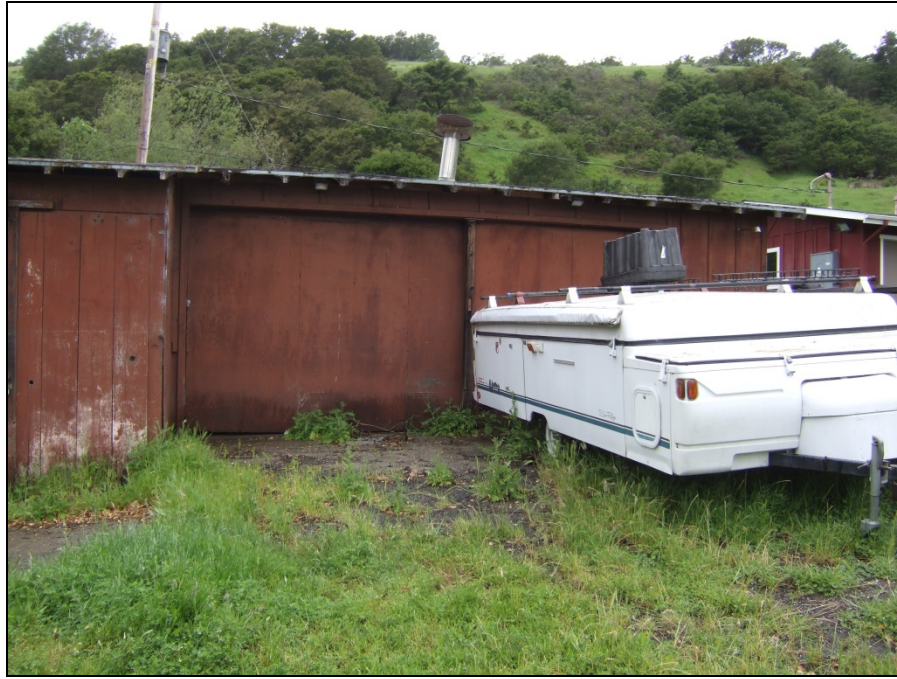
Integrity: The LFR-3 structure retains its integrity of feeling, association, location, and setting, but has lost its integrity of materials, workmanship, and design, as it appears to have replacement siding of plywood over much of its exterior. One large door on the east elevation and a central portion of its west (rear) elevation retains an older, wide, vertical board siding, the west section being board and batten. It has not been subject to alterations or additions over time. The shed retains its integrity.

LFR-3, workshop/shed, east elevation

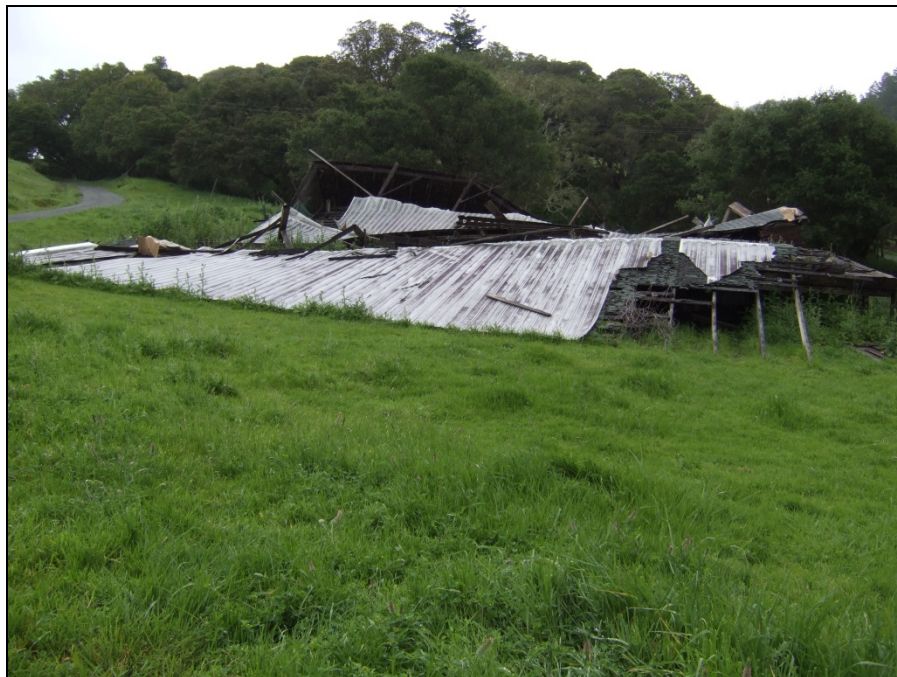
LFR-4, collapsed hay barn

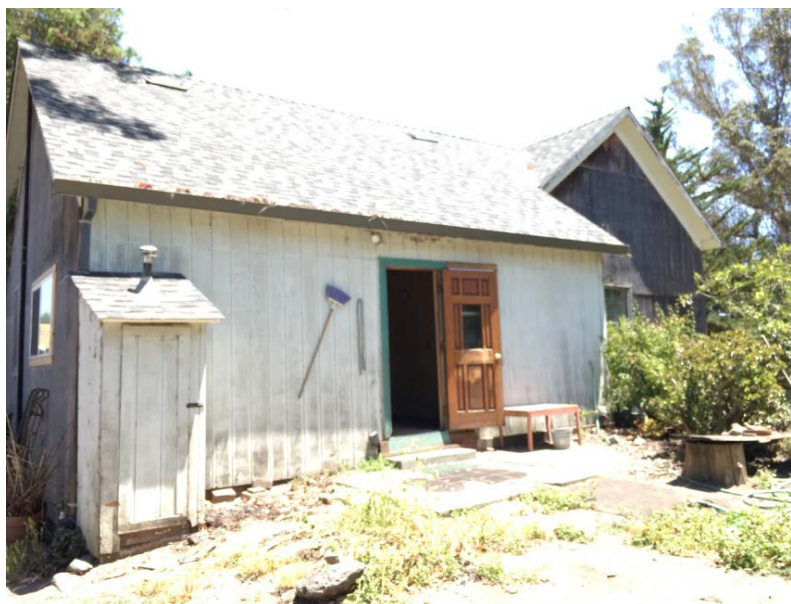
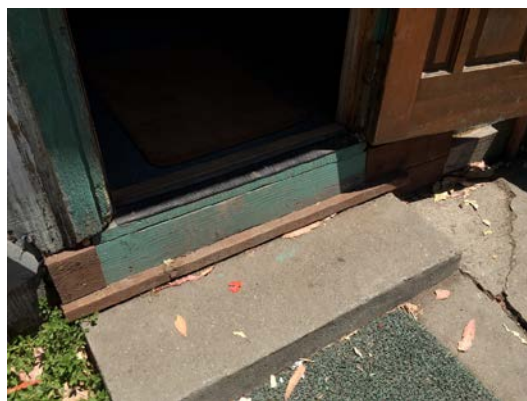
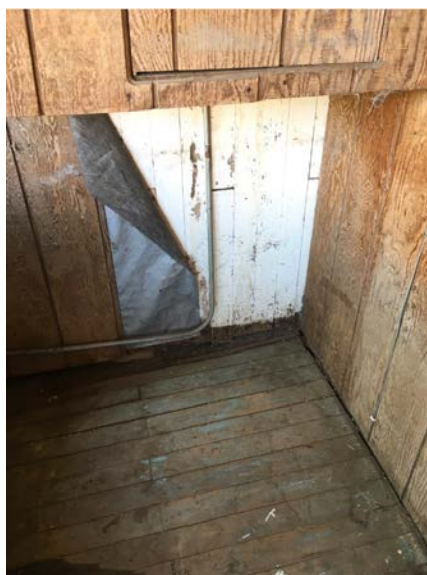
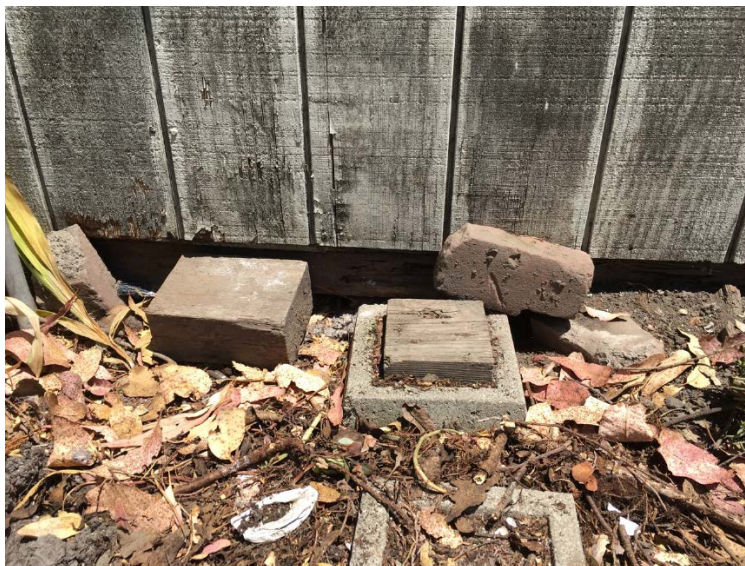
Exterior

Visitor Experience	This residence detracts from the visitor open space experience.
Condition of the Structure	From the Structural Assessment (see Attachment 2), it is clear that the structural integrity of this building is extremely poor. The foundation and flooring are severely degraded. The wall construction is very old and with the exception of the roof, exterior siding and bathroom, nothing in the house appears to be up to code.

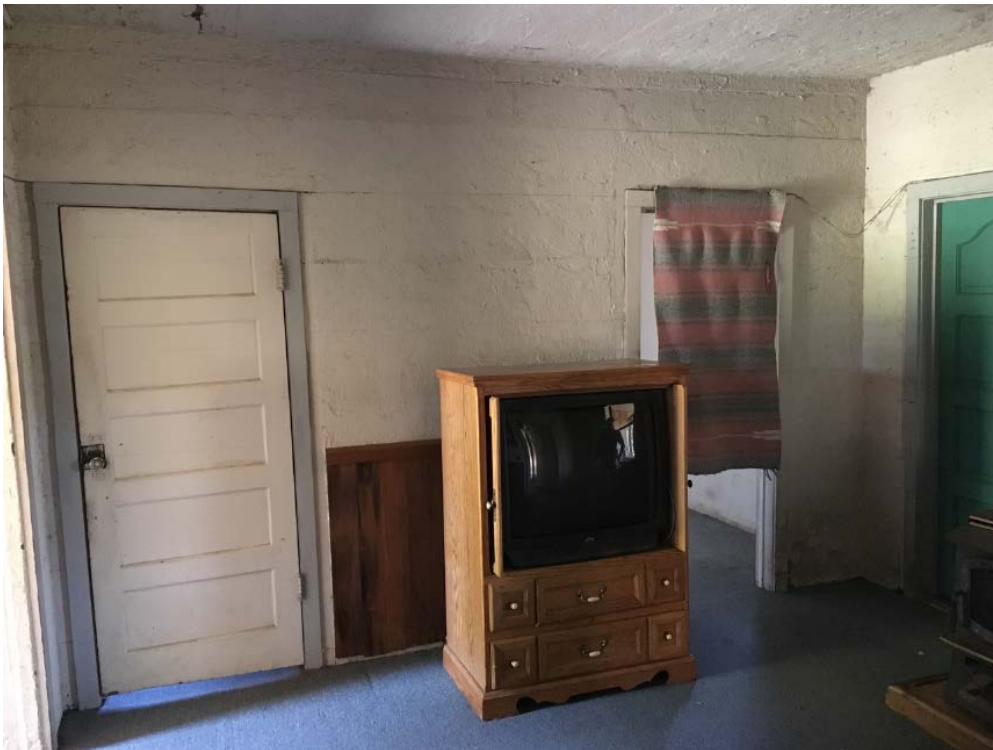
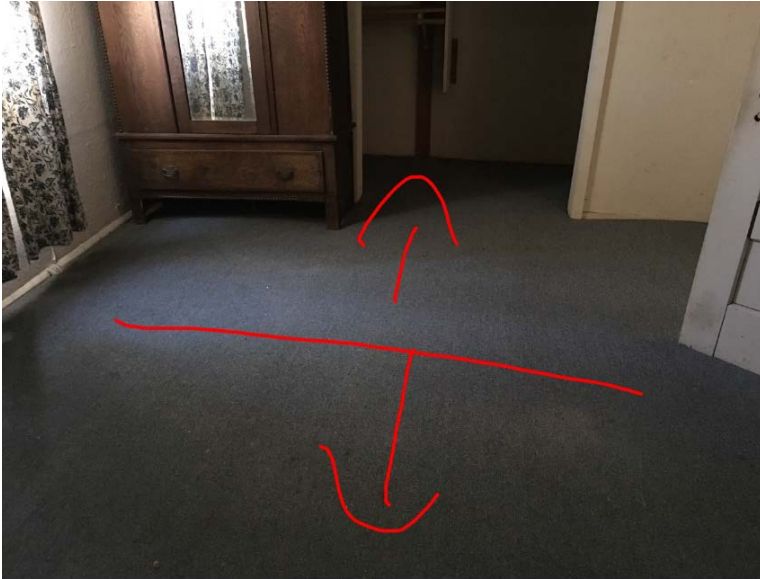
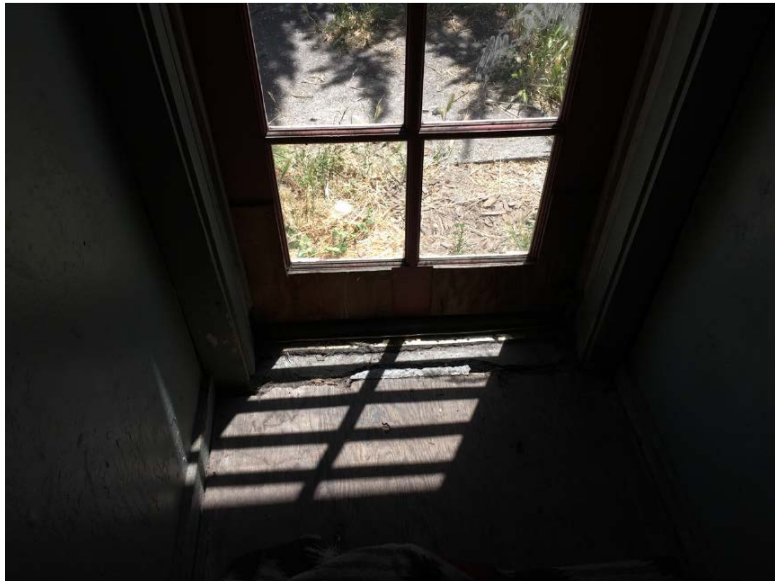
Floor Sloping and Damage

1. There does not appear to be any existing foundation. If there were support piers they have settled into the soil and the house appears to be resting on dirt.
2. The warped floors in the living room and bedrooms are likely due to the foundation degradation.
3. The horizontal plank wall construction is very old and may not have studs or reinforcing members.
4. With the exception of the remodeled bathroom, roof, and T1-11 siding, nothing in the house appears to be up to code. This house would likely be red-tagged by San Mateo County.

Approve the demolition of an unoccupied residence structure that lacks a foundation and has other structural issues and an associated shed located at 1150 Sears Ranch Road in La Honda Creek Open Space Preserve.
