Midpeninsula Regional
Open Space District

Toto Ranch Rangeland Management Plan Update

Toto Ranch
Tunitas Creek Open Space Preserve
Rangeland Management Plan

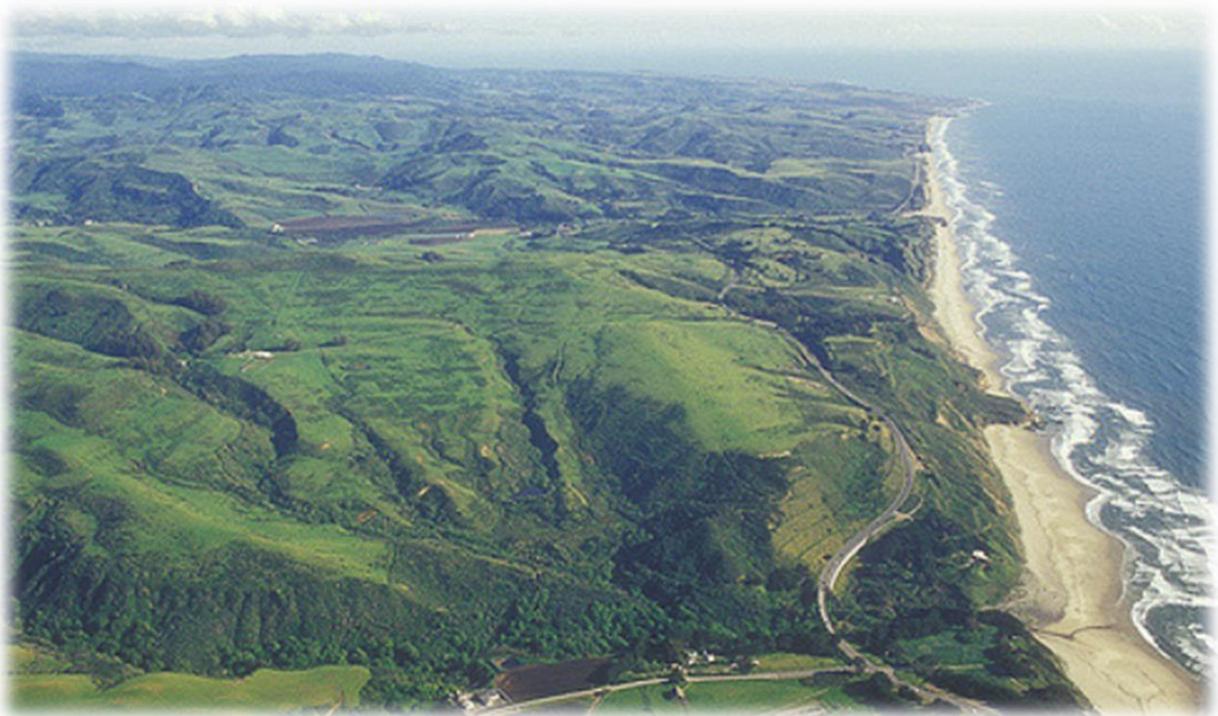
Figure-1: Looking south over the Toto Ranch. Highway-1 and the Pacific Ocean to the right with surrounding rangelands to the south and east of the Ranch. Several small residential parcels neighbor Toto Ranch, located along the north side of Tunitas Creek. Note the heavily wooded, steep Dry Creek and Tunitas Creek riparian corridors (bottom of photo) that comprises much of the northern border of the Ranch. Photo Credit – POST.

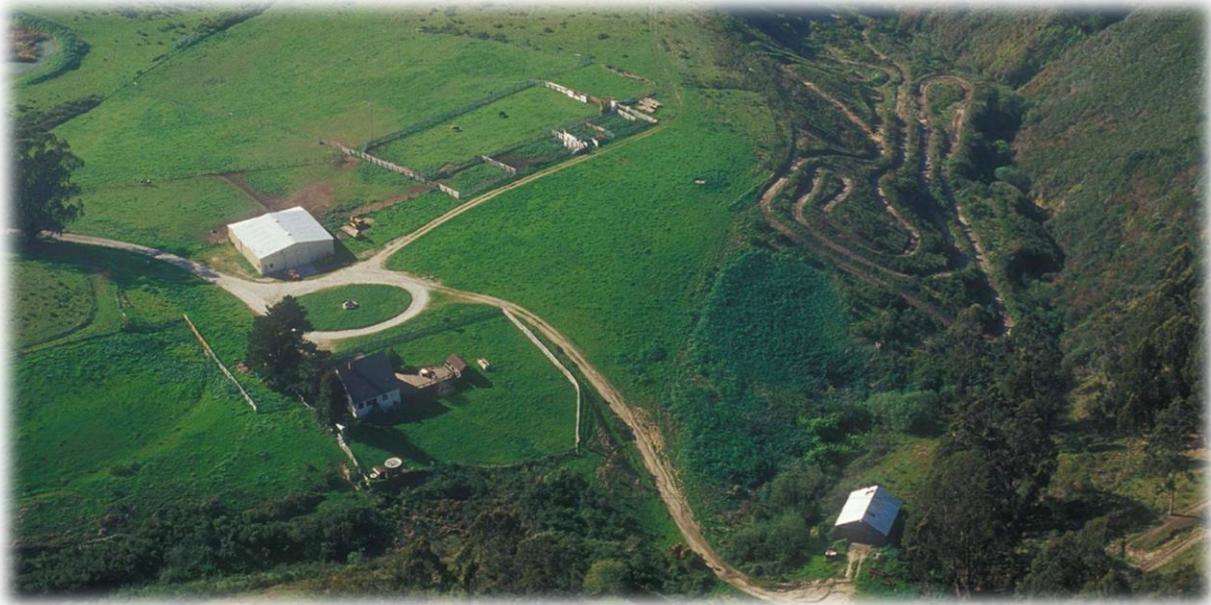
Figure-2: Aerial view of the Agricultural Lease area and associated buildings including hay barn (bottom right), residence (center), metal-sided shop/barn (top left) and the livestock corral (top center).

Agricultural buildings located on the Ranch include a 4,390 ft.² metal-sided barn/shop with utilities and a 1,325 ft.² hay barn. The metal-sided barn/shop/walk-in freezers for meat storage building is located in the main yard, includes running water, power, concrete floor, and bathroom and is in good condition. The hay barn is located just east of the residence and is in fair condition structurally; however, the roof is in poor condition.

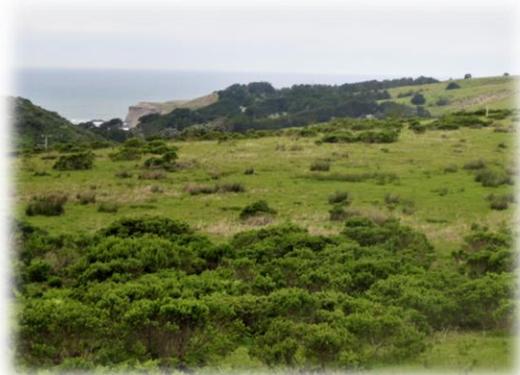
Figure-3: Exemplary upland habitat on the Toto Ranch comprised annual grasslands impacted by coyote brush encroachment. Many of the grassland/scrub habitat is comprised of about 60 percent annual grassland and 40 percent coyote brush.

A combination of annual grassland and coastal scrub habitat covers approximately 60-65 percent of the Ranch comprised of a diverse vegetation composition, ranging from 100 percent annual grassland to areas heavily influenced by coyote brush. The vast majority of the grassland forage species are introduced non-native palatable grasses and low forbs that are desirable for livestock grazing. Grassland and scrubland habitats are present on the ridge tops and gentle slopes throughout the Ranch. Upland slopes and ridge tops on the Ranch were historically dryland farmed but were returned to grazed pastureland during the 1970s. These areas are highly productive and relatively free of invasive thistles, except for sparse patches. Dense woody vegetation dominates many of the small drainages and steeper canyon lands within the grazed pasture. While these areas provide little palatable forage for livestock, they provide shaded locations for loafing, particularly along fringe areas adjacent to the grasslands. Vegetation diversity and overall forage production have historically been limited in the lower-lying portions of the ranch, dominated in many areas by dense brush and willows. Invasive plant control efforts by the landowner have reduced the presence and dispersal of invasive vegetation on the Ranch when compared to historic levels. In addition to invasive plant control, the tenant has mowed coyote brush for several years, increasing desirable forage in many of the front pastures between the Agricultural Lease and Highway-1. A comprehensive vegetation assessment was conducted on April 11, 2017, included as Attachment-C to this plan.

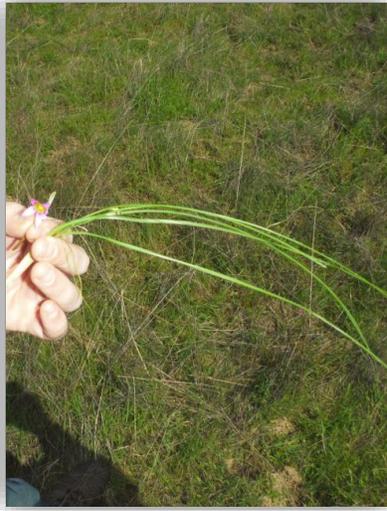
Figure-4: Onion grass (*Romulea rosea*) found on the Toto Ranch. Note the small purple flower and bulbous root balls.

Onion grass (*Romulea rosea*) is found growing throughout the annual grasslands across many parts of the Ranch. Onion grass occurrences in San Mateo County are becoming more common but have not yet been rated by the California Invasive Plant Council (Cal-IPC). Onion grass is a small, erect perennial herb with bulbous roots and produces a small purple flower in the spring (Figure-4). Onion grass is difficult for grazing animals to digest and if consumed in large quantities, can create a fiber block in cattle.

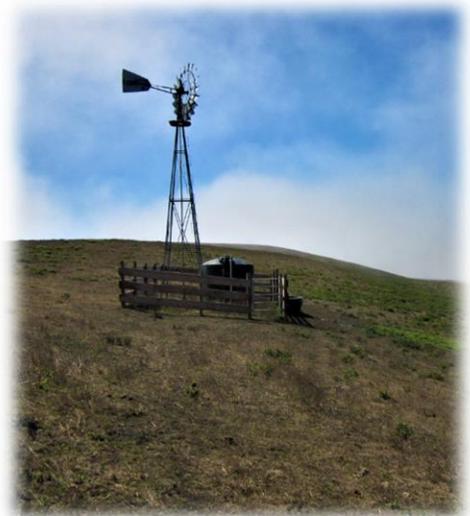
Figure-5: Windmill powered well located on the ridge along the southern property boundary. Well water is pumped into storage tanks and then flows via gravity to the Agricultural Lease area where water is provided to livestock in a number of water troughs.

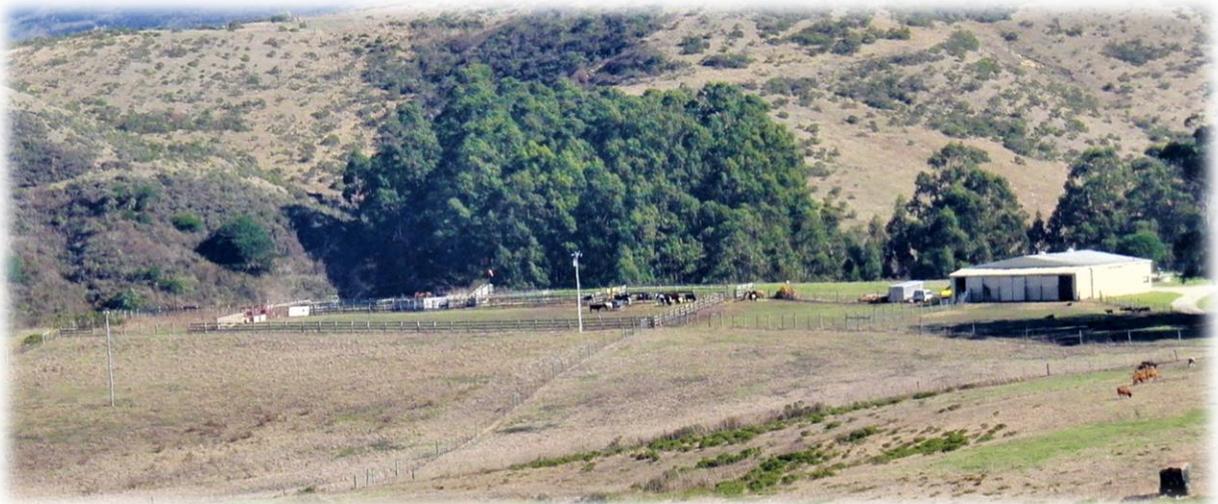
Figure-6: Wooden livestock corral with metal-sided barn/shop building (right). Small pastures or flight pens are ideal for running sheep, goats and other small livestock (foreground).

A set of wood livestock corrals are located within the Agricultural Lease area used for processing and shipping/receiving livestock. The corrals are old but in fair condition and function adequately for the existing livestock operation on the Ranch. The corral is accessible year-round by truck/trailer and semi-trucks via an all-weather gravel road.

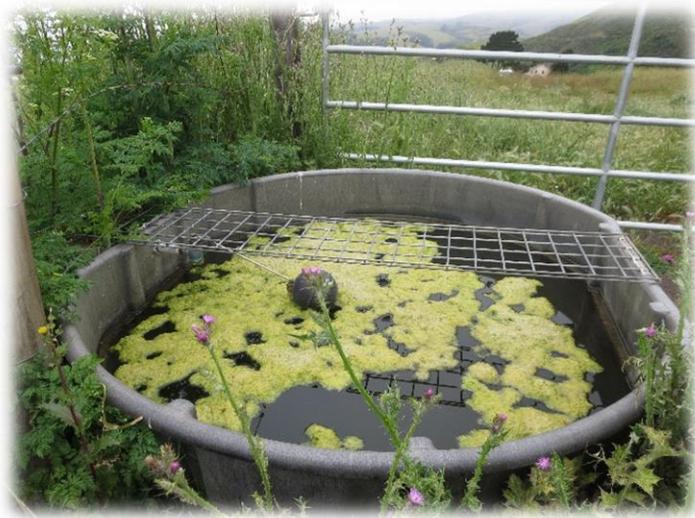
Figure-7: A plastic water trough in the pasture south of the residence. Note the invasive thistle and poison hemlock growing around the trough. These plastic troughs are designed to be temporary and should be replaced with galvanized or concrete troughs in grazed pastures. A wildlife escape ramp is missing from this trough and should be installed to protect wildlife that may fall into the water.

A number of stock water troughs are located within the Agricultural Lease/corral and in pastures adjacent to the Agricultural Lease, including numerous plastic troughs. More durable, permanent concrete or galvanized troughs should replace the plastic troughs. Continue to monitor water infrastructure and complete maintenance and repairs as necessary. Wildlife escape ramps should be installed in all water troughs on the Ranch.

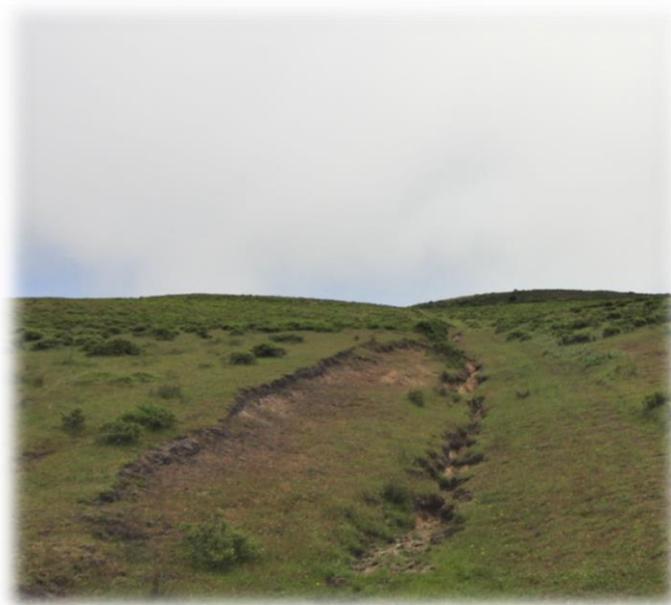
Figure-8: Gully/rutting activity along an insloped road just south of the Agricultural Lease. Large gully caused by surface water flow during winter storm events. Road should be re-graded and water diversion points installed to relieve surface flow to protect the integrity of the road.

- *Roads:* Most roads at Toto are generally in good condition. However, some improvements are recommended for resource management and protection. Two of the unpaved roads currently have significant gullies and rutting (RMP, page 46; and Attachment 5). The RMP recommends maintenance on these areas to sustain road functionality and minimize sedimentation from road erosion. In a third location, installation of a culvert is recommended to maintain road access and protect surface waters (RMP, page 46 and Attachment 5). The RMP also notes that resurfacing the paved primary access road may also be desirable to accommodate the high volume of traffic associated with ongoing agricultural business activities and potential future recreational use. Driveway improvements are scheduled for 2019. These recommendations are within the existing roadway footprint on the site, will facilitate use of the property, and reduce the risk of sediment transport to adjacent steelhead bearing streams.

In general, roads on the Ranch are in fair to good condition, though minimally maintained. Most Ranch roads are minimally graded with native vegetation ground cover present, often times delineated by vehicle tracks in the vegetation from continued use by the tenant. While many of the roads are stable and in good condition, several areas are impacted by active gullying/rutting from surface water flow. Winter rains will continue to cause damage to the road surface and potentially transport sediment into local streams. In addition, a number of roads, particularly

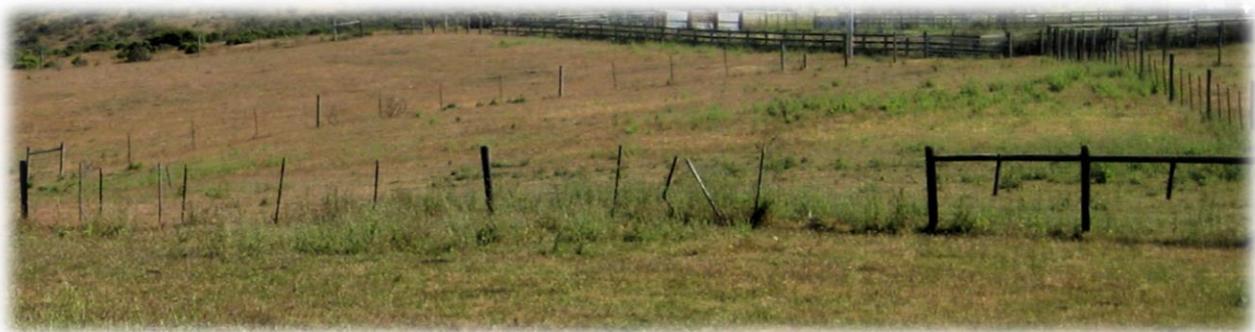
Figure-9: Sample of New Zealand style smooth wire fencing on the Toto Ranch. The high tinsel smooth wire is susceptible to damage and often breaks. Most fences on the ranch are older and in varying condition.

- *Fencing:* The RMP recommends several repairs and updates to the existing fencing system at Toto Ranch. Both the West and South boundary fences are deteriorating and recommended to be fully replaced to keep grazing animals securely contained. Approximately two miles of new fencing is proposed within the ranch to improve the

Toto Ranch is secured on all borders by a combination of “New Zealand style” smooth wire fencing and natural barriers. Interior pasture fencing currently divides the ranch into five (5) main pastures with numerous additional small pastures around the Agricultural Lease. Interior pasture fencing is comprised of “New Zealand style” fencing in varying condition, barbed wire fence, and natural barriers. Maintenance of the “New Zealand style” fencing is ongoing as fences are relatively old and the smooth wire used for the fencing tends to break often when compared to traditional barbed wire fencing. Landowner has installed new barbed wire fencing along some pasture boundaries. Natural slope, rock, and brush barriers have been used historically to contain cattle in many places on the Ranch; however, the brush barriers would be ineffective if wildfire should burn boundaries of the grassland areas.

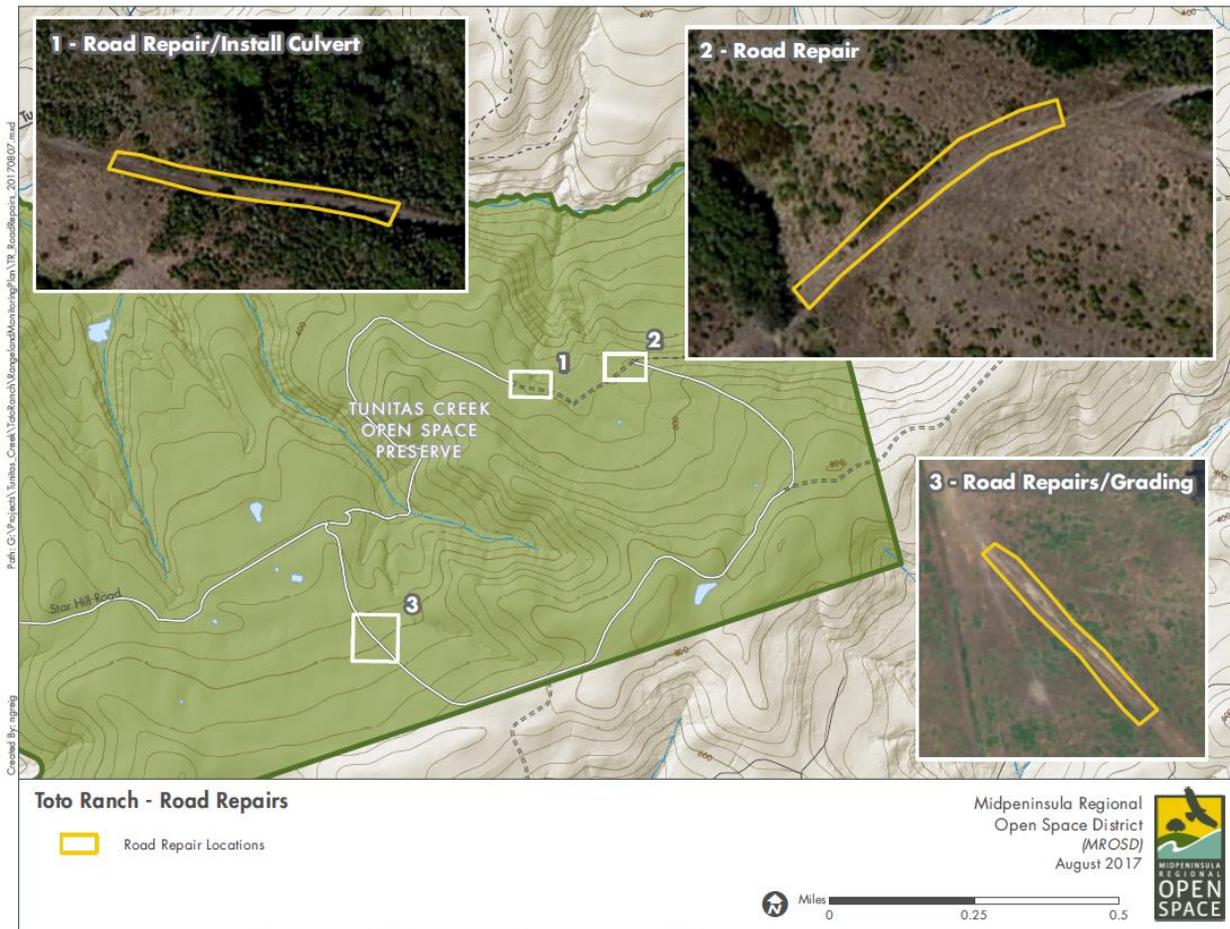
EXHIBIT-G – PROPOSED ROAD REPAIRS & MAINTENANCE

Any road repairs that may discharge sediment into downstream watercourses may require permits from regulatory agencies prior to implementation. Proposed road work should first be approved by District natural resources staff to ensure regulatory compliance.

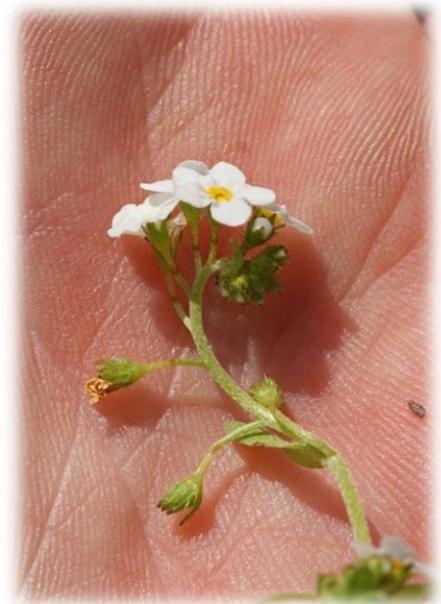
Figure-10: Choris' popcorn flower is a rare, native annual herb found in multiple locations throughout the Toto Ranch. Special attention should be paid to avoid populations of Choris' popcorn flower when implementing projects and routine maintenance on the Ranch. Implement BMPs as necessary to protect existing populations.

Choris' popcorn flower is an annual herb found in coastal prairie and coastal scrub habitats in San Mateo and portions of Santa Cruz County, listed by CNPS as "fairly endangered". The species is at risk from urban development, however, under rangeland conditions, primary threats to the species result from foot traffic/trampling and competition from non-native plants/annual grasses [11]. Choris' popcorn flower typically blooms from March-June [11] and will benefit from the reduction of annual/non-native vegetation through timed livestock grazing prior to bloom (December-February). Once flowers have dropped seed, livestock grazing may commence, typically in July. Continue to monitor for presence of the specie and note any changes in distribution and abundance of known populations. Adjust timing of grazing as necessary to promote reproduction. If trampling or vehicle traffic is noted to impact the Choris' popcorn flower, temporary fencing may be installed to protect populations.

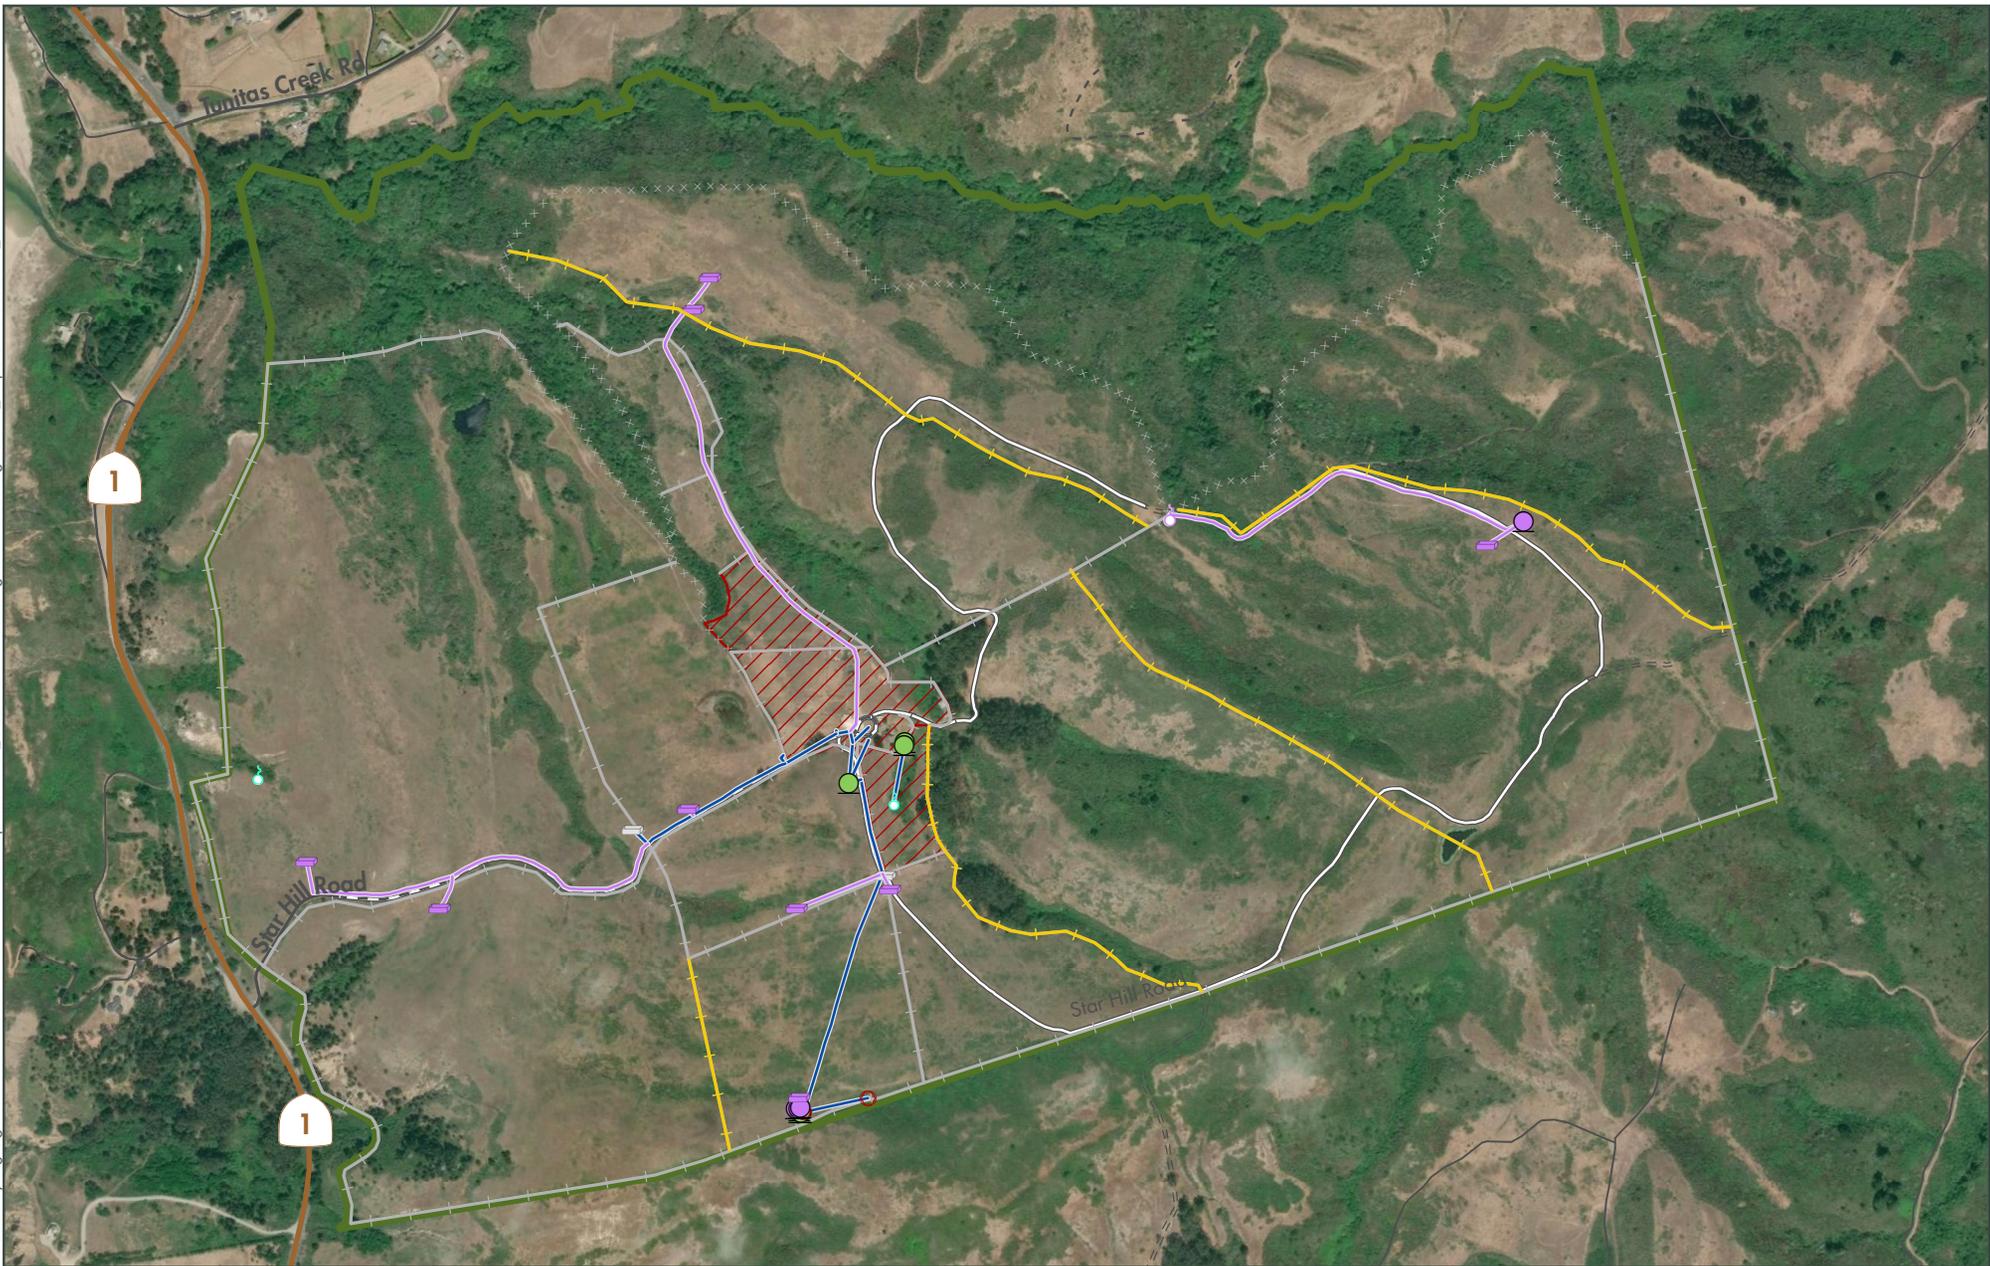
Toto Ranch - Proposed Infrastructure

To optimize effective use of grazing as a management tool for the rangelands at Toto Ranch, the RMP recommends several infrastructure improvements. The use of grazing animals to help manage the natural resources requires access for ranch vehicles, and fencing and water sources to manage the distribution of livestock. The proposed improvements include roads, fencing, and water resources.

- *Water:* The availability of clean and reliable water is essential to the function of the conservation grazing program. Having well-distributed water sources helps disperse the influence of livestock on the landscape and reduce impacts on natural waterways, such as streams. The RMP recommends replacing the plastic water troughs in and around the Agricultural Area, installing a new waterline and trough north of the Agricultural Area, and improving the Pasture 3 water system, including the spring, pump, tank, pipe and troughs (RMP, page 47 and Attachment 4).
