Midpeninsula Regional  
Open Space District

R-20-76  
Meeting 20-19  
August 26, 2020

Sediment Monitoring Results from the Watershed Protection Program at El Corte De Madera Creek Open Space Preserve

**WATERSHED PROTECTION PROGRAM EFFECTIVENESS  
MONITORING: EL CORTE DE MADERA CREEK OPEN SPACE PRESERVE,  
SAN MATEO COUNTY, CALIFORNIA**

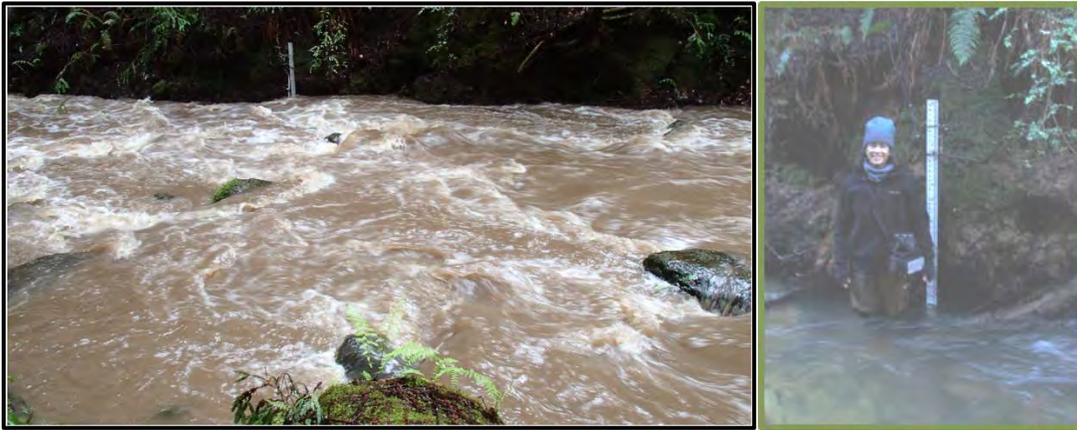
*Figure 3 At left, El Corte De Madera Creek Gage at High Flow Conditions 2019. At right, Midpen staff at Stream Gage 2006.*

By 2006, the long-term nature of the WPP was apparent. Balance recommended an additional independent line of evidence, separate from V\*, that would be necessary to effectively measure change over time. Midpen contracted with Balance to conduct a stream gaging and sediment sampling program to compliment the V\* data. Balance established a stream gage at the bottom of ECDM that measures the height of stream (“stage”). Using an electronic sensor, these data were recorded every 15 minutes. The gage data are also used to measure the volume of water that is leaving ECDM. By measuring the depth of water along the stream across from the

gage, Balance could relate the stream height on the gage and the depth to create an area of water. With a velocity meter (visualize a little propeller), Balance gathered stream velocity. Multiplied by the area, velocity provides the volume of water leaving ECDM (“discharge”) in cubic feet per second. Monitoring discharge allowed Balance to describe how and when water and sediment moved through the creek system.

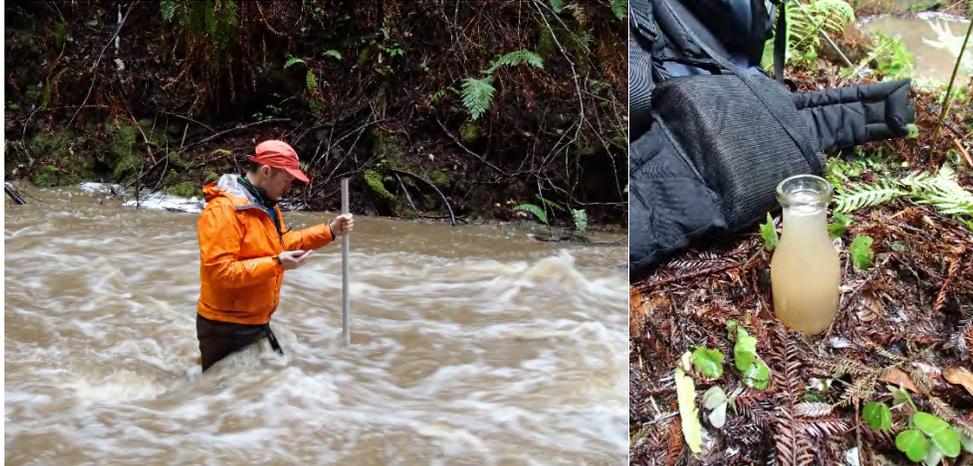
*Figure 4 Balance staff collecting sediment during a storm. Sample at right.*

When large storms come into the Santa Cruz Mountains, rain quickly mobilizes fine sediment particles into the creek, causing a muddy appearance. This is a natural process, but the degree to which the water is cloudy or muddy (“turbid”) reflects how much sediment is in the creek, naturally or because of human activity. During large storms, Balance collected water samples from the creek and then sent them to a laboratory to precisely weigh and describe the sediments in the creek from that exact moment it was collected. This turbidity data could then be connected to the discharge data, relating the magnitude of the storm (e.g. a 1-2 year storm event at ~200cfs, which is a storm that is likely to occur every year to every other year) to the quantity of sediment leaving ECDM. This relationship between storm events and sedimentation (bigger storms move more sediment and the inverse) established another ‘baseline’ and speaks to how sedimentation in ECDM might affect downstream salmonid habitat.

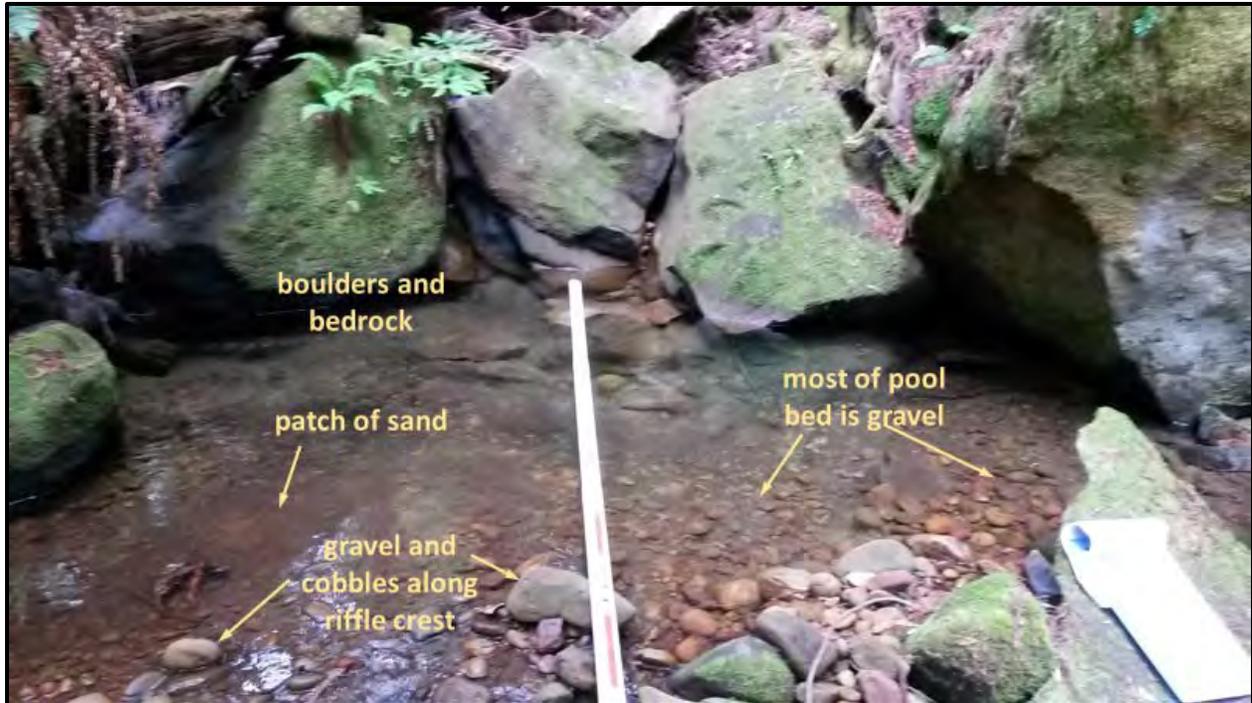
*Figure 5 Diagram Highlighting Stream Texture at a  $V^*$  pool*

During the  $V^*$  data gathering, Balance staff recommended at each data point Midpen record what size of rock is found on the pool surface (e.g. sediment, gravels, cobbles, boulders), called streambed texture. The  $V^*$  values speak to the volume of sediment reduced by the WPP but does not describe directly how that might affect fish habitat on the surface of the streambed. Coho and steelhead spawn in gravels and without gravels, they cannot reproduce as well. Their eggs also get smothered in sediments, reducing oxygen at a critical time. ECDM is too high up in the watershed for salmonids, past natural waterfalls that prevent migration, but the sediments, gravels and wood that leave the preserve directly affect downstream habitats. The streambed texture data gathered alongside the  $V^*$  data measures how pools in the preserve have changed in response to reduced sedimentation and suggests how downstream pools might have also changed.

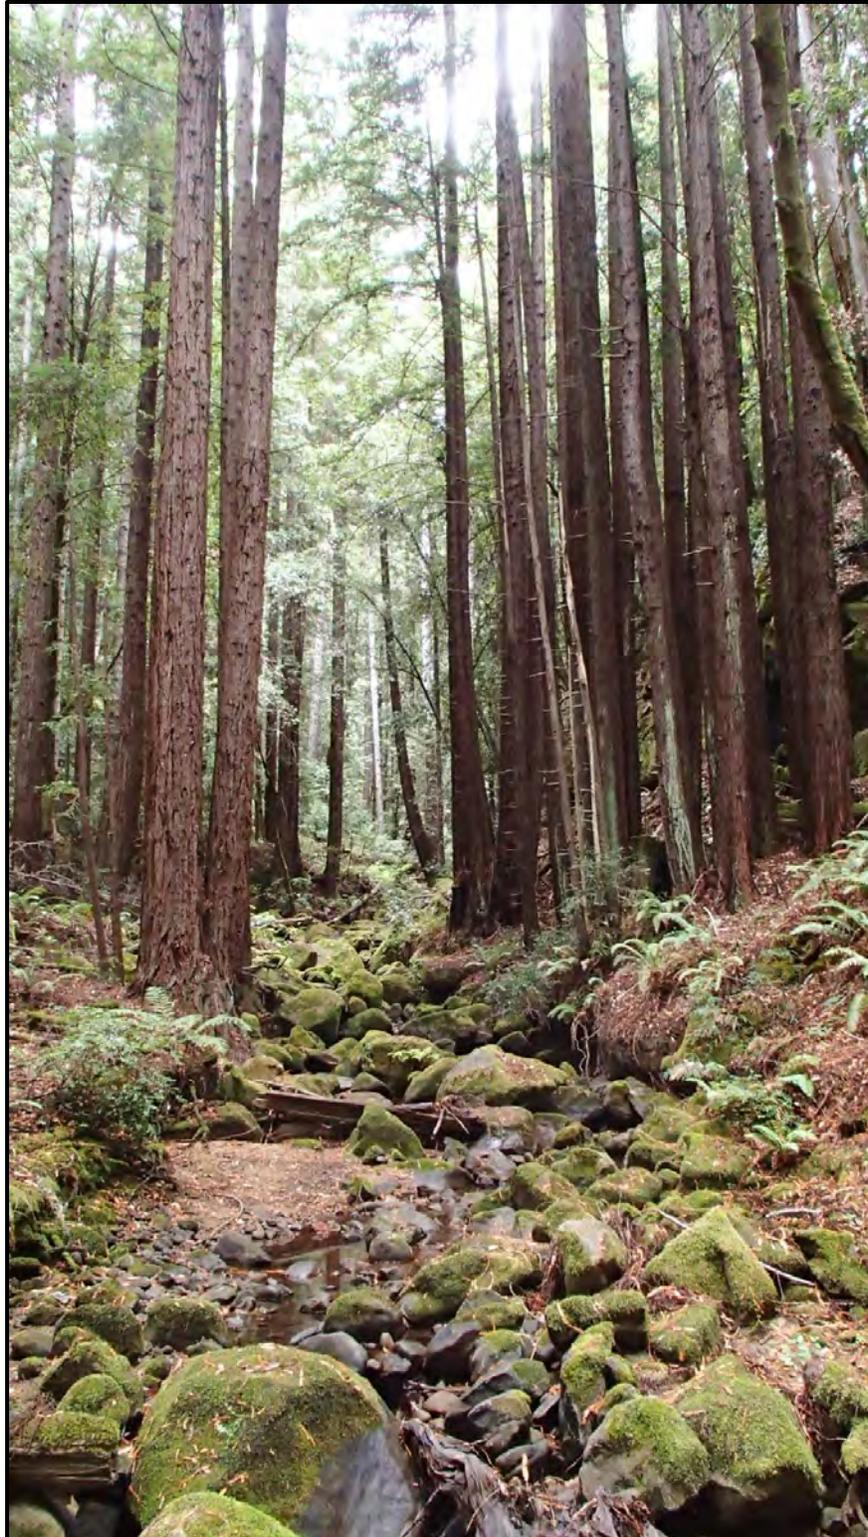
Figure 2-6 Section of El Corte de Madera Creek (2018). Looking upstream, near Methuslah tributary. Note redwoods and bedrock cliff at the right edge.

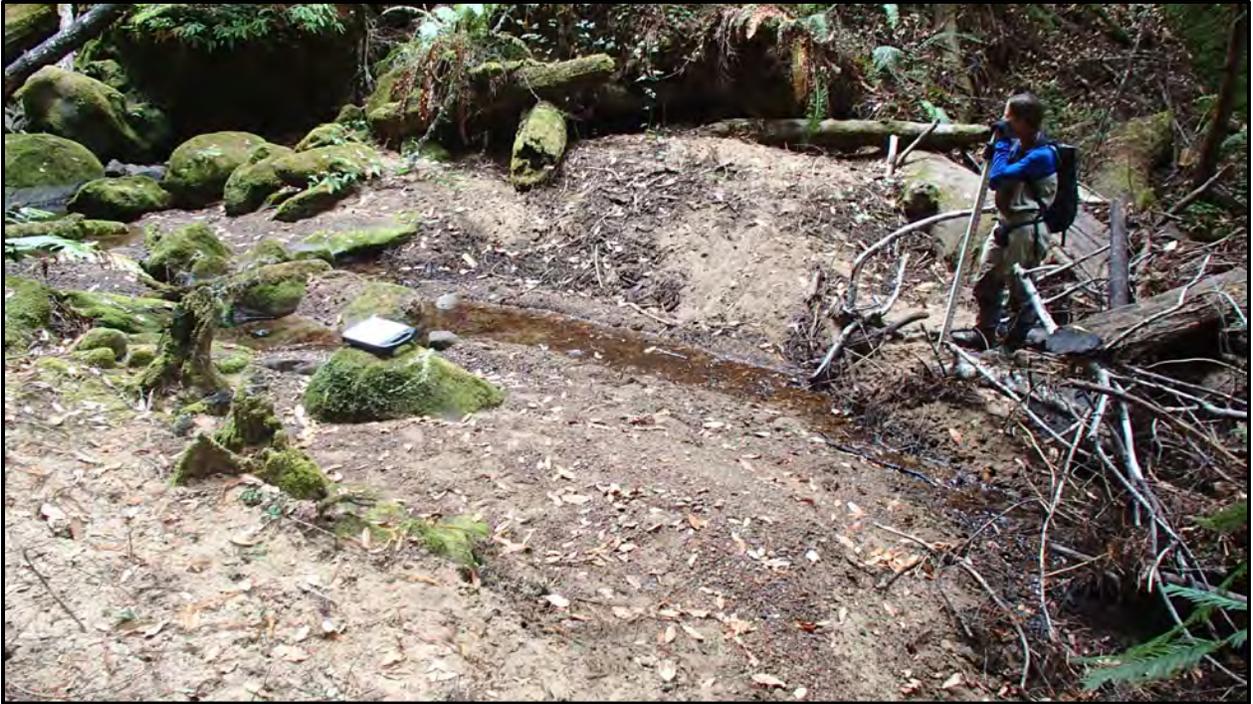
Figure 2-9 Typical sediment deposit behind a wood jam in El Corte de Madera Creek Preserve (2018). Flow is from left to right; this photo shows the recent sand deposit (much of which is still soft), and some winnowing to a coarser surface layer in the center of the channel. Only the top of the wood jam is visible.

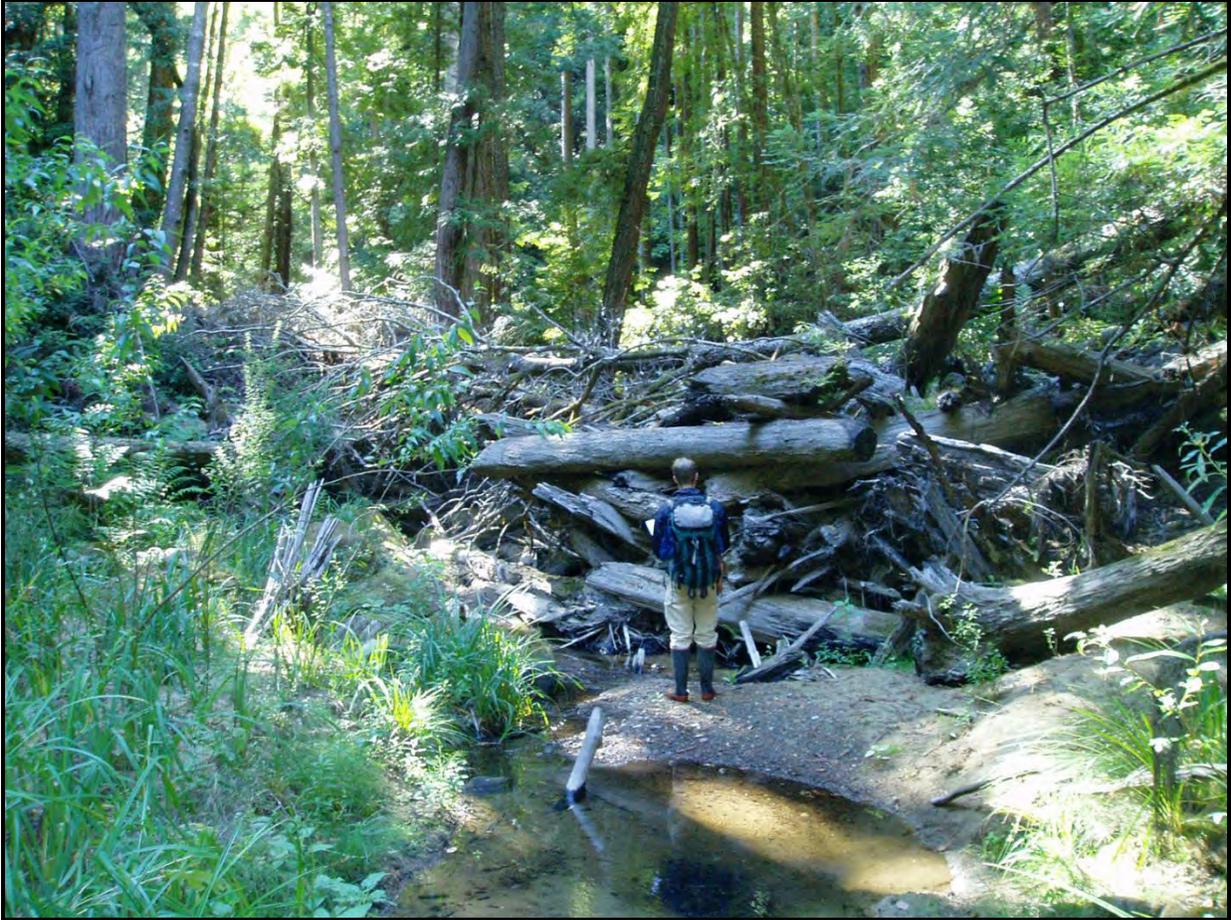
Figure 2-10 Typical wood jam in El Corte de Madera Creek Preserve (2004). Looking downstream: showing gravel deposit in the center, a sand deposit to the right, and a higher, partially-vegetated sand deposit to the left. Some wood jams are much larger than this example.

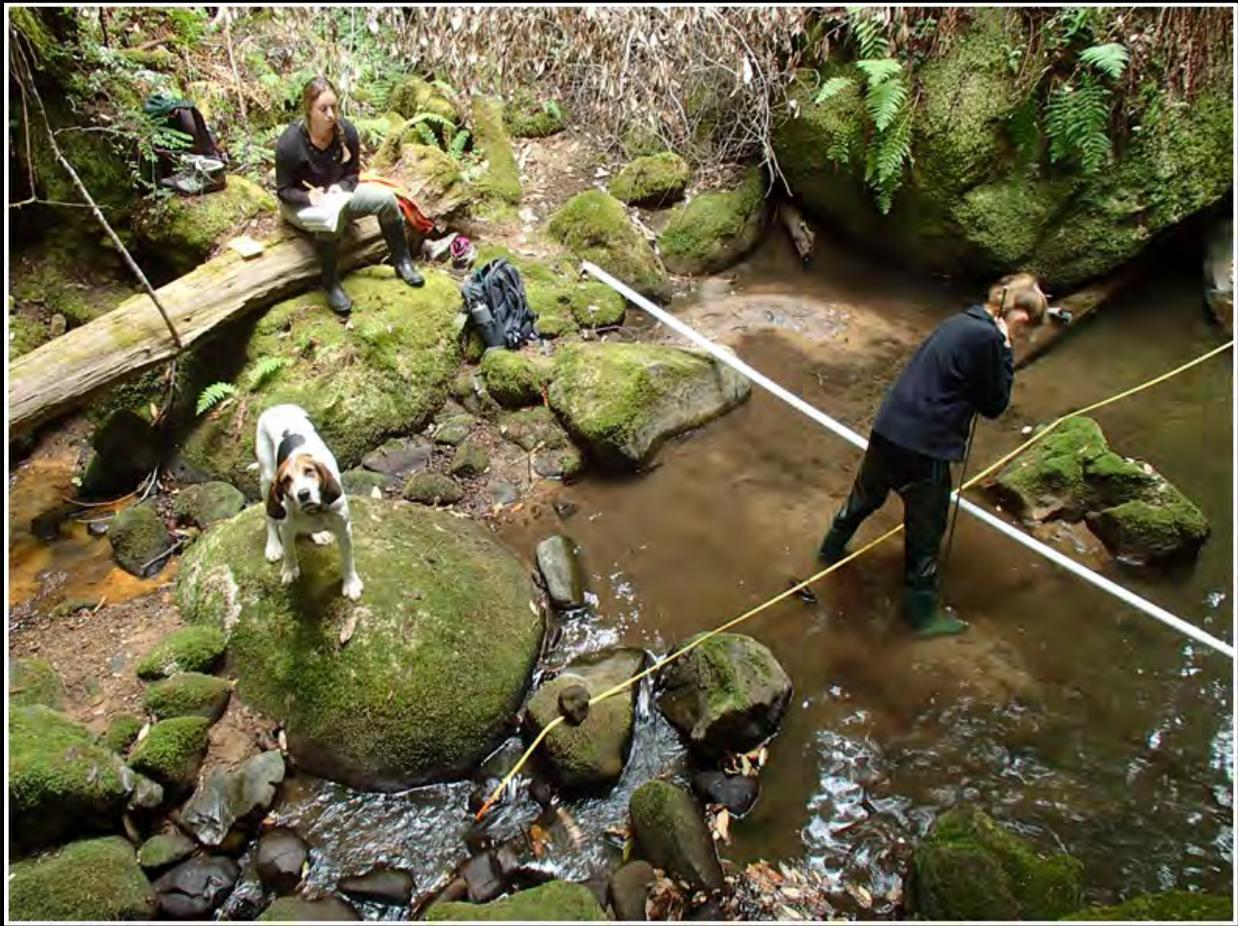
Figure 3-4  $V^*$  measurements being performed by MROSD interns: El Corte de Madera Creek Preserve, 2019. The downstream end of the pool (riffle crest) was defined here at approximately 3 feet on the tape, where the small boulders separate the flat pool surface from the moving water surface. The dog was a "volunteer" who had wandered into the Preserve, and was reunited with his owners- with assistance from MROSD rangers- at the end of the day (dogs are not permitted in ECDM).

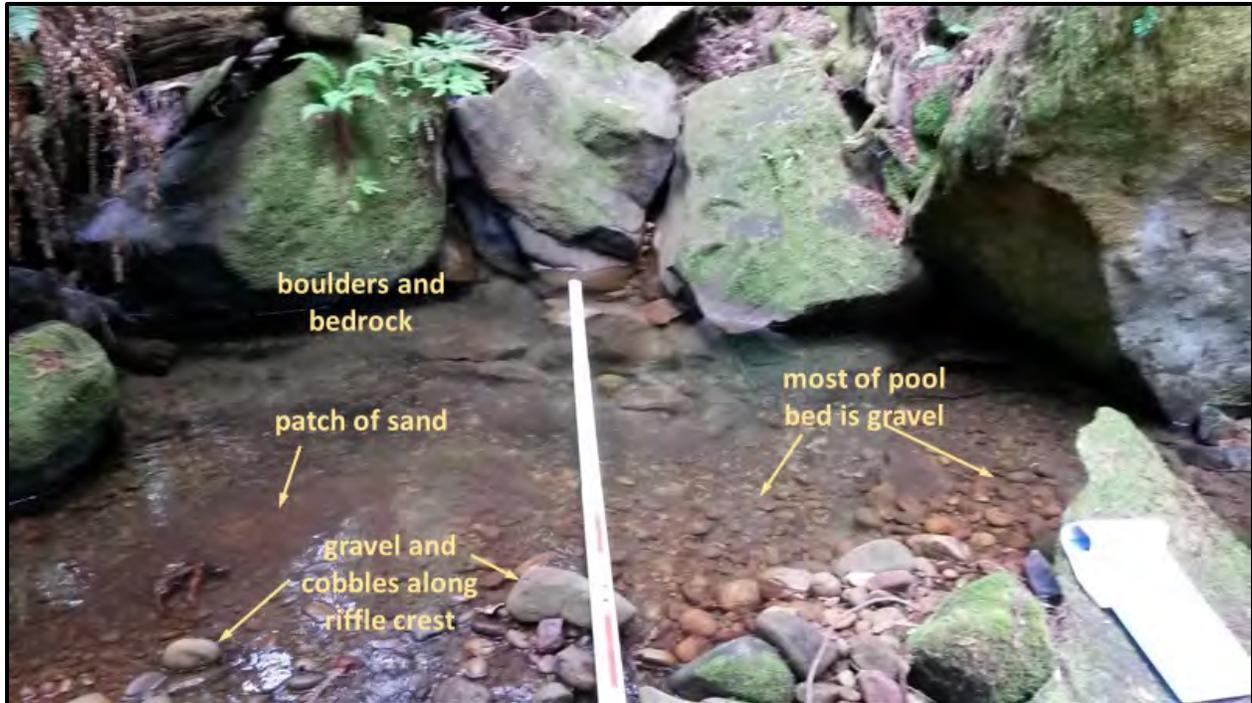
Figure 3-5 V\* pool showing different types of bed sediment that were recorded as part of the sediment-texture analysis. Photograph from 2018 when little sand was on the bed; the V\* value of this pool was measured to be 0.13 at the time.

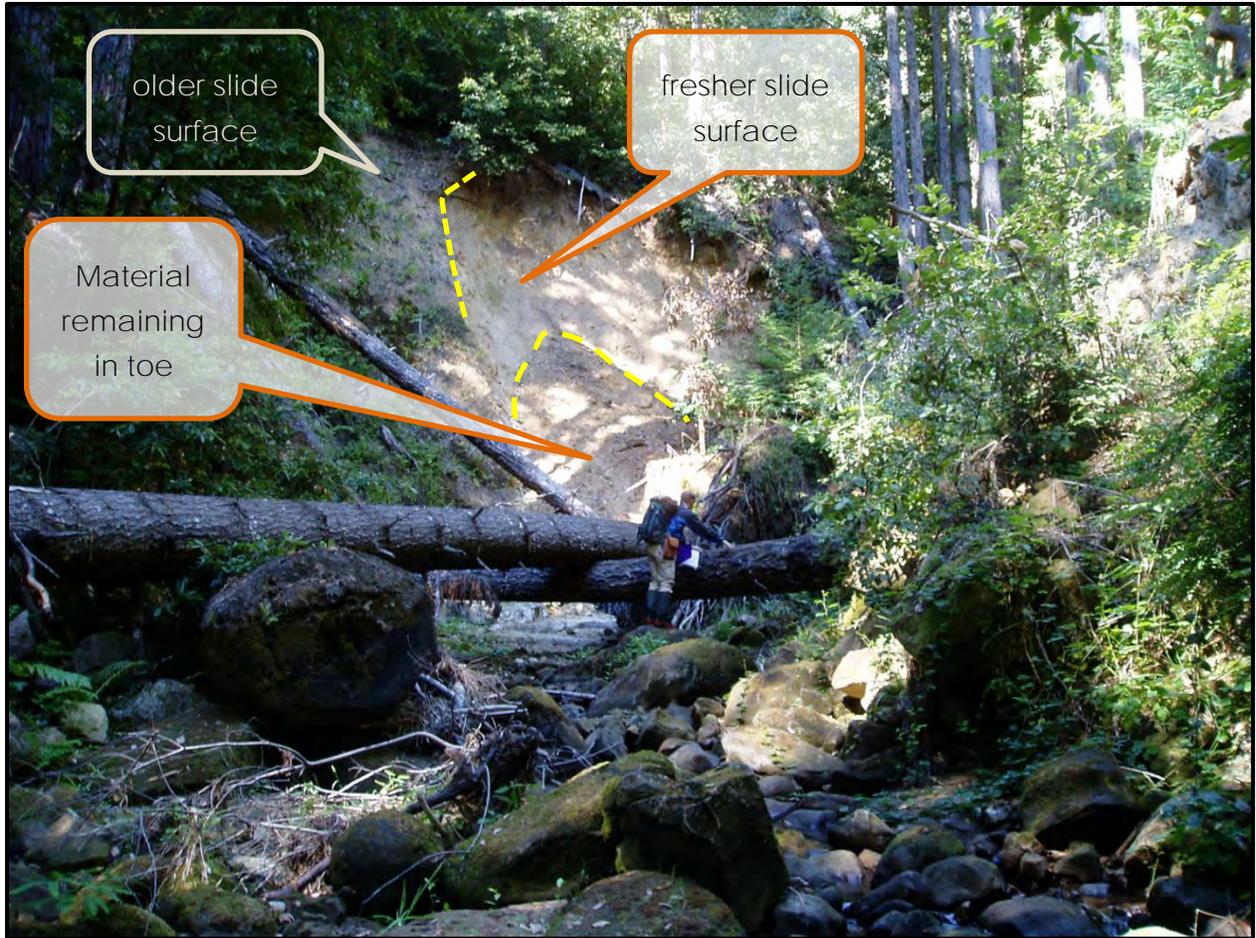
Figure 3-6 Typical sediment source that was measured, mapped, and inventoried: El Corte de Madera Creek Preserve. This photograph is from 2004; at least two episodes of sliding are visible in the photo, and a substantial portion of the sediment material remains at the toe of the slide. In the 2018 inventory, the hillslope above this location had also failed.

We inventoried large sediment sources near the channel, generally within the inner gorge, that were delivering sediment directly to the creek. The inventory included landslides, debris flows, bank failures, and gullies, plus selected other features (see Figure 3-6).

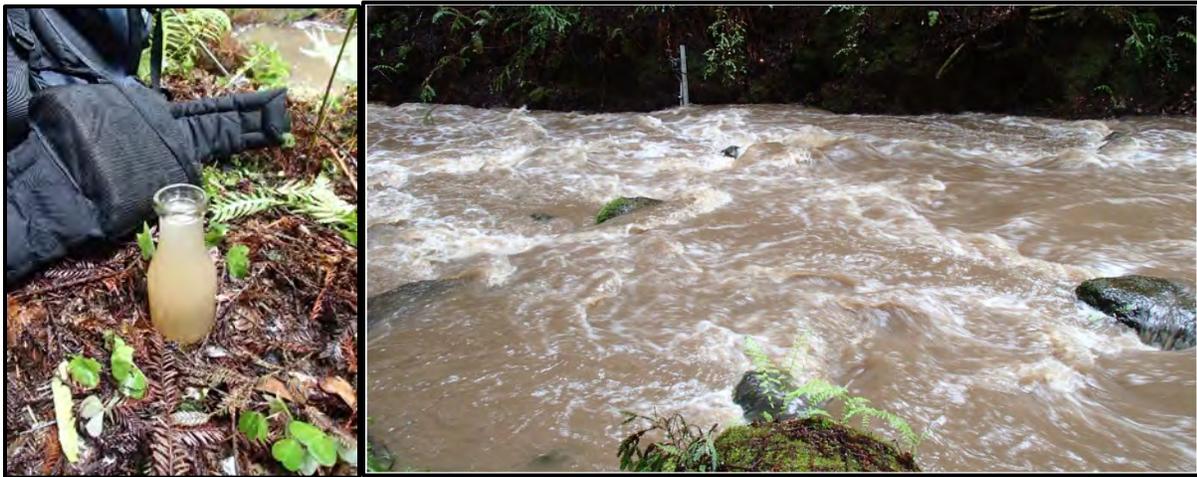
Figure 3-7 Sample in collection bottle and typical conditions during moderate to high flow: El Corte de Madera Creek at gaging station. Water is turbid and well mixed. We collected width- and depth-integrated suspended-sediment samples with a DH-48 sampler that we then analyzed for turbidity and suspended-sediment concentration.

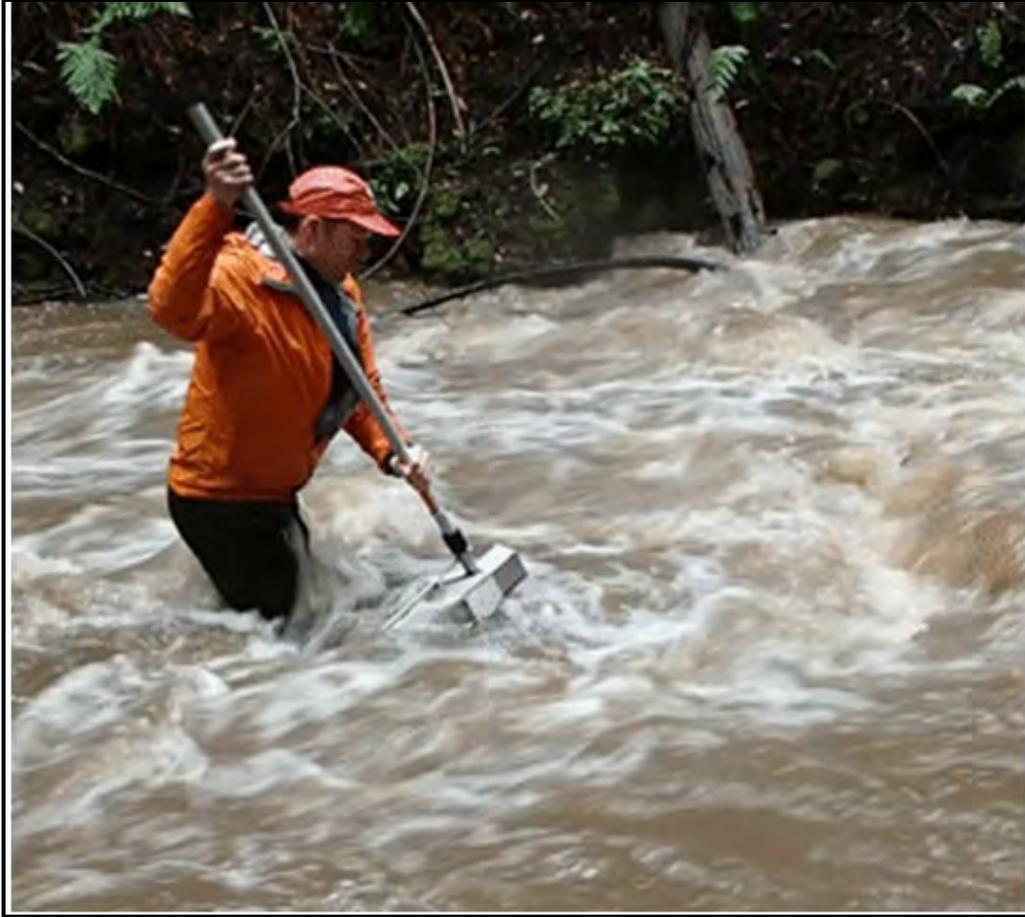
Figure 3-8 Bedload measurement near the peak flow of WY2018. We sampled bedload by wading across the creek and using a Helley-Smith bedload sampler at intervals across the active bed.
