January 17, 2020

## La Honda Creek Open Space Access Analysis

**La Honda Public Access Project**  
 Potential Driveway Access Locations

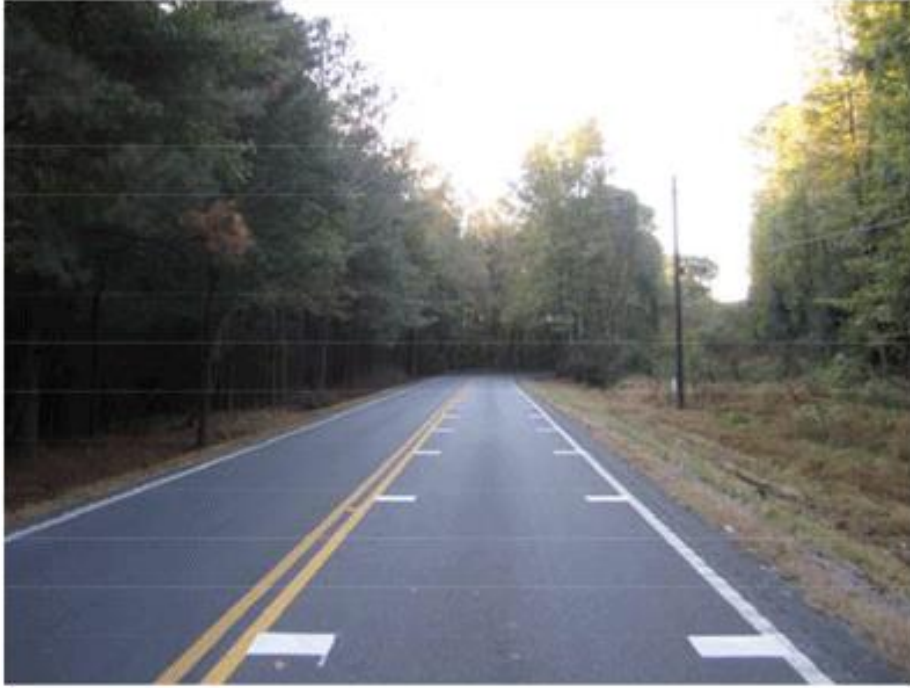
**Speed Reduction Markings (Optical Speed Bars)**

- *Speed reduction markings* are transverse pavement markings deployed at spot locations or along a corridor to reduce speeding. Markings are located along the edges of the roadway or across travel lanes, placed with decreasing spacing in the direction of travel. These visual cues typically result in drivers perceiving that their speeds are faster than their actual speeds. (Source: *California Manual on Uniform Traffic Control Devices*, 2014, Section 3B.22).

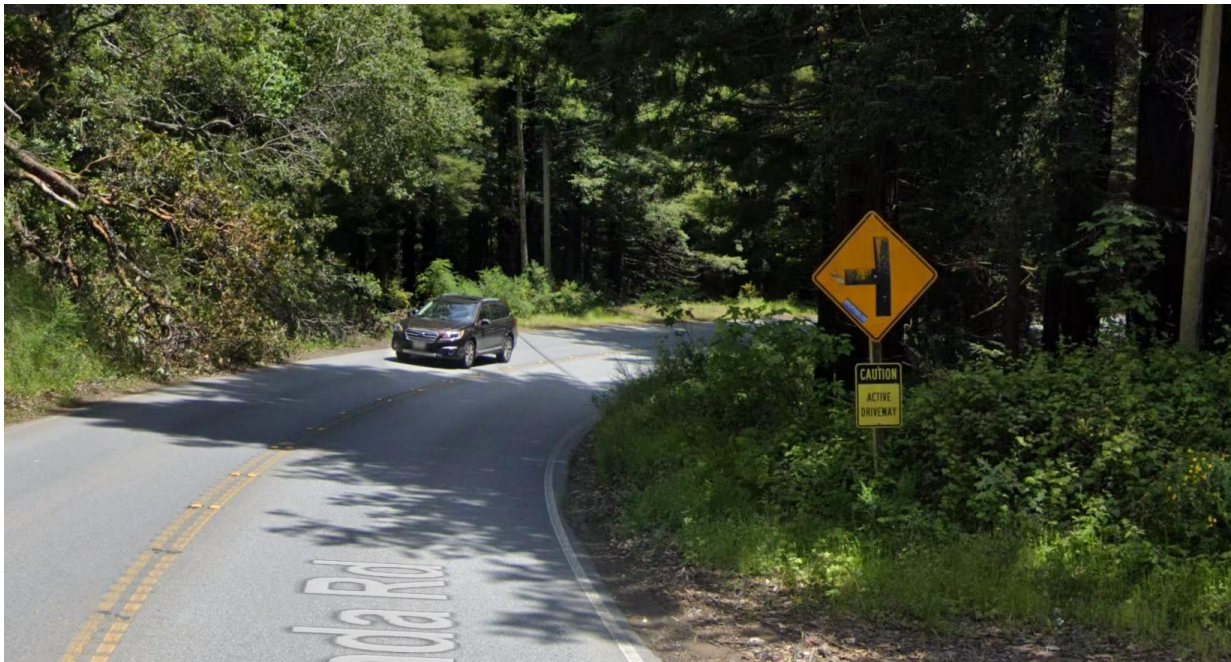
**Active Driveway Warning Sign**

- *Warning signs*, such as active driveway and speed warning signs, which help raise awareness for drivers of changes in the roadway conditions.
- *Radar speed feedback signs* are commonly used to make drivers aware of their speeds relative to the posted speed limit.

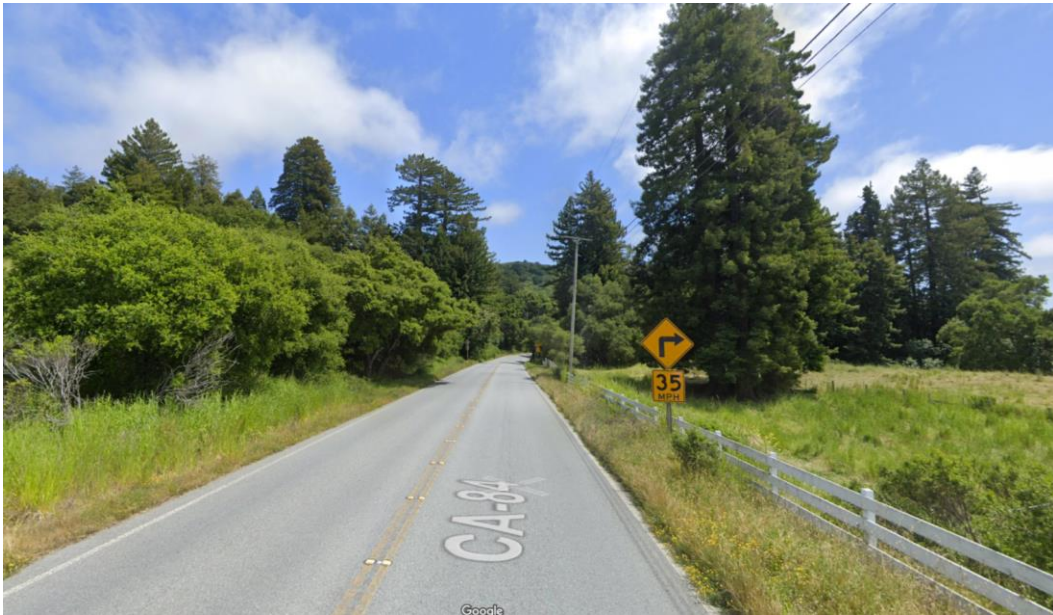
**Reduce Speed Warning Sign**

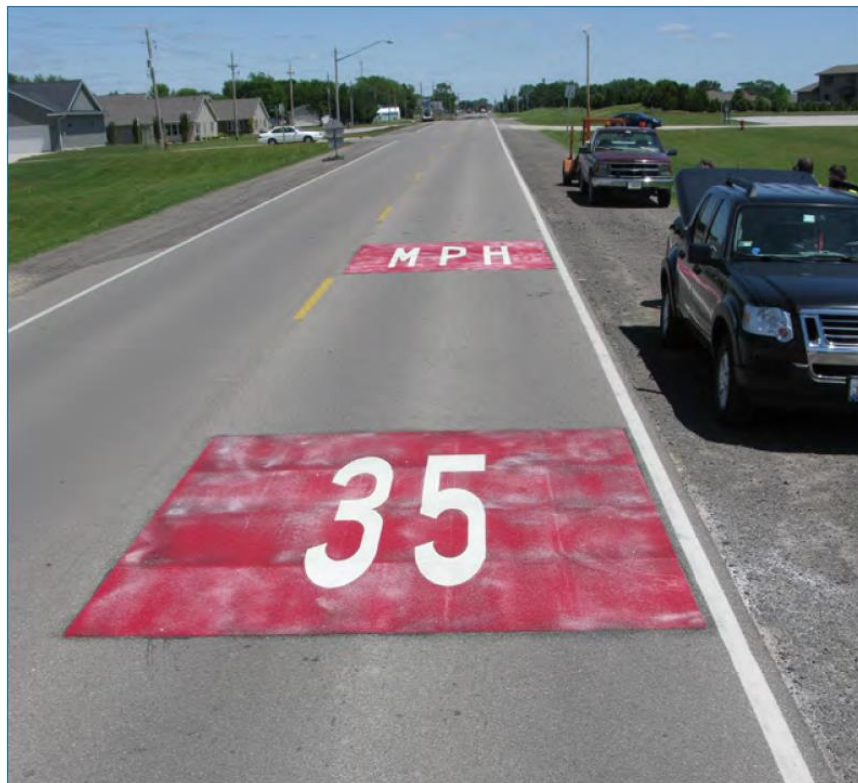
**Colored Pavement Speed Limit Markings**

- *Pavement speed limit markings* indicating the posted speed limit can help to emphasize the speed limit. Outside California, a variation on this has employed colored pavement to further raise awareness for drivers.

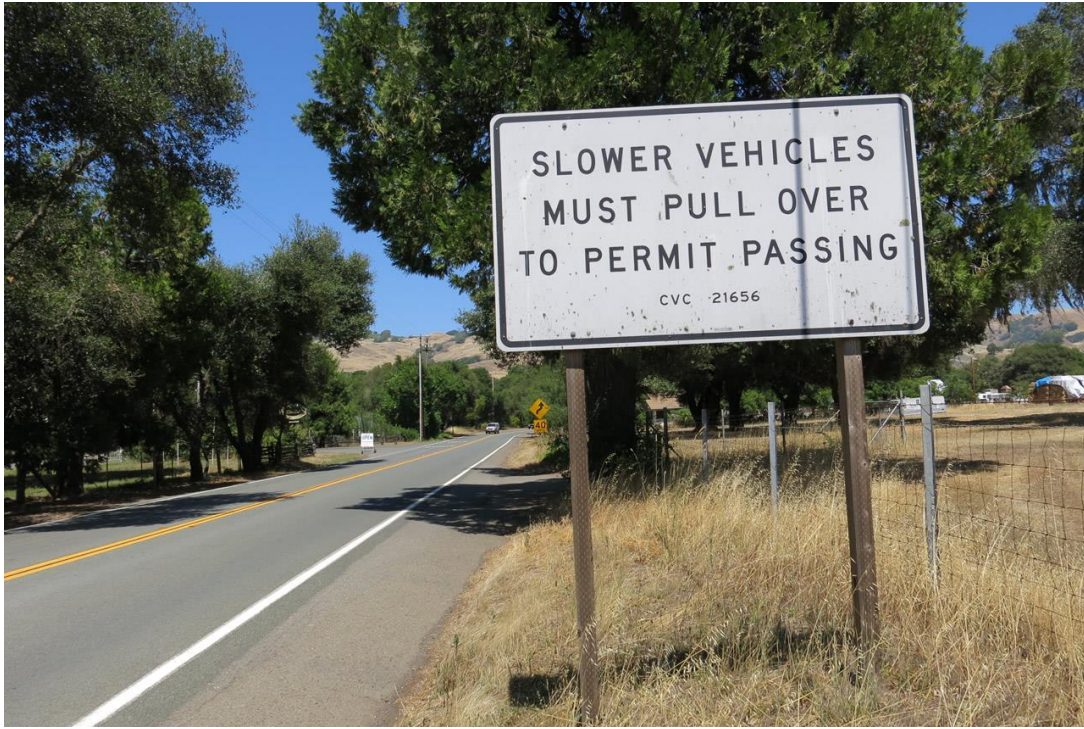
**Sign Directing Slower Drivers to Pull Over**

- *Passing lanes or turnouts* could provide an option for faster moving traffic to pass slower traffic and reduce the likelihood of vehicles passing by crossing the double yellow striping along the centerline of the roadway. There are numerous locations with paved or unpaved areas along the shoulder; however, it is unclear if these are located in the public right-of-way. Signage can also be used to complement the use of passing lanes or turnouts.

- To help reduce the incidence of unsafe passing, locations could be identified where there is sufficient right-of-way for passing lanes or turnouts. Where sufficient space is available, these could be modified and highlighted with the appropriate signage to direct slower vehicles to pull over.
