## La Honda Creek Open Space Access Analysis

**La Honda Public Access Project**  
 Potential Driveway Access Locations

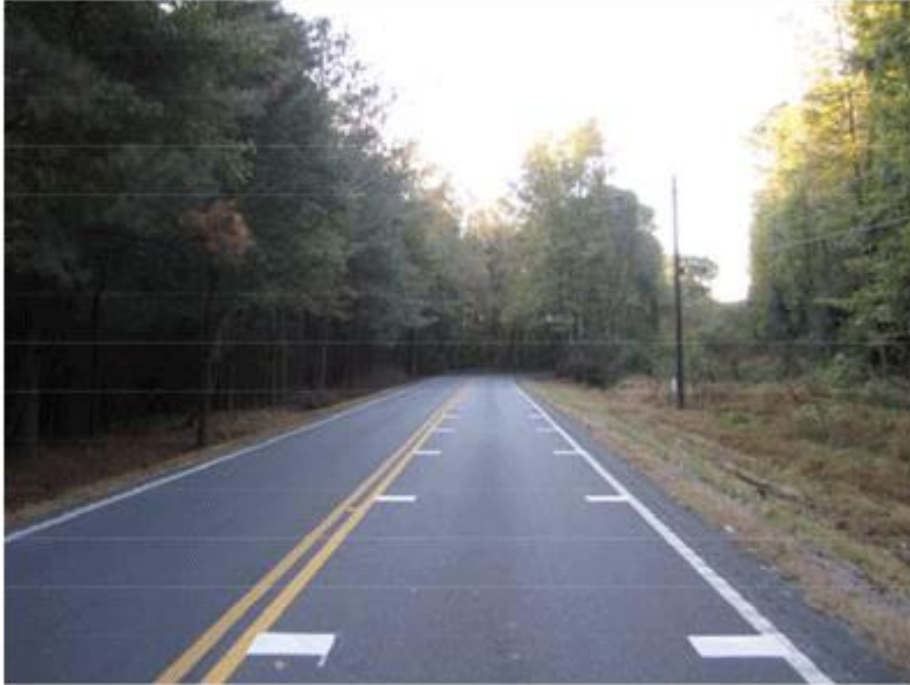
**Speed Reduction Markings (Optical Speed Bars)**

- *Speed reduction markings* are transverse pavement markings deployed at spot locations or along a corridor to reduce speeding. Markings are located along the edges of the roadway or across travel lanes, placed with decreasing spacing in the direction of travel. These visual cues typically result in drivers perceiving that their speeds are faster than their actual speeds. (Source: *California Manual on Uniform Traffic Control Devices*, 2014, Section 3B.22).
