Board Questions April 24, 2019

Item 4 - 3 historic structures

**LA HONDA CREEK OPEN SPACE PRESERVE
UNINCORPORATED SAN MATEO COUNTY, CALIFORNIA**

B: Structural Conditions Assessment and Treatment Recommendations

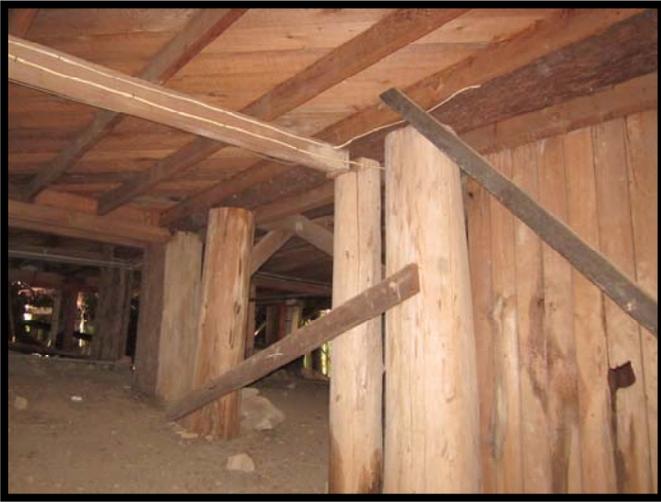
Substructure

The existing substructure consists of a series of vertical poles or 12 –inches to 16-inches in diameter partially embedded below grade. The depth of embedment is not known. The poles are typically located directly beneath beams and walls. Due to the sloping ground beneath the building, the posts vary in height above ground from around 1-foot to around 10-feet.

Three of the embedded poles were tested for deterioration below grade by pushing a screwdriver into the pole just below grade. In all three locations, the screwdriver could penetrate easily the full 6-inch length of the blade, suggesting significant deterioration of the below-grade portion of the poles. This is expected to be a fairly typical condition for the buried portions of the vertical poles. The above-grade portions of the poles were typically found to be in a reasonably good condition.

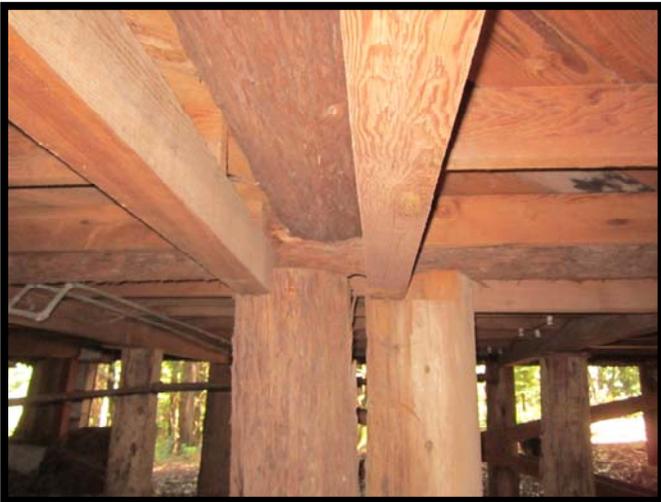
Floor Framing

The first floor framing includes a series of sawn lumber beams spanning in the North-South direction and sawn lumber joists directly above the beams spanning in an East-West direction. The beams are typically supported on notches in the substructure poles. The joists bear directly on top of the beams and there is typically no blocking or bracing between joists.

The floor framing is typically in good condition. The finished wood floor showed little distortion, squeaks, cupping, warping, etc. Overall the floors appear to be sound and level.

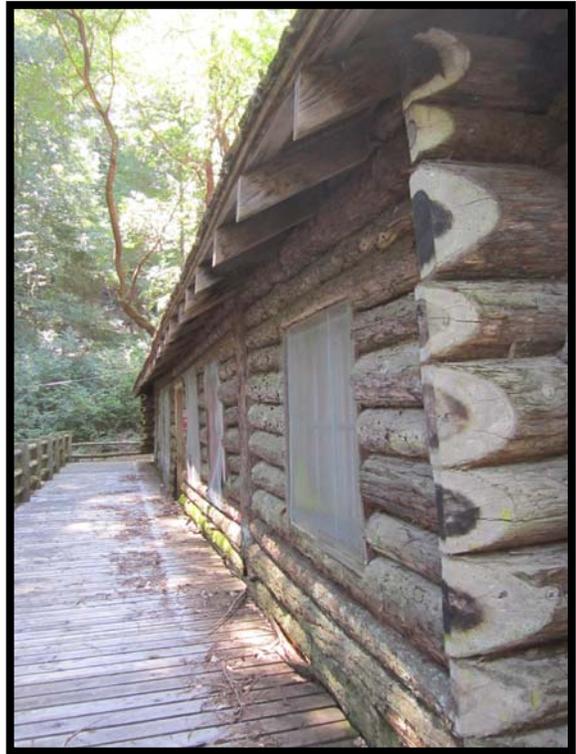
At door and window openings, the horizontal logs terminate at the opening framing. The logs are stabilized by vertical dowels of around 1.5-inch diameter that appear to have been installed into vertical holes in the logs. It appears that once the second log was installed, a vertical hole was drilled through the second log and partially into the first log below. The dowel was then driven into the hole, securing the second log. This was repeated up the height of each wall opening. The dowels are typically not visible but can be clearly observed at several locations.

In general, the log walls appear to be in good condition. Some localized beetle or termite damage was observed and a more extensive inspection should be completed by a licensed pest control firm. Some gaps have developed between logs due to shrinkage and loss of the fibrous caulk material. These gaps should be re-filled and made rodent-proof.

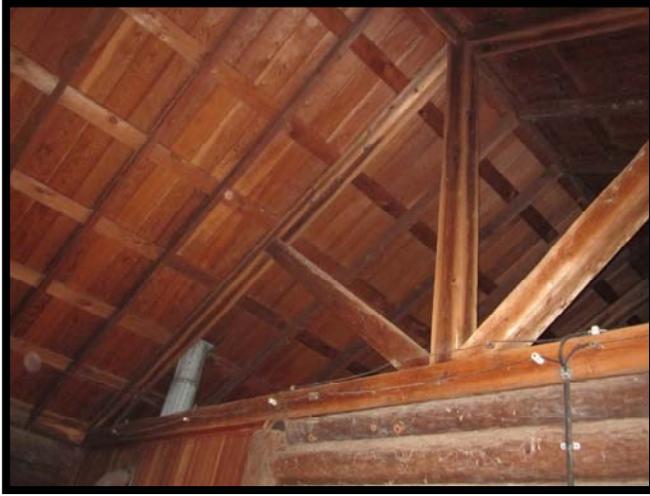
Roof Structure

The double pitched roof structure includes heavy timber trusses, rafters and sheathing.

In general, the roof structure appears to be in good condition, with no significant deterioration or distress observed. The shingles may need to be replaced in the near future, although the evaluation of roofing materials is outside of our expertise.

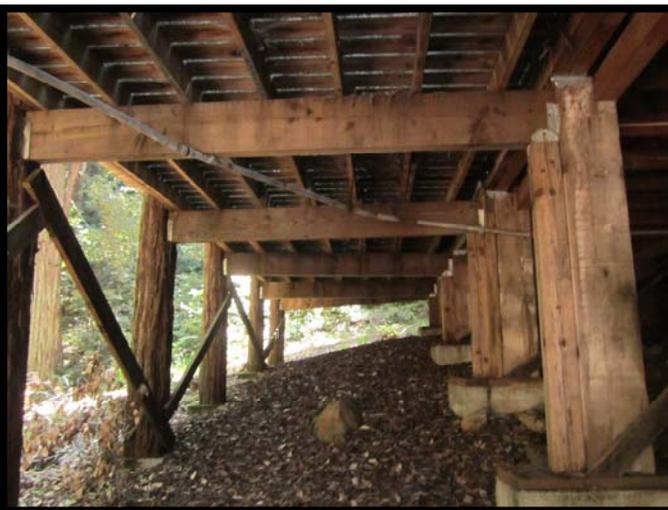
Perimeter Deck

A sawn lumber deck extends around all four sides of the building. The deck around the west side of the building appears to be an older redwood deck with untreated joists and beams. The deck on the east side of the building appears to be newer and included pressure-treated beams and joists and untreated wood decking. The deck beams are typically supported by vertical logs of around 12-inches in diameter at the edge of the deck and on 6x6 sawn lumber posts at the edge of the

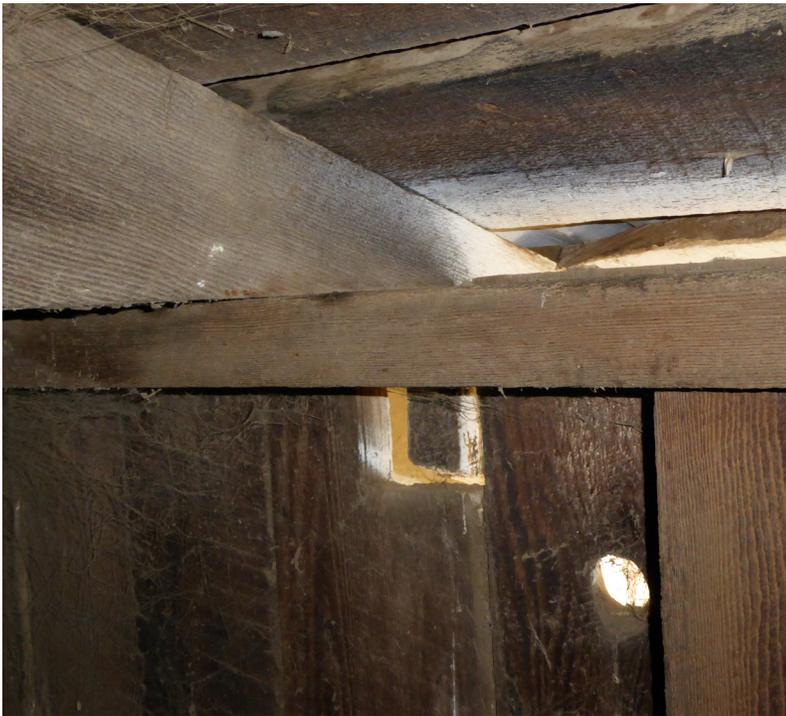
Image 30 - (top left) The notch in the rafter tail at the top plate.

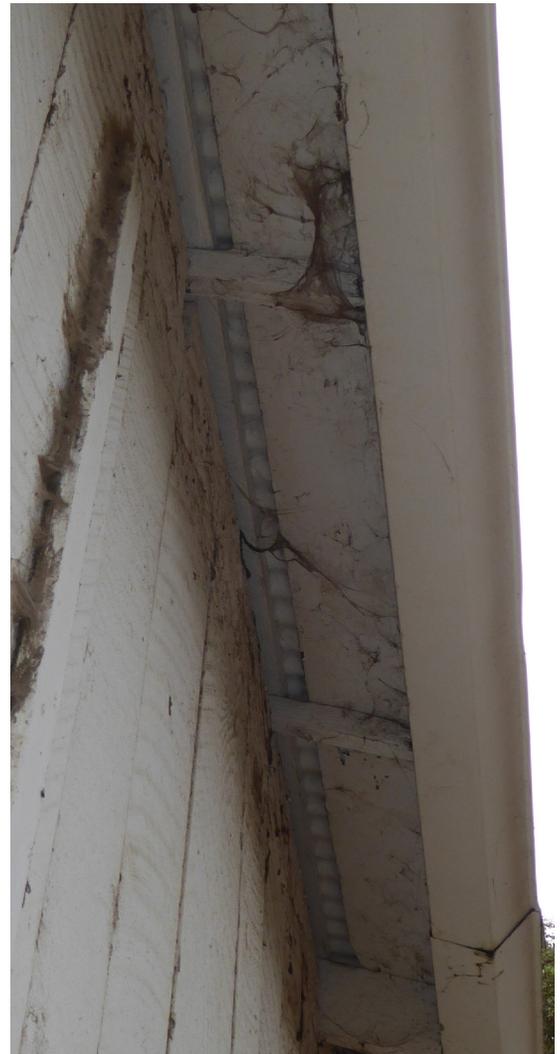
The rafters in fair condition are broken at the tail outside the exterior walls or show heavy deterioration of the tail end only. Rafter ends are most deteriorated where the gutter does not extend.

Image 31 - (above) Deteriorated or broken ends of rafter tails are visible behind the gutter.

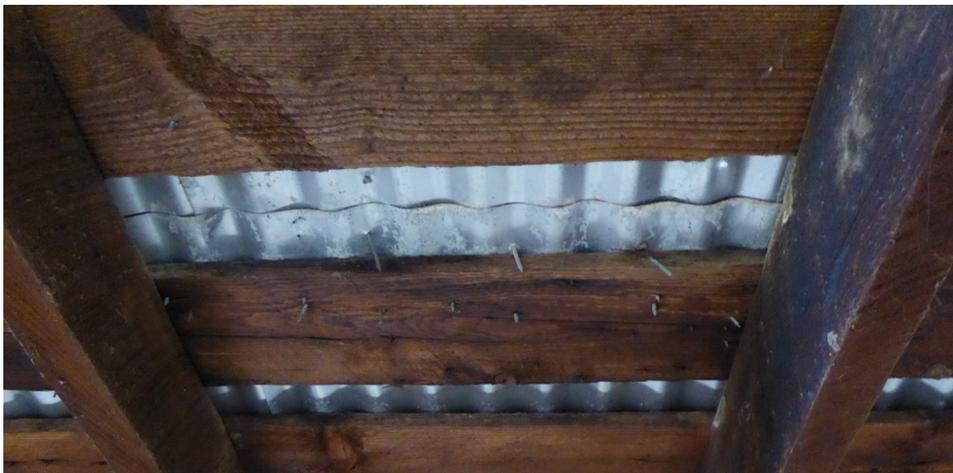
Image 36 - Nails protrude beyond the sheeting into the headspace of the rafters.
