Midpeninsula Regional  
Open Space District

Contract Amendment for Engineering Services with Wiss, Janney, Elstner Associates, Inc., for the Mount Umunhum Radar Tower Repair Project

## **MOUNT UMUNHUM RADAR TOWER Condition Assessment and Recommendations**

### **Final Report**

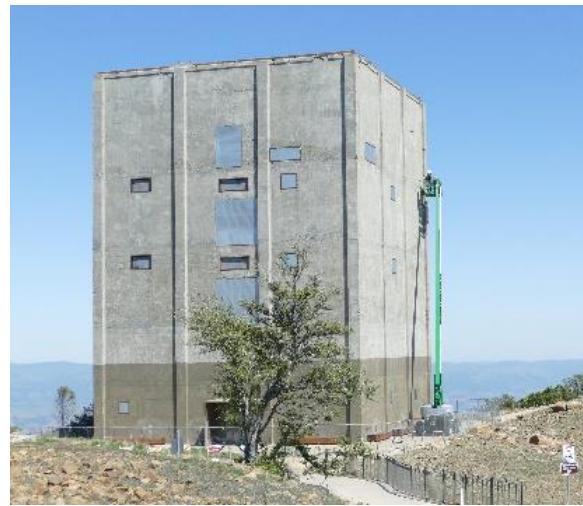
*Figure 2. Recent exterior view of the radar tower facing east.*

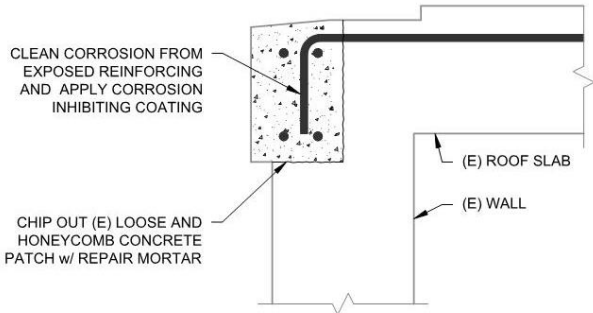
**2 ROOF EDGE REPAIR**  
SCALE: 1 1/2" = 1'-0"

Figure 7. Base perimeter roof edge beam repair.

At a minimum, we recommend performing the following repairs at the walls to address the most significant areas of distress using common concrete repair procedures. Schematic details for these repairs are provided in Figure 6 through Figure 8. These repairs will be needed regardless of which other repair strategies for the remaining portions of the wall are selected. The base exterior concrete repairs are intended to address the conditions of significant concrete deterioration including the pilasters that provide a significant portion of the load-carrying capacity of the walls. The base repairs are likely to allow the structure to remain standing without collapse for at least one hundred years. Implementing only the base repairs, without Options 1 or 2, however does not allow for the installation of an elastomeric coating on the walls. The lack of coating on the walls will lead to continued moisture penetration into the building, resulting in standing water and deterioration of the floors and interior. WJE recommends the following base wall repairs:

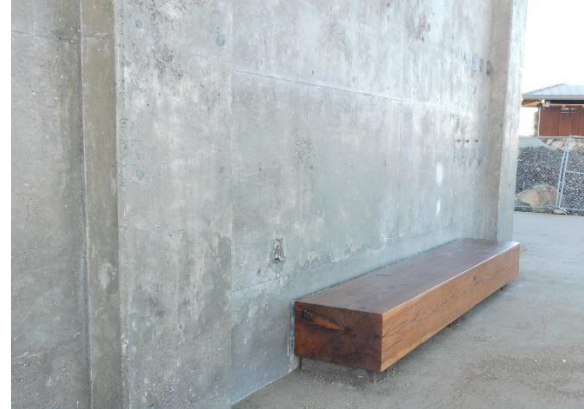
Figure 11. Wood bench installed close to exterior wall.

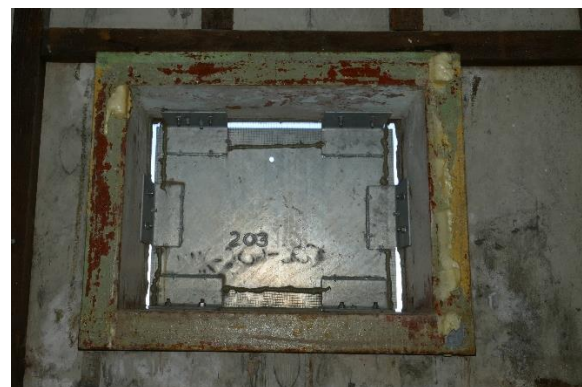
Figure 16. Interior of similar opening in concrete wall with gap around steel plate perimeter.

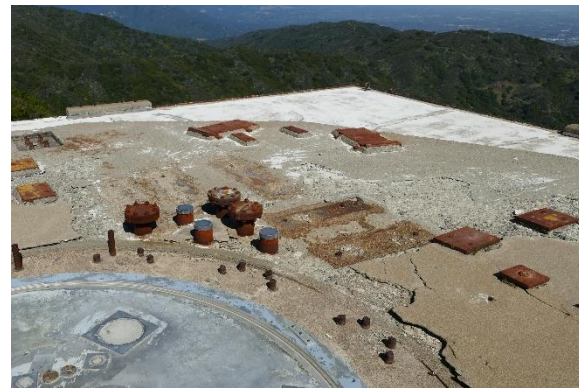
*Figure 20. Steel plates, pipes, conduit, and other penetrations at the top of the concrete pedestal.*

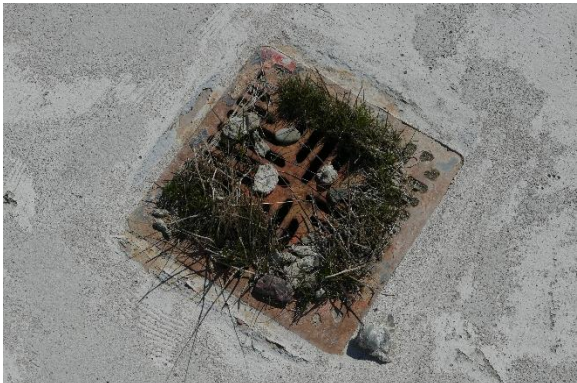
The roof is divided into quadrants by perpendicular expansion joints in the wearing slab (Figure 30) that do not extend through the structural slab (Figure 31). There is a roof drain (Figure 32) in the center of each quadrant, however the drain pipe was reportedly disconnected and sealed with grout to prevent animal intrusion. All four roof drains had plants growing out of them at the time of our observation.

Figure 32. One of four area drains with plants growing out of the drain.

The built-up roofing membrane is concealed beneath the wearing slab and could not be observed. Single-ply membrane flashings have been added around the concrete pedestal and roof hatches (Figure 67), and a fluid-applied waterproofing coating has been applied to the wearing slab over the entire main roof area (Figure 68) and onto these single-ply flashings (Figure 69). There is also evidence of waterproofing repairs at underlying cracks in the concrete wearing slab, and spray foam in many joints and gaps at penetrations and flashings. There are grasses and moss growing along many joints, cracks and gaps at the roof, including plants growing out of all four roof drains (Figure 32).

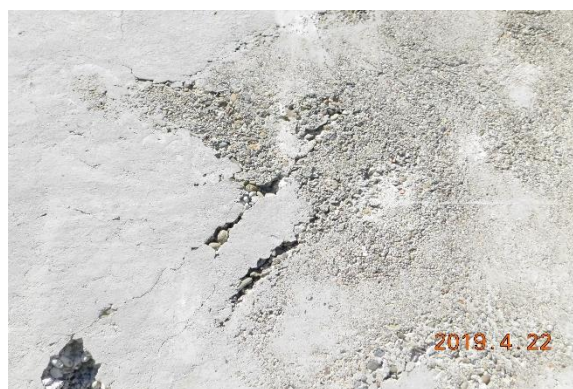
The exterior surface of the concrete walls have an anti-graffiti coating on all four elevations up to a height of approximately 16 feet above the exterior grade. Above this level, the concrete walls are currently uncoated. The surfaces of the concrete are generally rough, weathered, and have numerous areas of poorly consolidated concrete with exposed aggregate, surface voids due to poor consolidation (honeycombing/rock pockets) (Figure 37 and Figure 38). Some areas have little or no concrete cover over reinforcing steel, with corrosion staining and spalls visible at these locations (Figure 39 and Figure 40). Also observed were debris embedded in the concrete from the original construction including pieces of wood and a cigarette lighter (Figure 41 and Figure 42). WJE sounded the surface of the concrete to identify areas of loose concrete. Areas of surface voids and loose concrete are indicated on elevation sketches for each wall, which are provided in Appendix C.

Figure 38. Concrete with a rough surface and areas of poor consolidation.

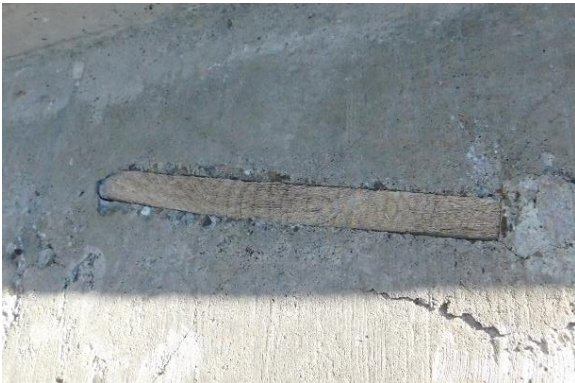
*Figure 41. Piece of wood embedded in the concrete wall on the east elevation.*

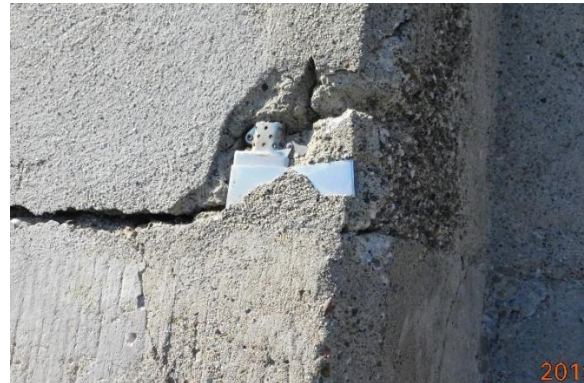
*Figure 42. Cigarette lighter embedded in the concrete wall on the south elevation.*

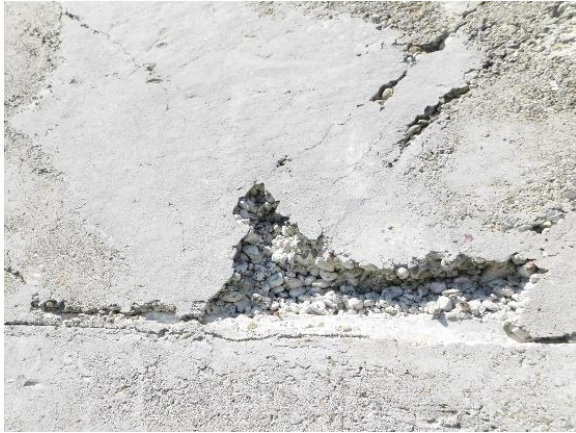
Areas of poor consolidation of the concrete are typically concentrated at the base of the walls immediately above the second through fourth floor slabs (Figure 43 and Figure 44). At these locations horizontal construction joints between the slab and wall concrete placements contain a key (a small formed ridge of concrete along the top of the top of the slab along and within the thickness of the wall to enhance the mechanical bond between the separately-placed slab and wall). At numerous locations, the poorly consolidated concrete extends sufficiently deep into the wall's thickness to expose the reinforcing steel. Acoustic hammer sounding suggested a majority of the concrete adjacent to the visible areas of poorly consolidated concrete with pockets of exposed aggregate are structurally sound, with aggregate well-bonded to the wall, despite their appearance and localized small areas of loose aggregate. Some of these areas of poor consolidation appear to have been modified at some time in the past, by the addition of a trowel applied patch material, possibly following initial concrete placement. These patches were identifiable by their surface finish and coloration, which distinctly differ from the cast-in-place concrete wall (Figure 43). Some of these patches appear to be delaminating from the concrete substrate.

*Figure 43. Poorly consolidated concrete above the horizontal construction joint above the floor slab with a smooth patch area above.*

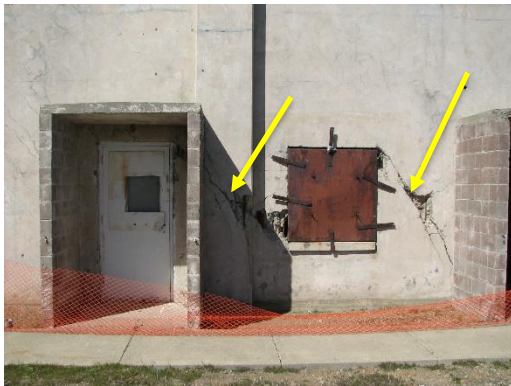
Diagonal cracks were observed at multiple locations on the exterior walls. At the first floor on the east side, previously patched cracks were observed between window and door openings (Figure 45) that likely formed during the Loma Prieta Earthquake in 1989, whose epicenter was only 5 miles to the southeast. The most significant of these cracks were present until about 2014 when they were repaired and the adjacent window and door openings were infilled with concrete (Figure 46).

*Figure 45. Cracks visible at east elevation (arrows). (Photo taken in 2013 by WJE)*

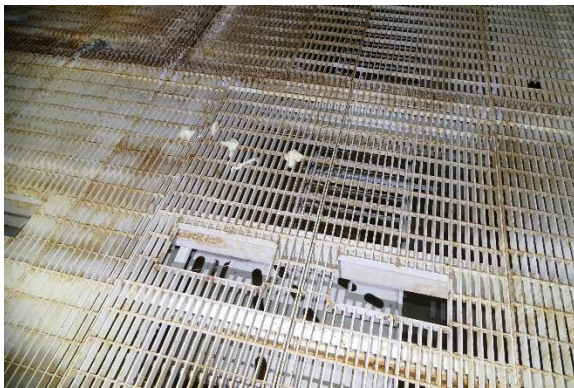
Several abandoned openings (former mechanical penetrations) in the floor slabs are covered with metal plates which may date to the building's decommissioning, but most floor openings are covered with plywood fastened to the floor, reportedly installed in 2016. The metal plates typically have surface corrosion (Figure 82), and the wood covers are generally in fair condition (Figure 83), though ongoing deterioration of these wood covers should be expected given the indications of moisture intrusion throughout the building. The metal grate floor of the fifth-floor mezzanine has a number of rectangular holes (Figure 84) that someone could be injured by stepping into, and generally has surface corrosion (Figure 85).

*Figure 84. Rectangular holes in the mezzanine floor grating are large enough to accidentally step through.*

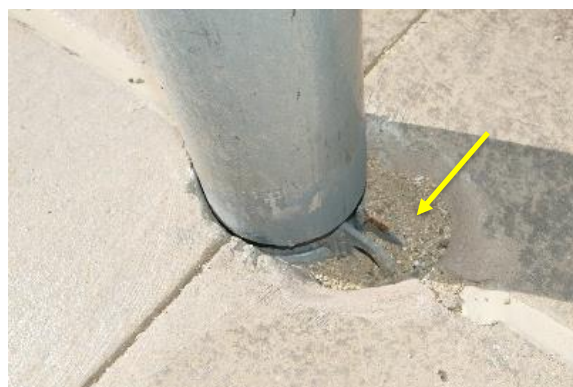
the concrete sidewalk and can be removed (Figure 88 and Figure 89). Removing these bollards can be difficult due to sand and debris that collects between the bollard and the sleeve.

*Figure 89. Base of removable bollard. Note sand in the recess adjacent to the bollard sleeve (arrow).*

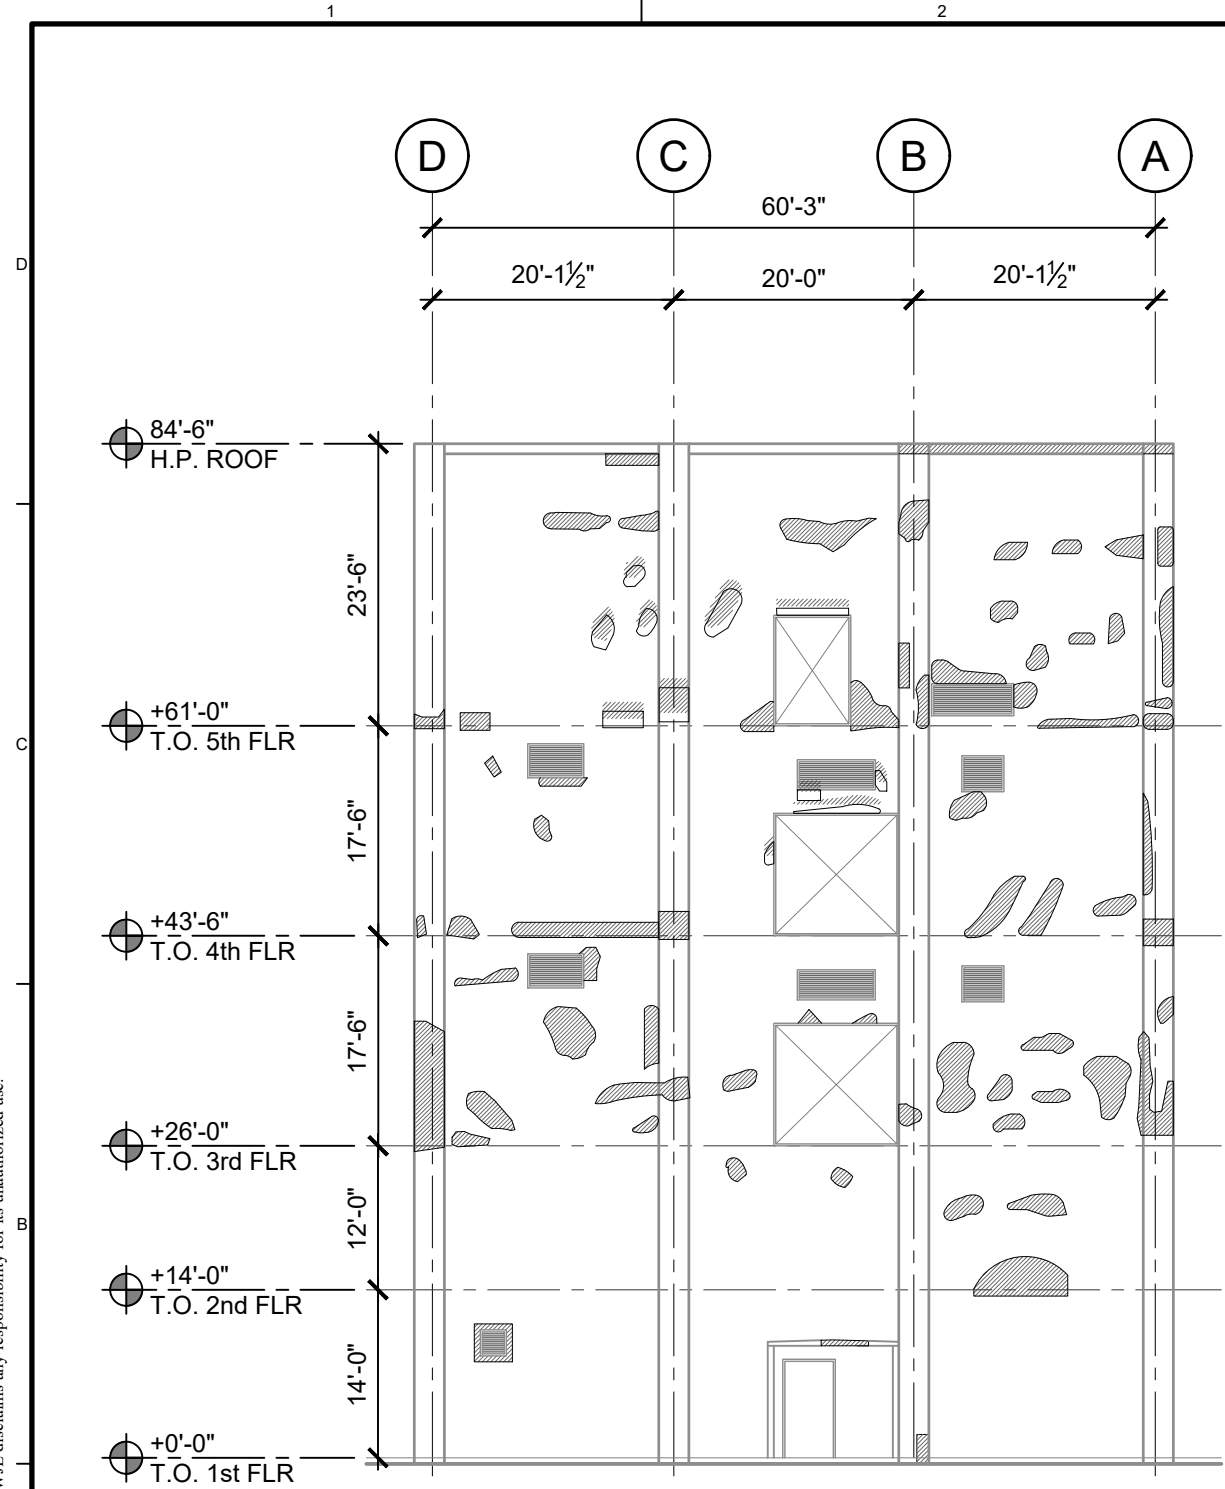
**1 WEST ELEVATION**  
SCALE: 1/16" = 1'-0"

## **APPENDIX C: RESULTS OF EXTERIOR WALLS SURVEY**
